Listing Information Package

Inspection Report

AmeriSpec Move in Ready

Property Address:
123 Timber Leif Ridge
Blue Mountains Ontario N0H 1J0

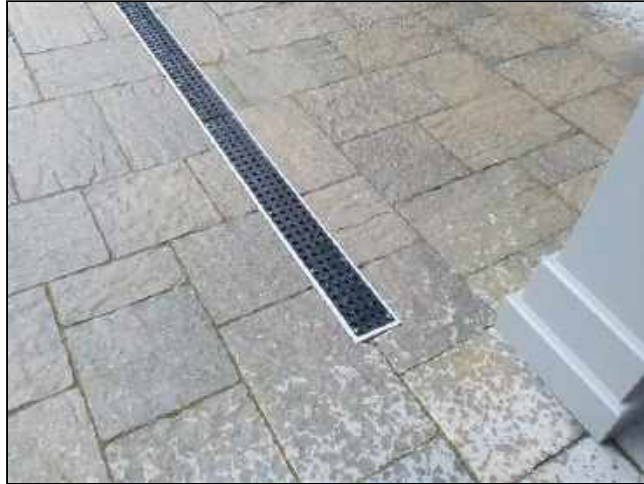
1.10 (2) Trench drainage system observed on the pool patio. It is beyond the scope of this inspection to inspect or perform tests on underground drainage systems. Suggest client obtain information from sellers about the drainage system.

1.10 Item 1(Picture) Trench drain

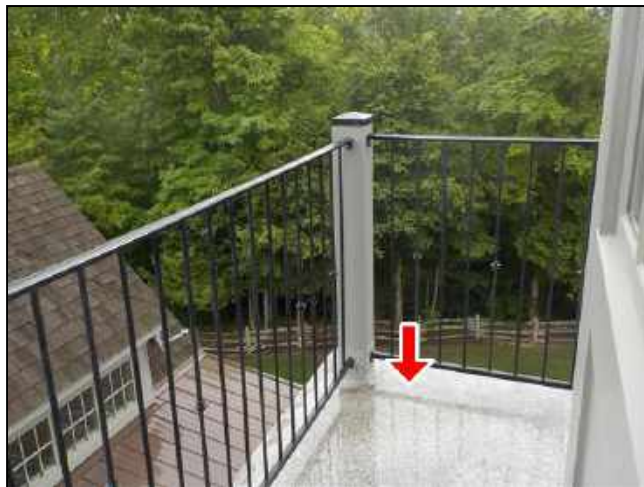
1.15 Item 1(Picture)

1.15 Inspected. DURADEK roof and deck cover noted.

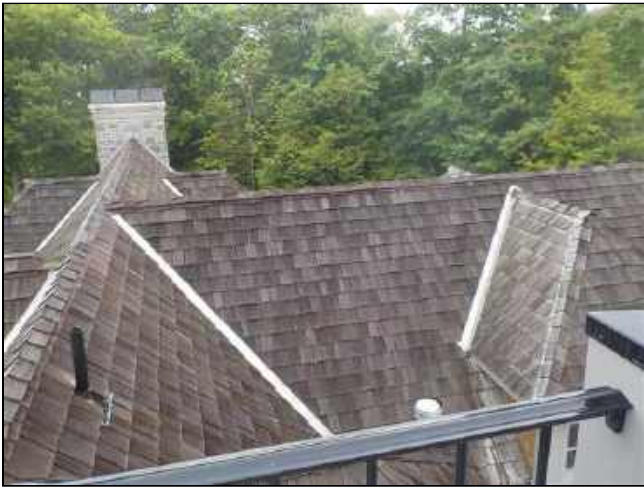
2.0 The roof was inspected from the ground and eaves only due to the roof type, height and pitch. Our roofing review is limited to visible accessible components as viewed from these areas. Roof shows normal wear for its age and type. No damaged, deteriorated, or missing roofing materials were observed; it appears to be in serviceable condition at time of inspection.

2.0 Item 1(Picture) Roof conditions

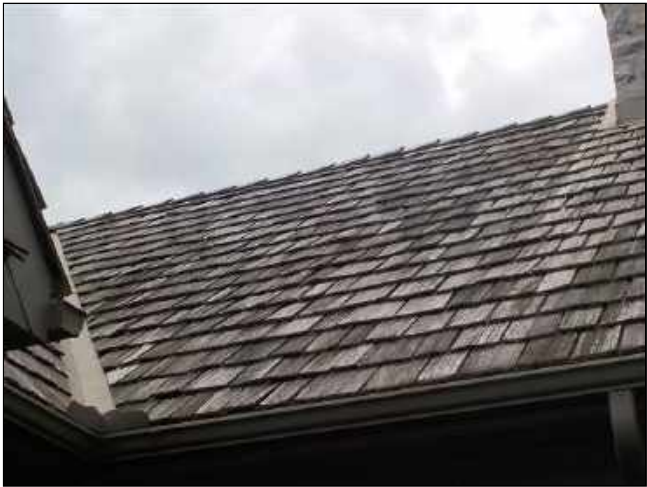
2.0 Item 2(Picture) Roof conditions

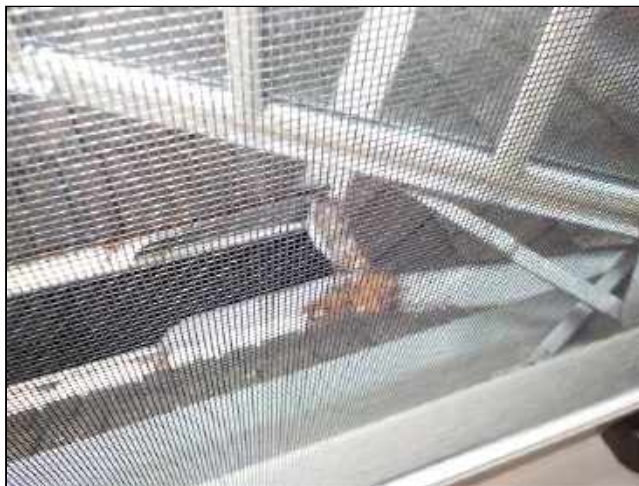
2.2 Debris blocked areas observed, suggest cleaning gutters and downspouts, which should be a regular part of maintenance.

2.2 Item 1(Picture) Gutter debris

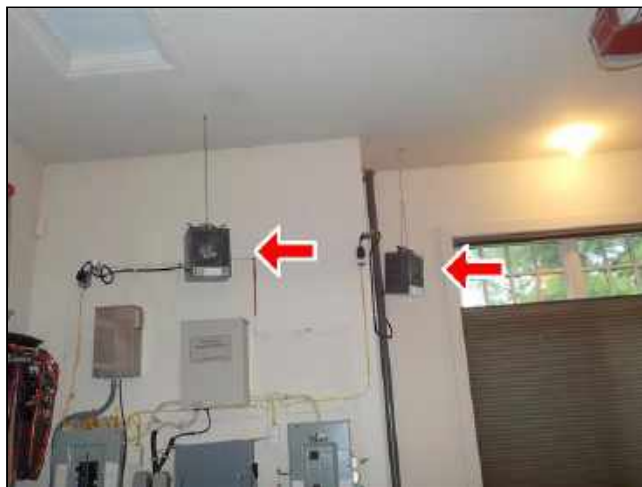
3.10 (1) Ceiling mounted electric heaters present.

3.10 Item 1(Picture) Electric heaters

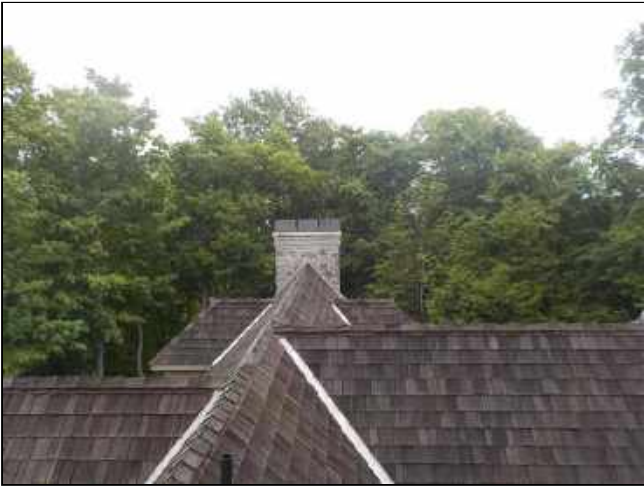
4.0.C Item 1(Picture) Chimney conditions

4.4.C The chimney is used to vent the outdoor wood burning fireplace, the main floor gas fireplace and the basement gas fireplace.

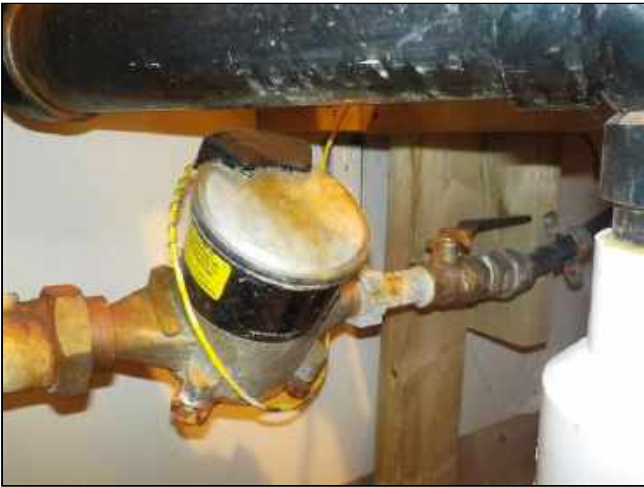
6.0 Item 1(Picture) Main shut off

6.0 (2) A cross connection control (back flow prevention) with an expansion tank is present.

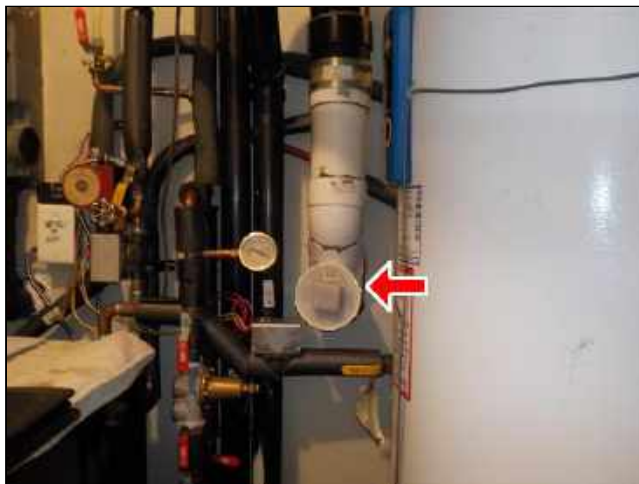
6.1 Item 1(Picture) Main clean out

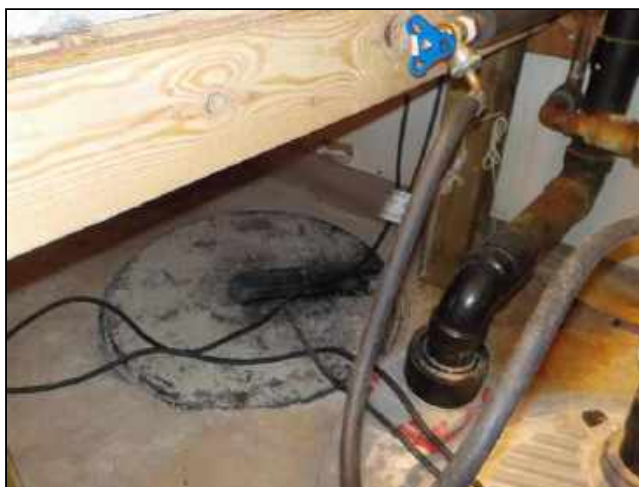
6.3 Item 1(Picture) Sump

6.3 (2) Sump pumps should be tested on a regular basis. Installation of a backup pump and power supply is recommended.

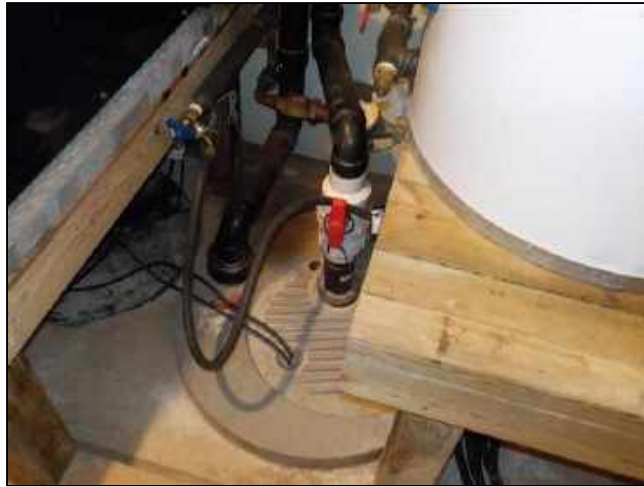
6.4 Inspected. Check valve and vent pipe present.

6.4 Item 1(Picture) Sewage pump

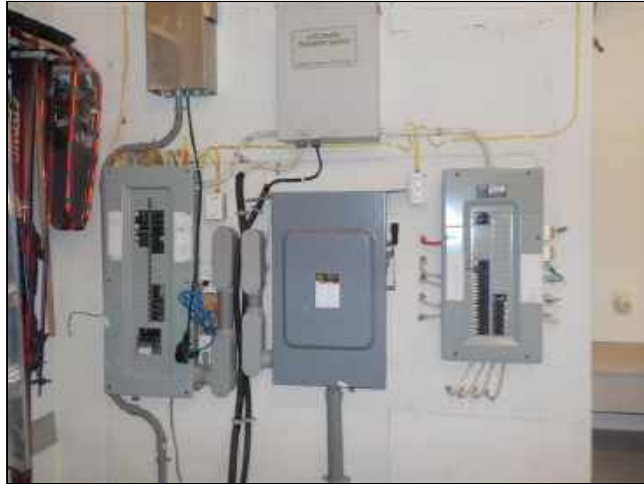
7.2 Item 1(Picture) Service disconnect and main panel

- **Futures are available for expansion in the electrical panel**

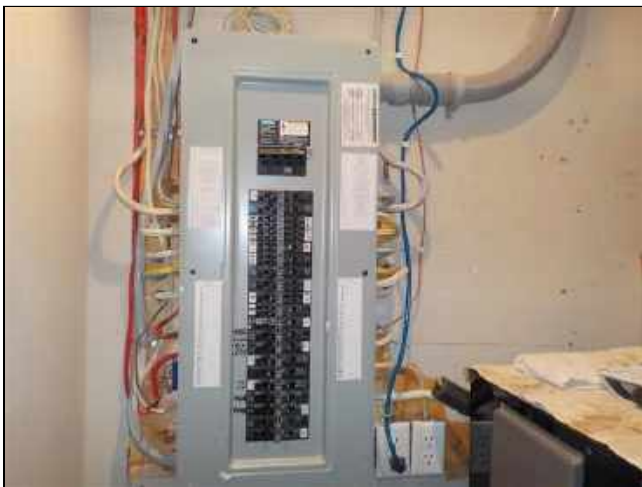
7.3 Item 1(Picture) Mechanical room sub panel

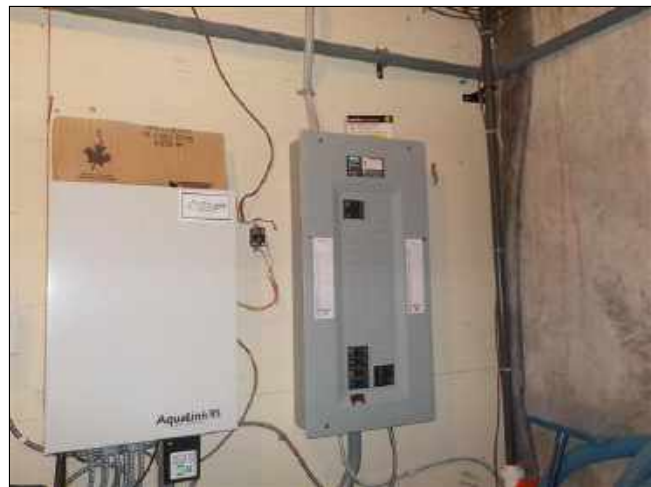
7.3 Item 2(Picture) Pool room sub panel

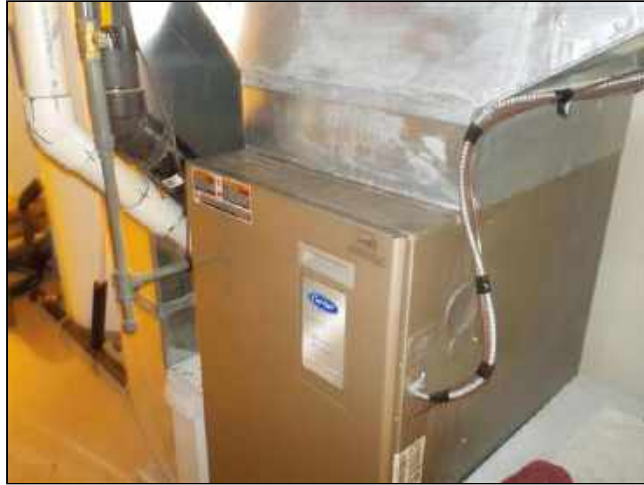
8.0 (1) The gas furnace and heat pump was tested using normal operating controls and functioned properly at time of inspection. The system has been annually maintained and serviced by the installation contractor. We recommend obtaining this information from the seller.

- **Unit is a high efficiency gas furnace. Due to inaccessibility of many of the components of this unit, the review is limited. Holes or cracks in the heat exchanger (if applicable to this type system) are not within the scope of this inspection as heat exchangers are not visible or accessible to the inspector. Unit was operated by the thermostat. As with all mechanical equipment the unit can fail at anytime without warning. Inspectors cannot determine future failures. If a detailed inspection is desired, a licensed heating contractor should be consulted prior to closing to ensure proper and safe operation of this unit.**

8.0 Item 1(Picture) Gas furnace

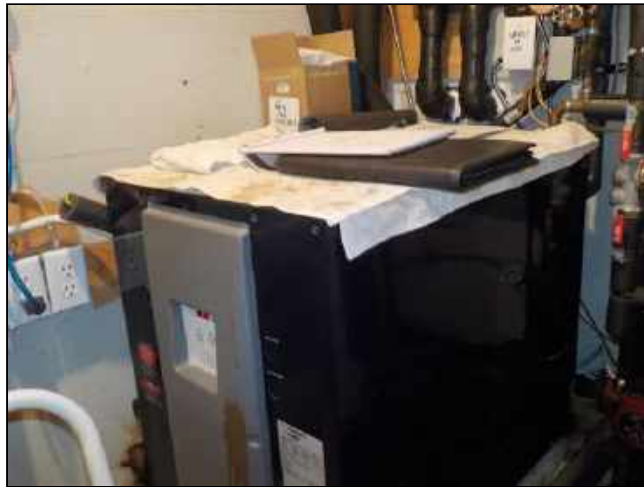
- A geothermal heat pump is present for the radiant floor heat and the cooling system. A heat pump is basically a compressor-cycle air conditioning system that can operate in reverse. As long as the unit is functioning properly in either the heating or the cooling mode, it is an indication that the major components (compressor, fans, coils) are operational, with the exception of the reversing valve. This unit was tested for standard operating functions start up and shut down. Heat pumps are only tested in one mode or the other (Heating or Cooling). If the outside temperature is above 65 degrees F. the heat pump is tested in the cooling mode only. If the outside temperature is below 65 degrees F. the heat pump is tested in the heating mode only. Individual heating elements are not tested and should be tested by a qualified HVAC contractor if further review is desired. Adequate airflow is important to the efficiency of these units: the filter should be kept clean as with air conditioners. Electric heat strips provide emergency heat.

8.0 Item 2(Picture) Heat pump

8.7 Geothermal systems should be serviced on an annual basis to ensure safe and proper operation. The client should commence an annual maintenance, cleaning, and parts replacement program with a qualified plumbing and heating contractor in order to keep the heating/cooling equipment in optimum and safe working order.

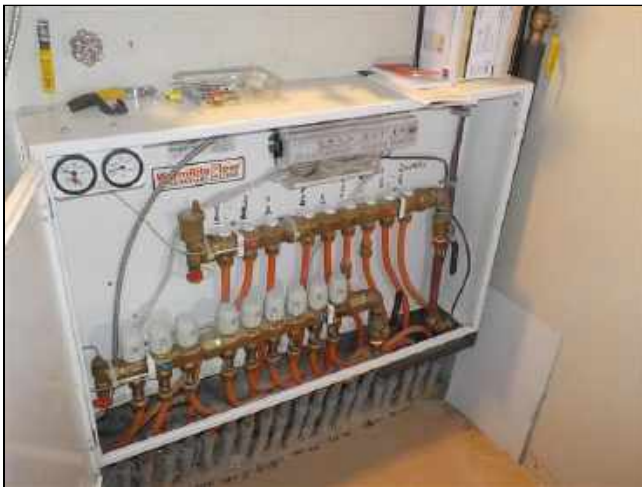
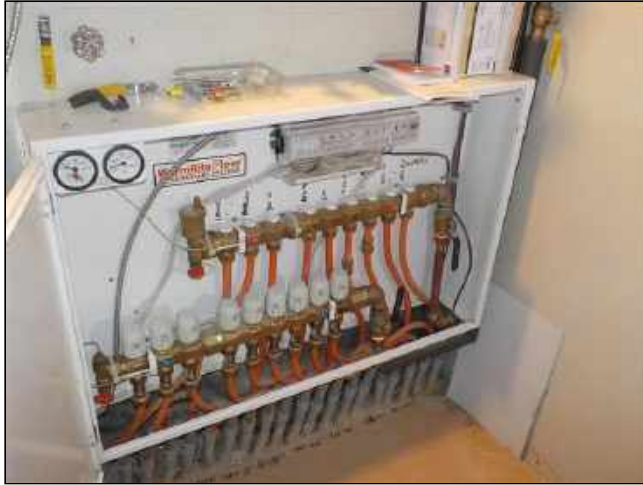
8.5 (1) Kitec plumbing supply lines manufactured in Canada as IPEX were installed in homes between 1995 and 2007. This product was recalled in 2007 due to corrosion and failure issues at the pipe connections. Many insurance providers now recognize the water damage risk regarding this type of plumbing. We recommend consulting your insurance broker for their conditions for insuring a home with this type of piping. For more information please visit this website <http://www.kitecsettlement.com>. A comprehensive inspection and condition report of the HVAC system and components has been provided by the original installation contractor.

8.5 Item 1(Picture) Radiant floor heating

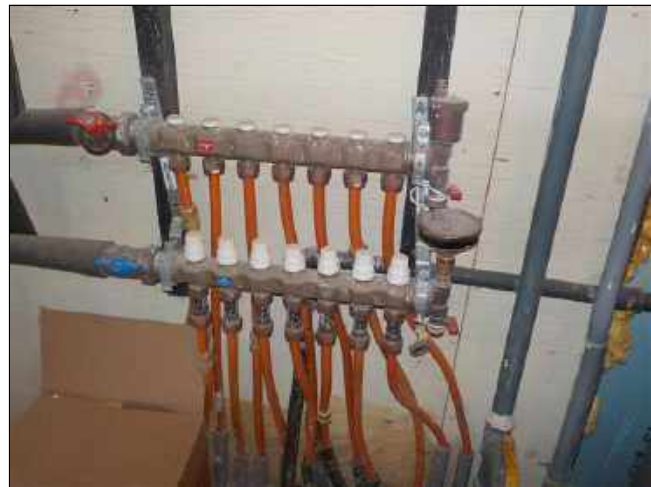
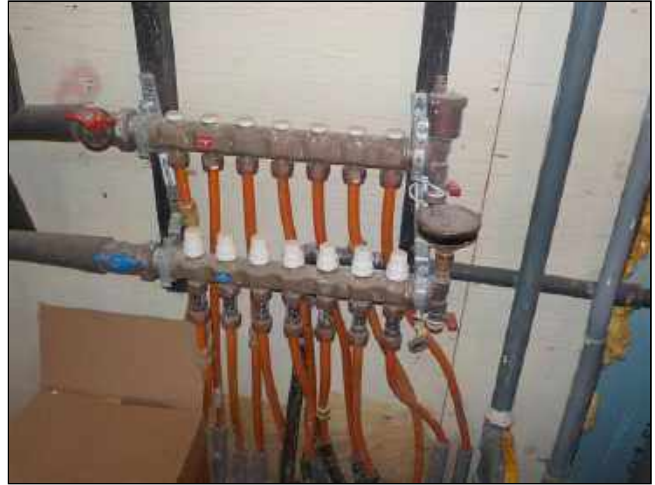
8.5 Item 2(Picture) Outdoor manifold

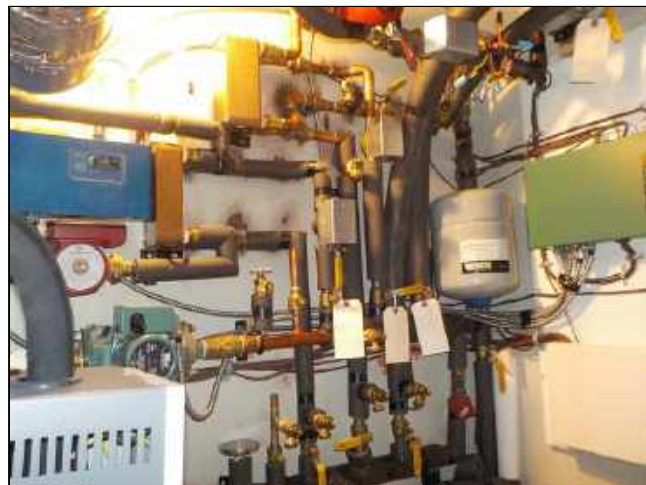
8.5 (2) Circulation pumps and zoned controls present for the radiant floor heating. Plate exchangers noted for the exterior radiant floor heating.

8.5 Item 3(Picture) Circulation pumps, plate exchangers and zoned controls

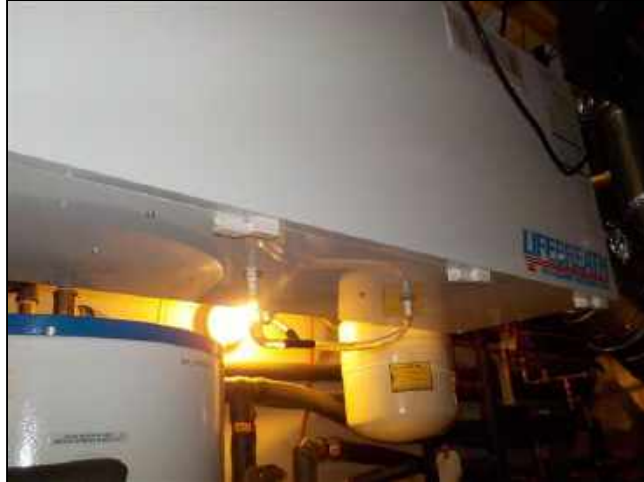
8.8 The home is equipped with a LIFE BREATH heat recovery ventilation system (HRVS). The system tested operable at the time of the inspection. HRVS are mechanical ventilation systems that provide controlled ventilation to homes. This type of system delivers a continuous supply of fresh air into the home, while venting stale, humid indoor, along with household pollutants, to the exterior of the home. While in operation, the HRV will extract heat from the outgoing stale air (cool air in the summer), and use it to preheat (or cool) the incoming fresh air. The stale air then gets exhausted to the exterior of the home. As a result of this process, significantly less energy is required to heat (or cool in summer) the incoming air. Your filters and core of the HRV should be cleaned according to manufacturer's directions and serviced annually. If you are not comfortable doing it yourself, contact a technician accredited by the Heating, Refrigeration and Air Conditioning Institute of Canada (HRAI). Make sure the technician you call has been trained by the manufacturer of your HRV. You can find additional information on maintaining your HRV at this site http://www.cmhc-schl.gc.ca/en/co/maho/gemare/gemare_004.cfm

8.8 Item 1(Picture) HRV

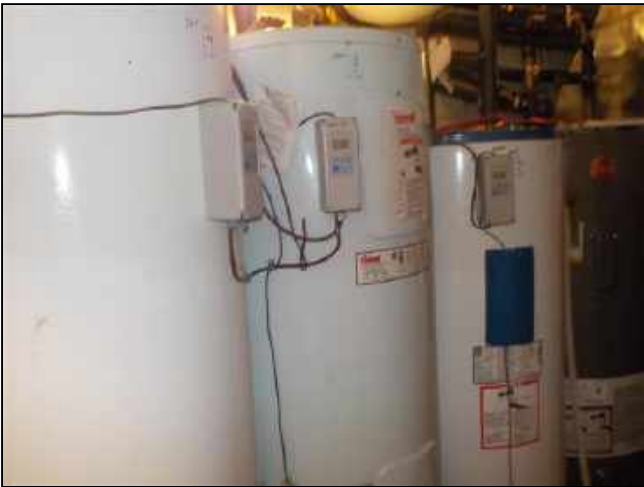
9.0 Item 1(Picture) Water heaters

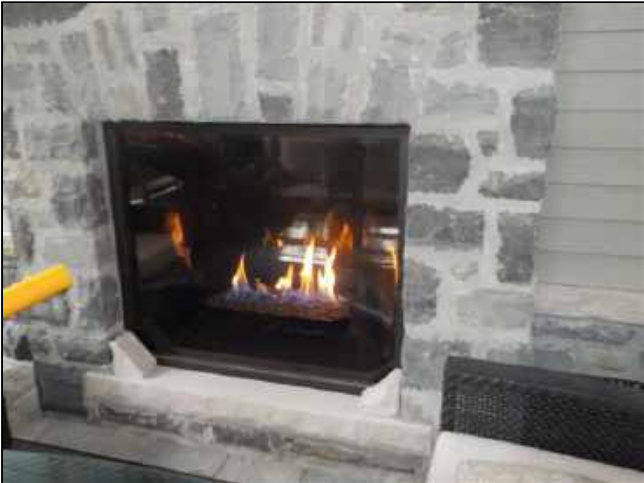
13.8 (1) The gas fireplace(s) tested operable using the normal operating controls.

13.8 Item 1(Picture) Cottage fireplace

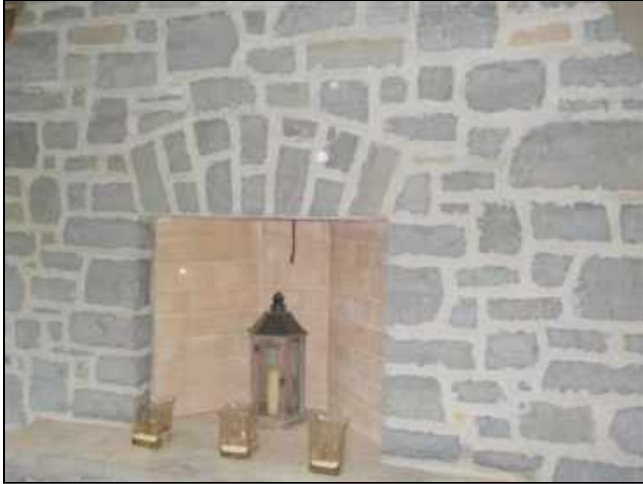
13.8 (2) An outdoor wood burning fireplace is present on the left side balcony. Operational damper noted. The fireplace does not appear to have been in use and a detailed assessment of the adequacy of the installation, clearances to combustibles materials and shielding was not completed as part of the home inspection. We recommend consulting with a Wood Energy Transfer Technology (WETT) certified inspector or contractor for further assessment to ensure safe and proper installation prior to close. Please refer to the Ask the Inspector article regarding Wood Burning Systems for further information found at www.amerispec.ca

13.8 Item 2(Picture) Wood burning fireplace

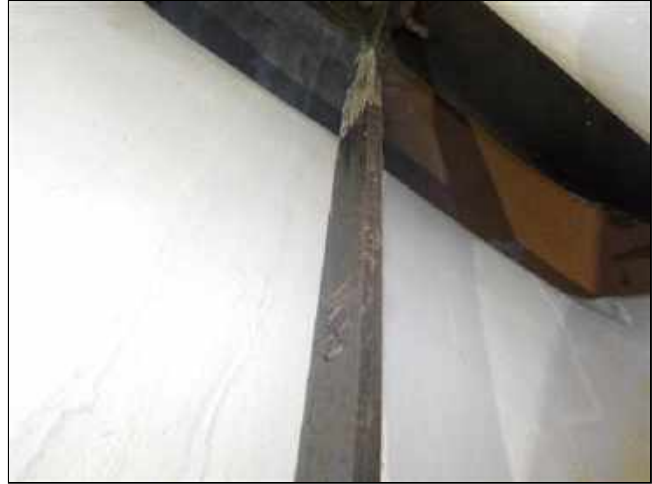
13.8 Item 3(Picture) Damper condition

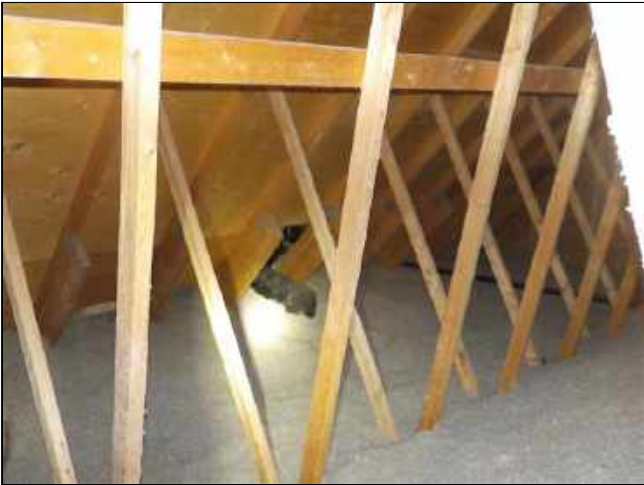
14.3 Item 1(Picture) Insulation conditions
