20 Parkview Avenue, Meaford

Inspection Report

Property Address:
20 Parkview Avenue
Meaford Ontario N4L 1C4

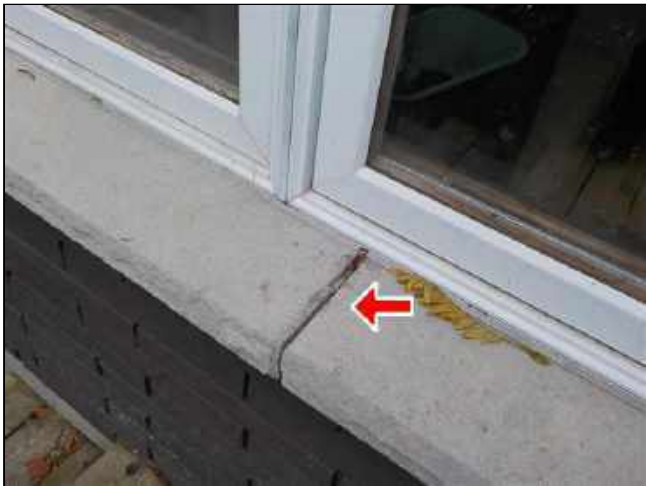
1.4 Deteriorated sill mortar noted. Recommend sealing or caulking to prevent water penetration and additional deterioration.

1.4 Item 1(Picture) Sill mortar condition

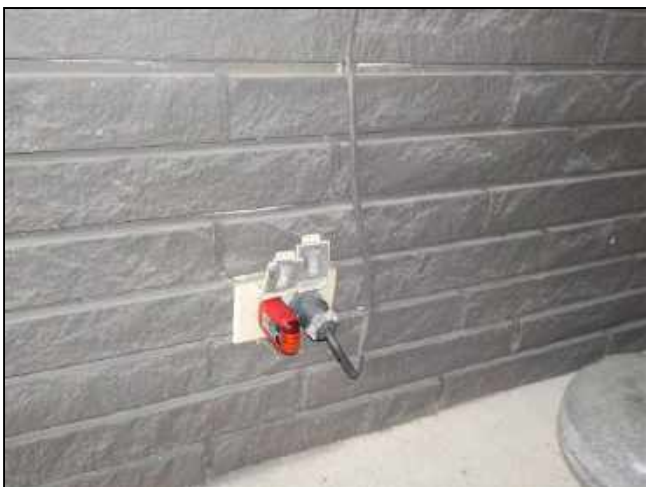
1.7 (2) Not all receptacles are ground fault circuit interrupter (GFCI) protected. This may not have been required when home was built; client is advised to install ground fault circuit interrupter outlets as a safety enhancement. Temporary wiring noted to the porch light fixture. We recommend upgrading as required. Soffit lighting present.

1.7 Item 1(Picture) Standard outlet and light wiring

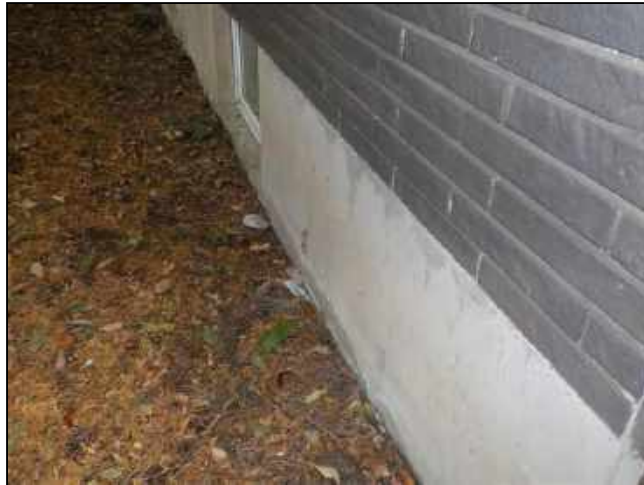
Low areas observed along the left side foundation. Adding dirt back-fill to any low lying areas located around the foundation is recommended to ensure proper drainage away from the foundation at all times.

1.10 Item 1(Picture) Low drainage area

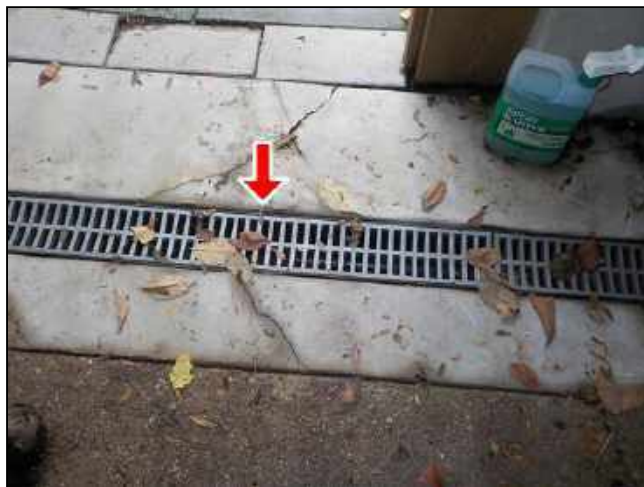
1.10 (2) Surface drains were noted. It is beyond the scope of our visual inspection to verify drainage systems. If such a review is desired, we recommend consulting a specialist.

1.10 Item 2(Picture) Trench drain

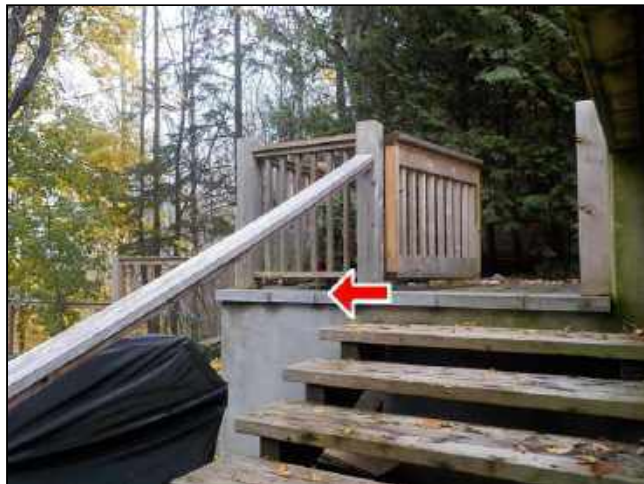
1.11 Open railings noted on stairs to the deck, Client may wish to reduce spacing as a child safety enhancement.

1.11 Item 1(Picture) Stair railings

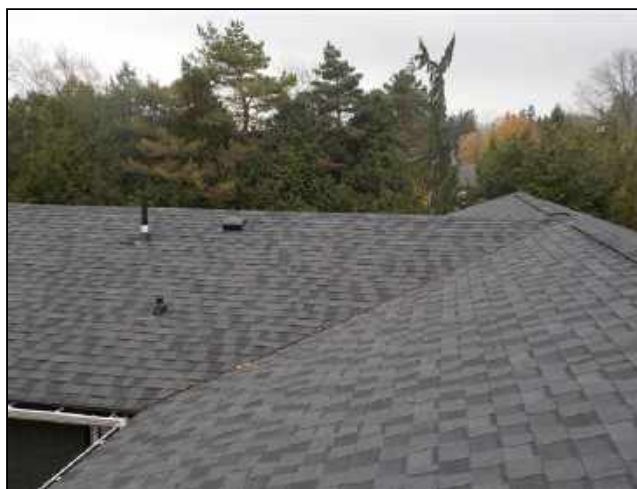
2.0 Roof shows normal wear for its age (stated 2019) and type. No damaged, deteriorated, or missing roofing materials were observed; it appears to be in serviceable condition at time of inspection.

2.0 Item 1(Picture) Roof conditions

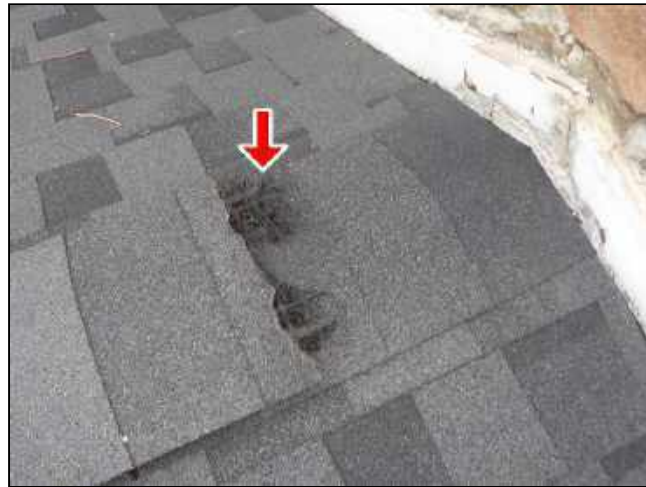
2.1 Pest damaged ridge vent noted. We recommend replacement as required.

2.1 Item 1(Picture) Damaged ridge vent

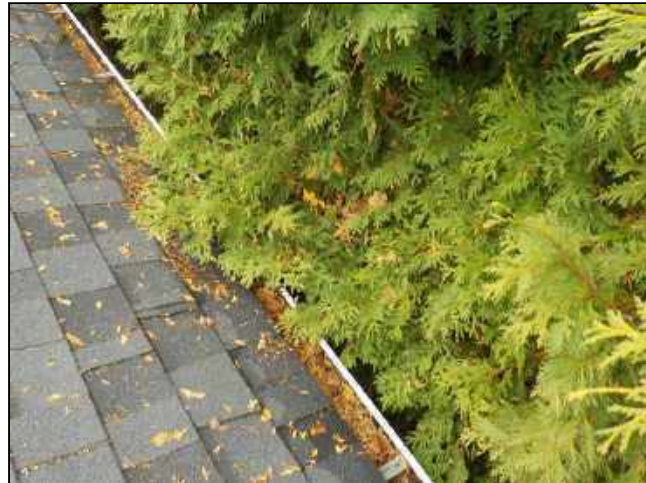
2.3 Tree limbs in contact with the roof covering at left side. These should be trimmed to prevent damage.

2.3 Item 1(Picture) Tree limb contact

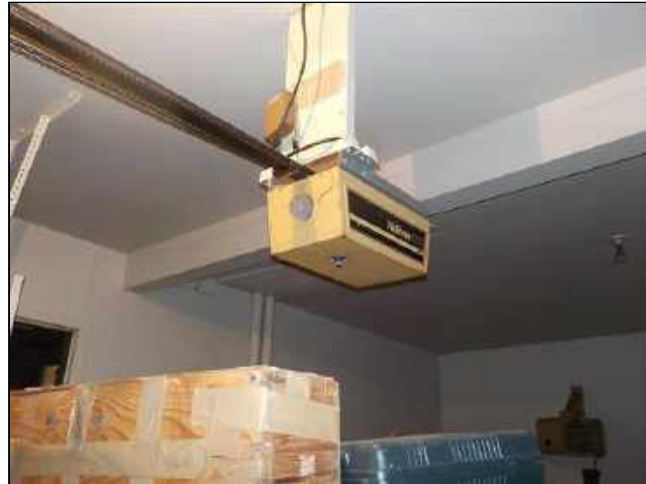
3.4 This is an older door opener and is not equipped with a safety reverse device. It is recommended all garage doors be equipped with a safety reverse device to reverse the direction of the door if it should meet any resistance on the way down (important safety where children are present). Buyer may wish to consider upgrading as a safety enhancement

3.4 Item 1(Picture) Door opener

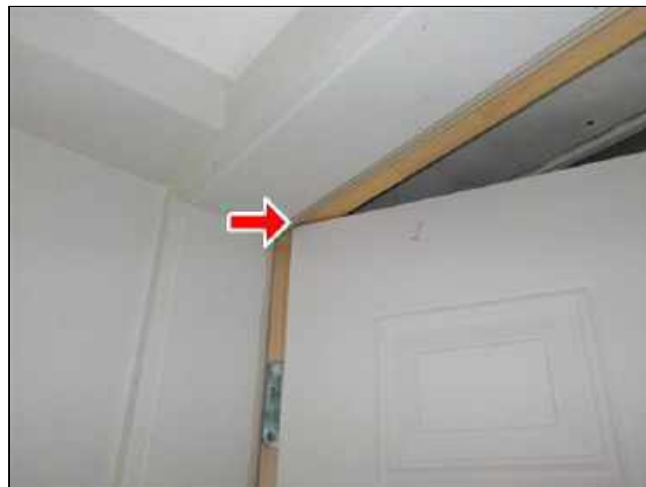
3.5 No self-closer observed. Suggest installing self-closer as a safety measure.

3.5 Item 1(Picture) Missing closer

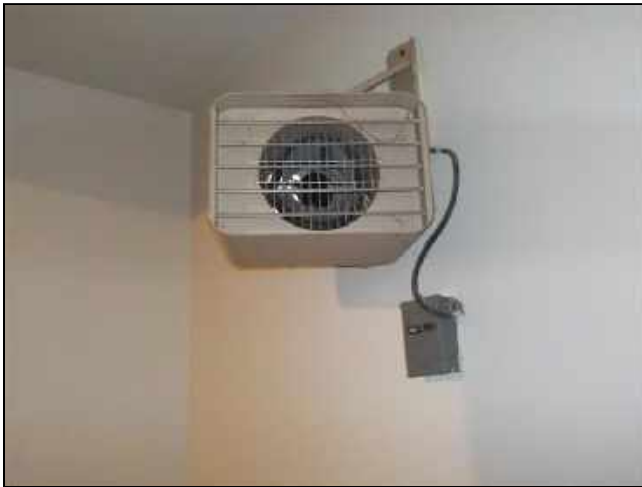
3.9 Abandoned electric heater noted. We recommend removal as required. Damaged outlet noted. We recommend replacement.

3.9 Item 1(Picture) Obsolete heater

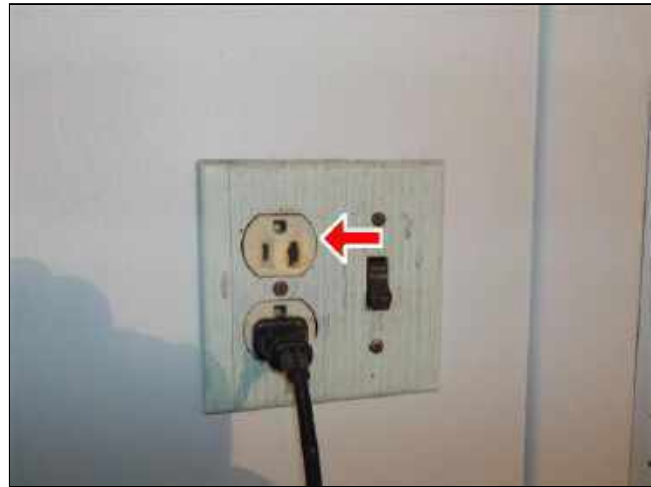
3.9 Item 2(Picture) Damaged outlet

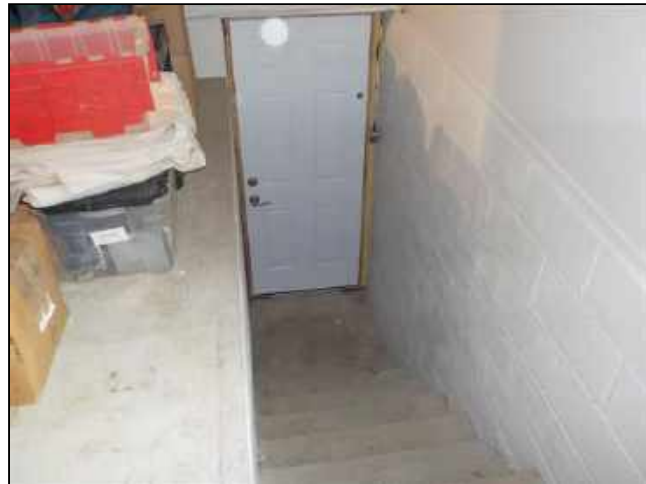
3.10 (1) Missing railings observed on the basement entry. We recommend client consider installing guardrails/handrails as a safety enhancement.

3.10 Item 1(Picture) Missing railings

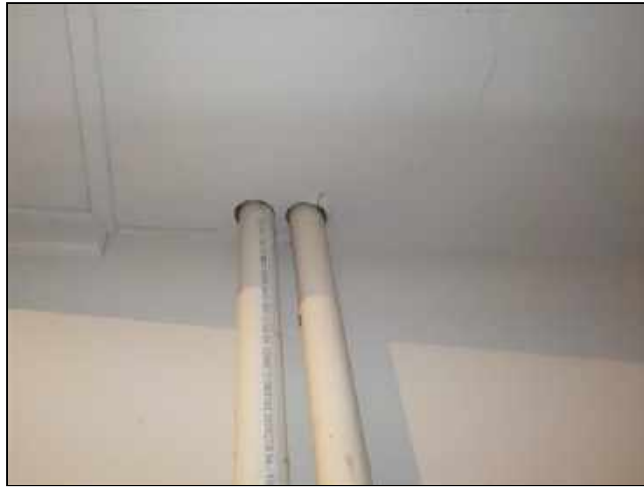
3.10 (3) Piping for the direct vent boiler are present through the garage. We recommend insulating and enclosing as required. Please refer to the Heating System section for additional information.

3.10 Item 2(Picture) Vent pipes

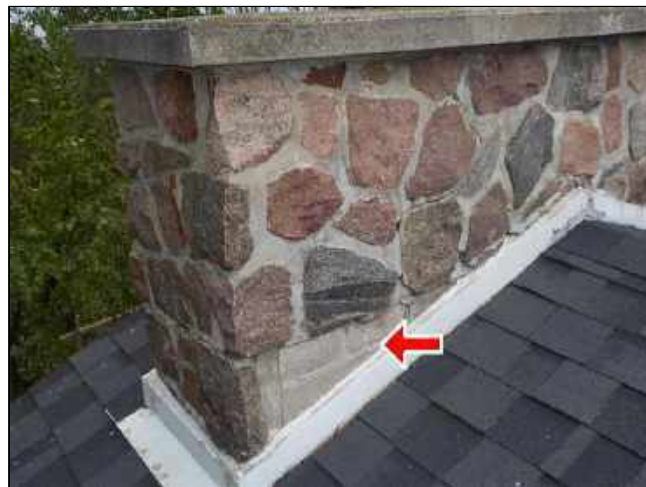
4.0 Loose or missing stone facing noted. We recommend repair as required.

4.0 Item 1(Picture) Stone facing conditions

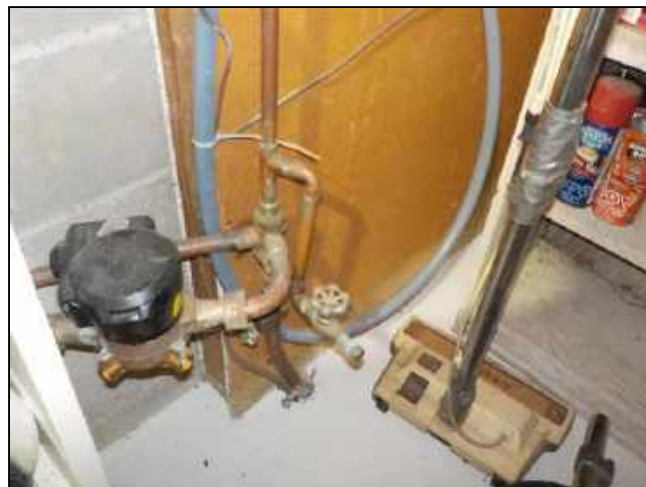
6.0 Gate-type valve observed. Since main shut-off valves are operated infrequently, it is not unusual for them to become frozen over time. They often leak or break when operated after a period of inactivity. For this reason main shut-off valves are not tested during a home inspection. We suggest caution when operating shut-offs that have not been turned for a long period of time. We recommend that the client consider upgrading the shut-off valve to a high quality ball-type valve which tend to be more reliable than gate valves.

6.0 Item 1(Picture) Main shut off

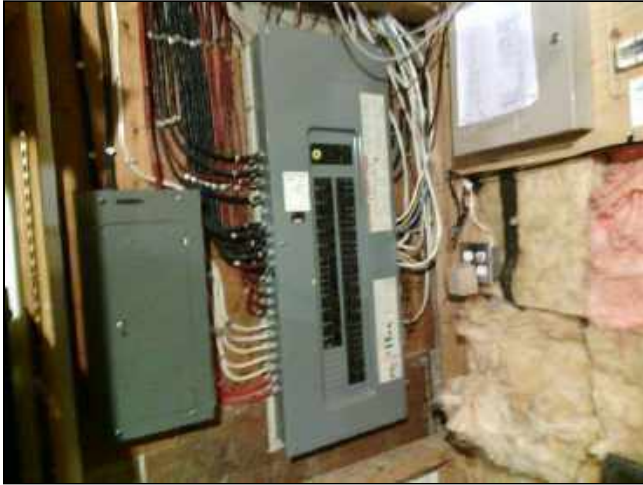
7.2 (1) The main panel conditions were inspected by a licensed electrician (Journey Electric).

7.2 Item 1(Picture) Main panel and junction box

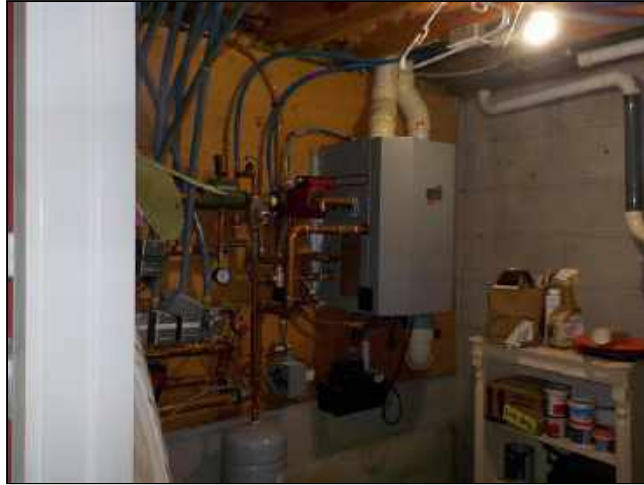
8.0 The electric baseboards and gas-fired boiler was tested using normal operating controls and functioned properly at time of inspection. Zoned controls, circulation pump(s) and expansion tank noted. The boiler is used for the radiant floor heating and for domestic hot water. Due to inaccessibility of many of the components of this unit, the review is limited. Holes or cracks in the heat exchanger (if applicable to this type system) are not within the scope of this inspection as heat exchangers are not visible or accessible to the inspector. Unit was operated by the thermostat. As with all mechanical equipment the unit can fail at anytime without warning. Inspectors cannot determine future failures. If a detailed inspection is desired, a licensed heating contractor should be consulted prior to closing to ensure proper and safe operation of this unit.

8.0 Item 1(Picture) Direct vent gas boiler

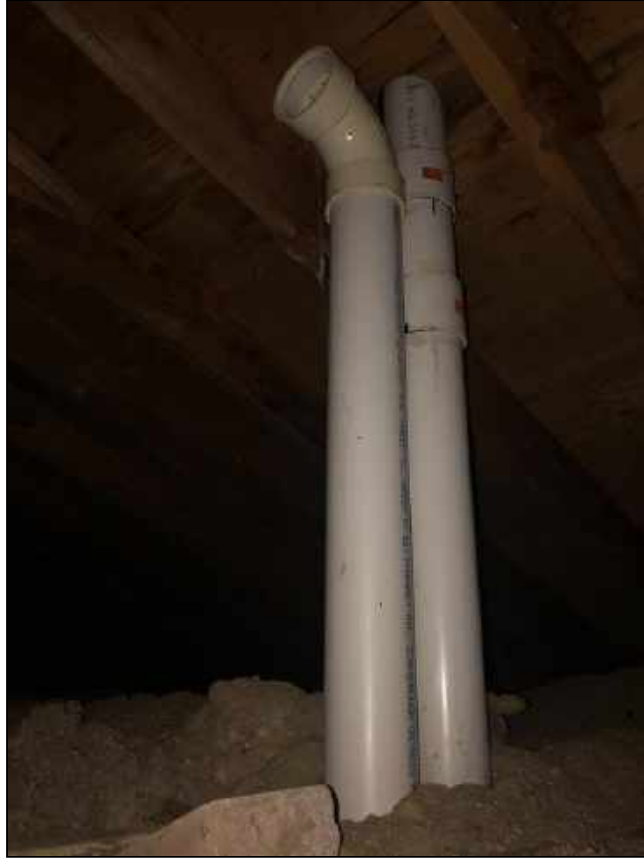
8.2 Improper roof termination noted and un-insulated piping noted in the garage and attic. We recommend review and repairs by a licensed plumbing and heating contractor to ensure proper and safe venting.

8.2 Item 1(Picture) Venting conditions

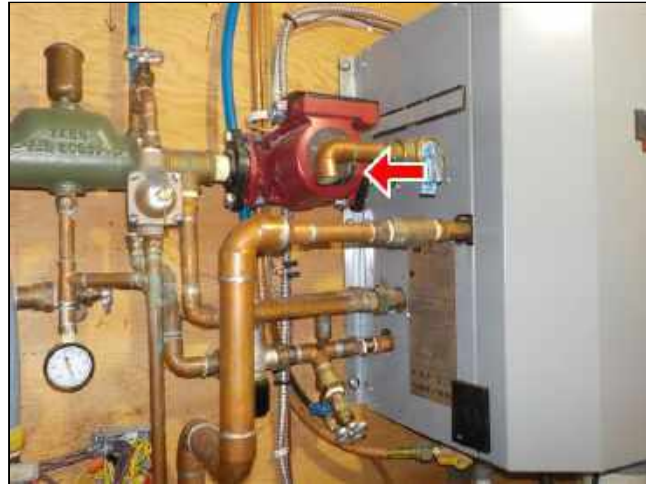
9.4 Discharge pipe is missing on the temperature pressure relief valve. Suggest installing the required 3/4 inch discharge pipe on the temperature pressure relief valve to within 6 inches of floor or to exterior of the building to ensure safety.

9.4 Item 1(Picture) Missing extension pipe

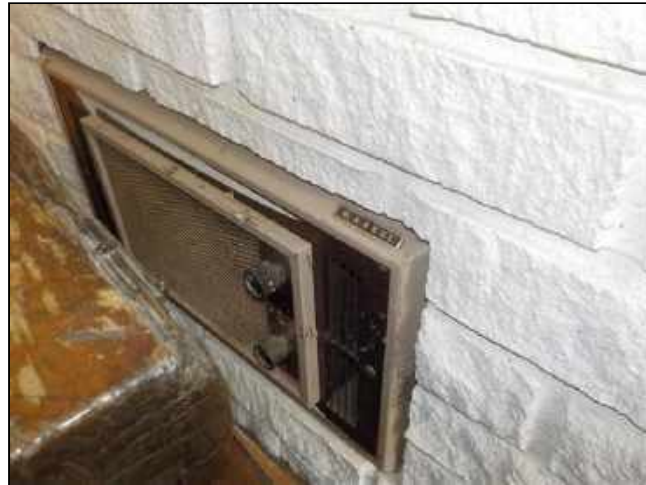
10.3 Obsolete electric wall heater noted. We recommend disconnecting and removal as required.

10.3 Item 1(Picture) Obsolete electric heater

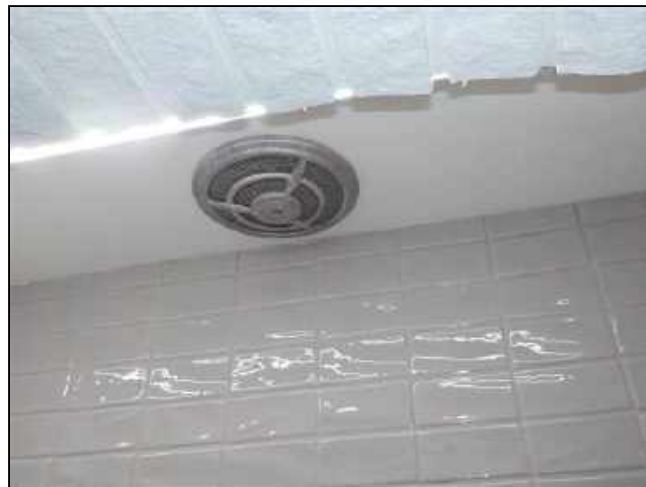
10.10 Ceiling extraction fan noted. Client may consider installation of an exterior vented range hood to improve ventilation in this area. Please refer to the Attic section for additional information.

10.10 Item 1(Picture) Kitchen extraction fan

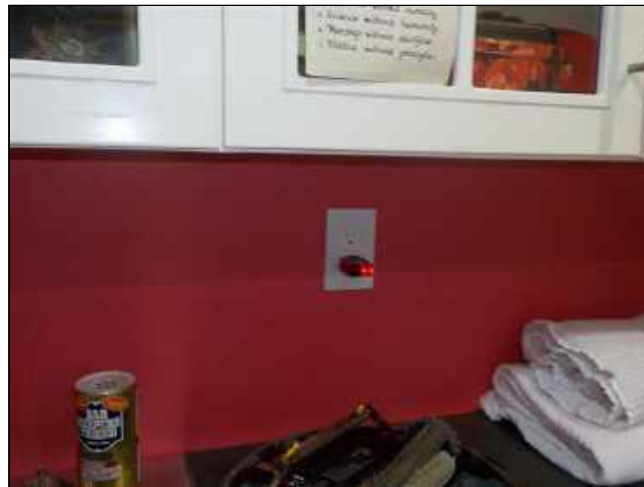
12.8 Not all receptacles are ground fault circuit interrupter (GFCI) protected. This may not have been required when home was built; client is advised to install ground fault circuit interrupter outlets as a safety enhancement.

12.8 Item 1(Picture) Standard outlet

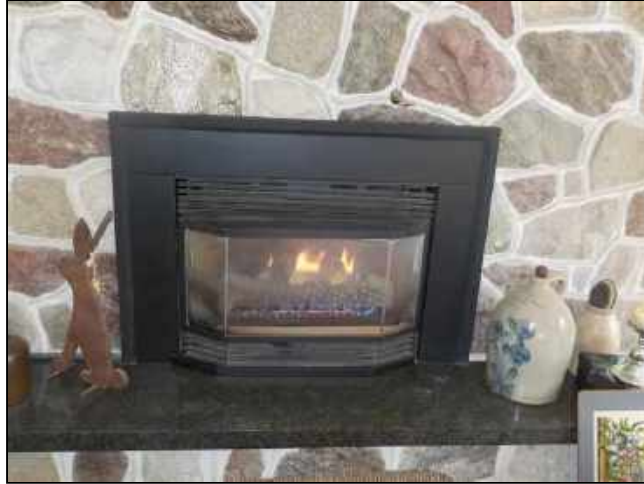
13.8 The gas fireplace tested operable using the normal operating controls. Suggest having this unit professionally cleaned and tuned to ensure proper and efficient operation.

13.8 Item 1(Picture) Gas fireplace

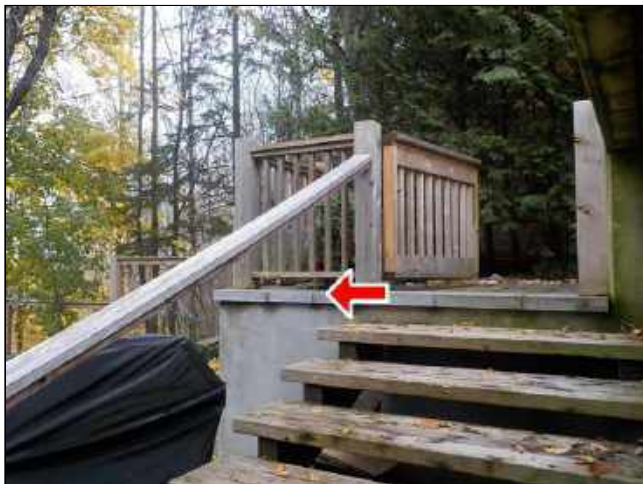
Open railings noted on stairs to the deck, Client may wish to reduce spacing as a child safety enhancement.

1.11 Item 1(Picture) Stair railings

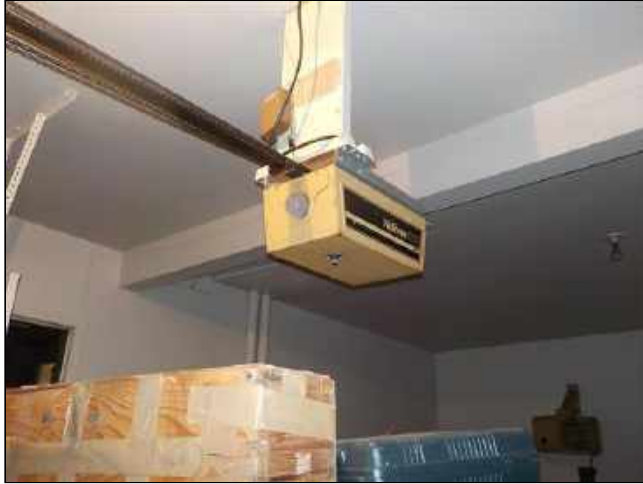
This is an older door opener and is not equipped with a safety reverse device. It is recommended all garage doors be equipped with a safety reverse device to reverse the direction of the door if it should meet any resistance on the way down (important safety where children are present). Buyer may wish to consider upgrading as a safety enhancement

3.4 Item 1(Picture) Door opener

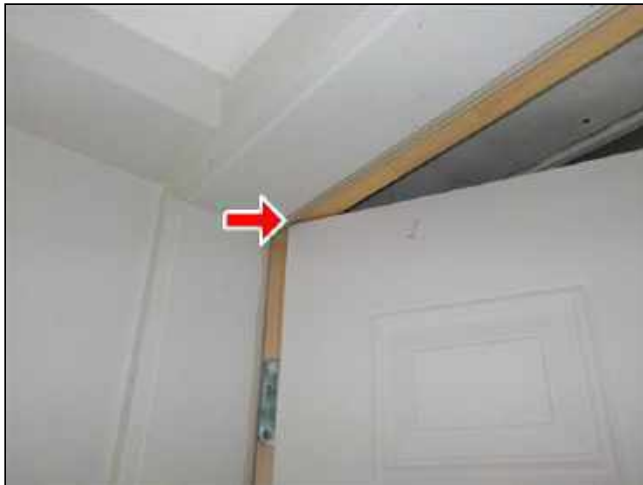
No self-closer observed. Suggest installing self-closer as a safety measure.

3.5 Item 1(Picture) Missing closer

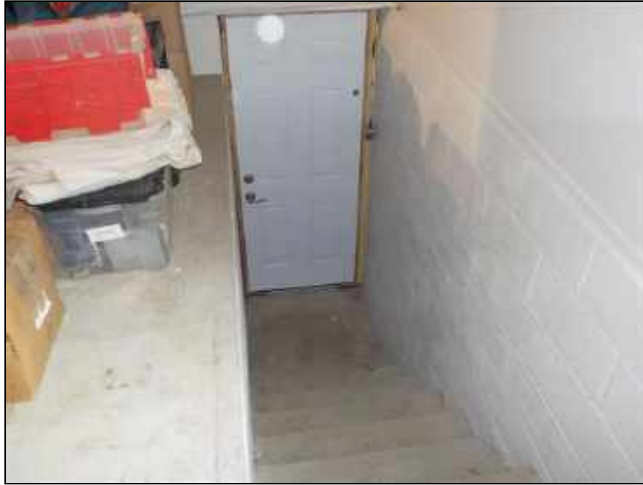
(1) Missing railings observed on the basement entry. We recommend client consider installing guardrails/handrails as a safety enhancement.

3.10 Item 1(Picture) Missing railings

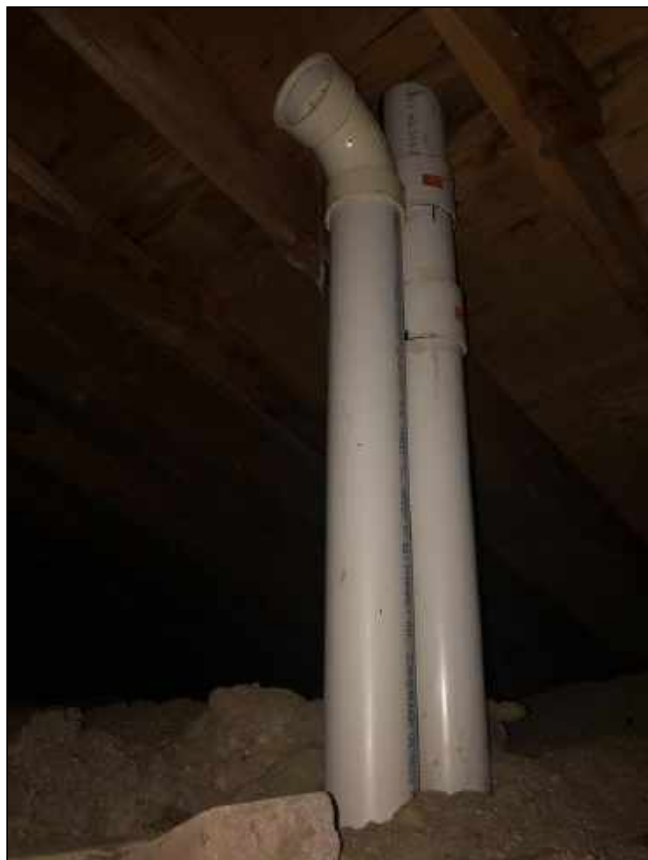
Improper roof termination noted and un-insulated piping noted in the garage and attic. We recommend review and repairs by a licensed plumbing and heating contractor to ensure proper and safe venting.

8.2 Item 1(Picture) Venting conditions

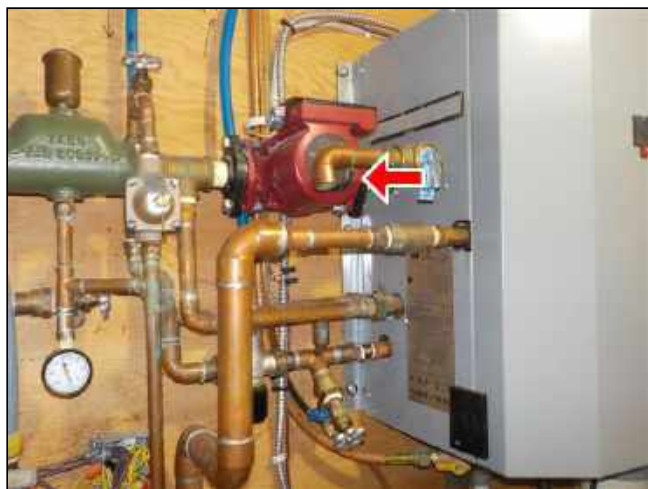
Discharge pipe is missing on the temperature pressure relief valve. Suggest installing the required 3/4 inch discharge pipe on the temperature pressure relief valve to within 6 inches of floor or to exterior of the building to ensure safety.

9.4 Item 1(Picture) Missing extension pipe
