Listing Information Package

**2111 Concession 8 South Nottawasaga Road,
Glen Huron**

This inspection is intended to assess the structure (including foundations, floors, walls and roofs), building envelope (including roofing), mechanical systems (including heating and plumbing), the attic space (including insulation), electrical systems and windows.

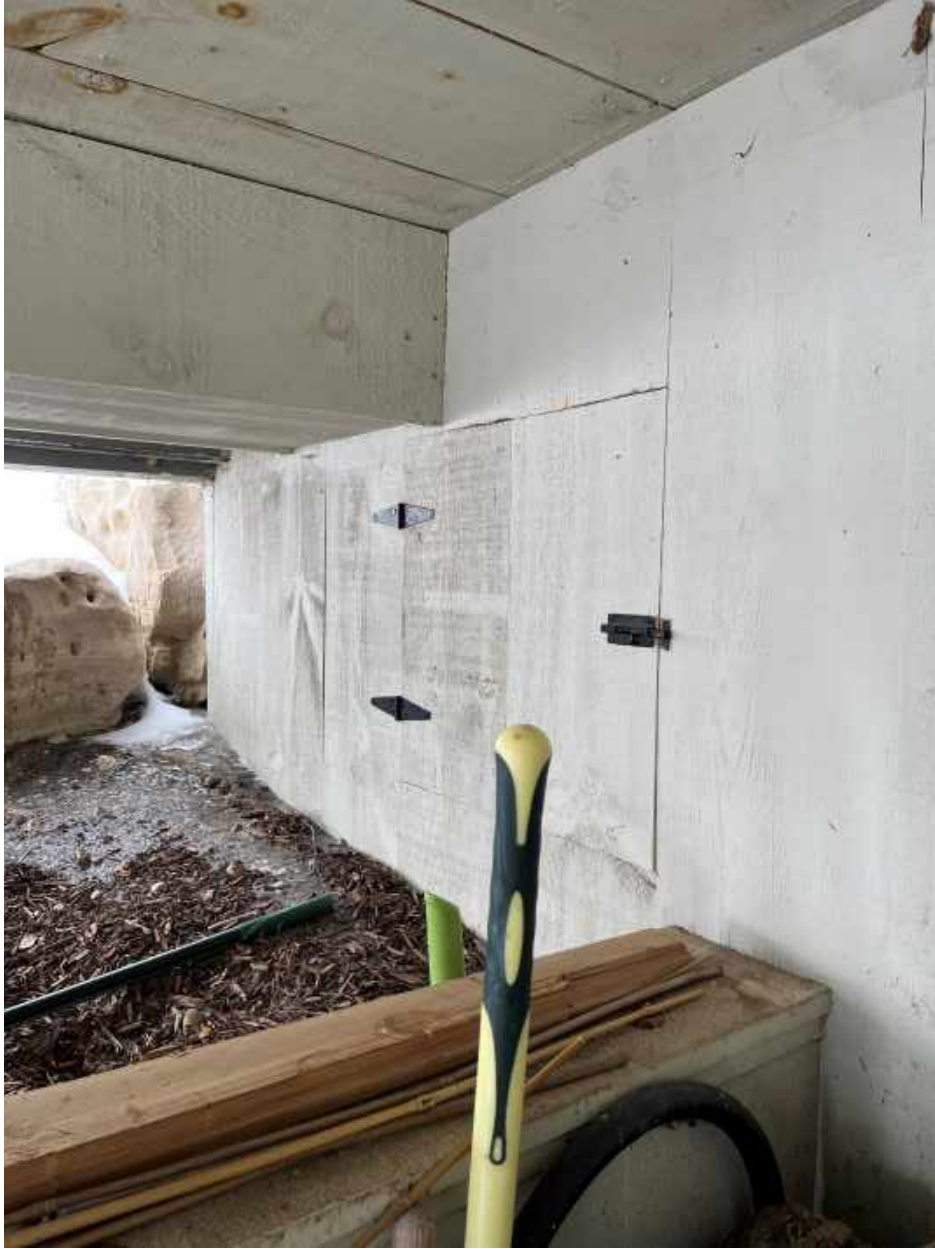
Some Possible Earth/Wood Contact at Skirt Wall Left of Sunroom:

The exact nature of the wall support at the left side of the rear crawlspace is not known to this inspector. It is not known whether any form of waterproofing

system is in place at the right side of the wall under the left perimeter of the rear crawlspace. Long term moisture decay is a possible concern there. Perhaps a as-built information can be obtained by the installer.

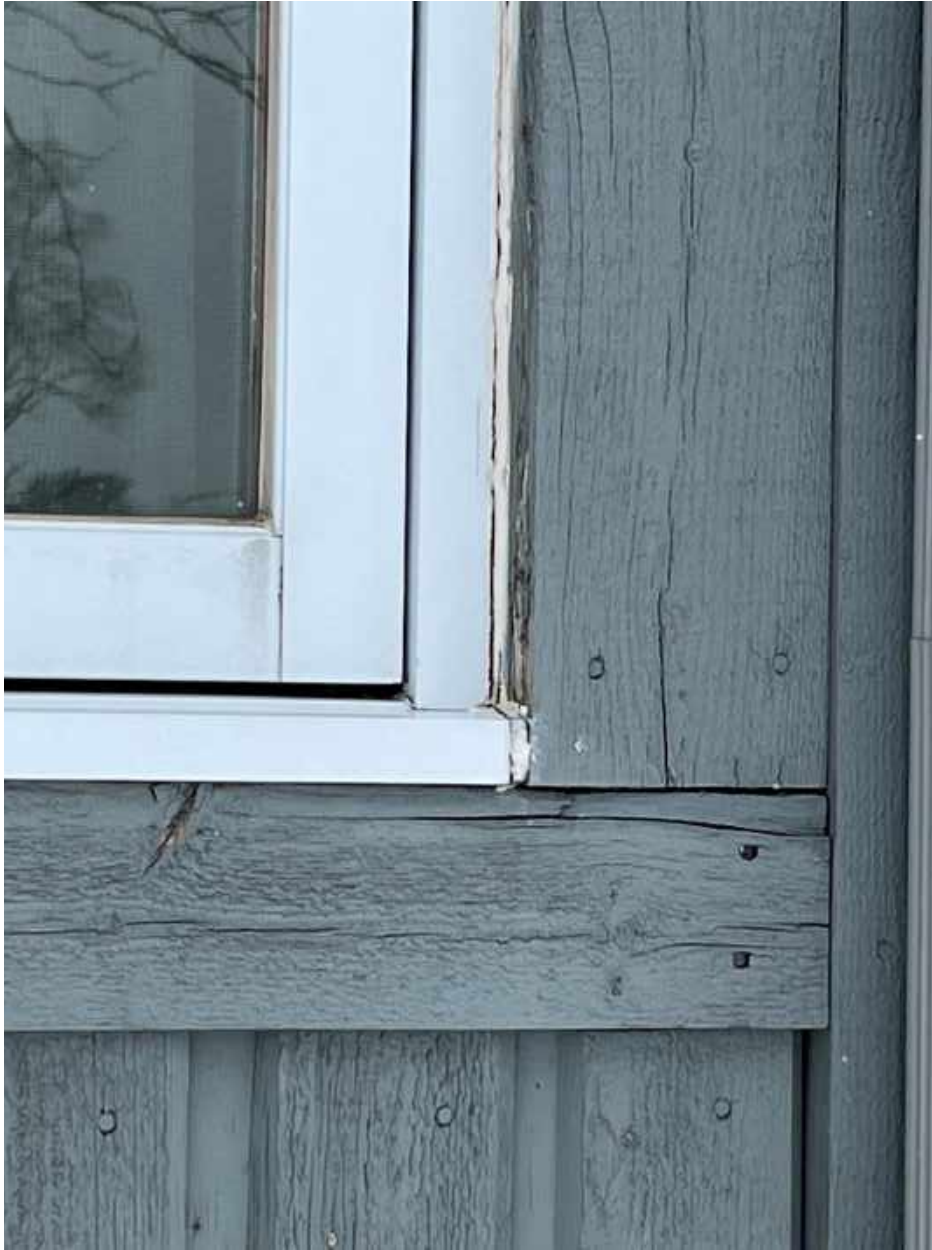
Minor Caulking at The Building Envelope:

A few open joints should be sealed.

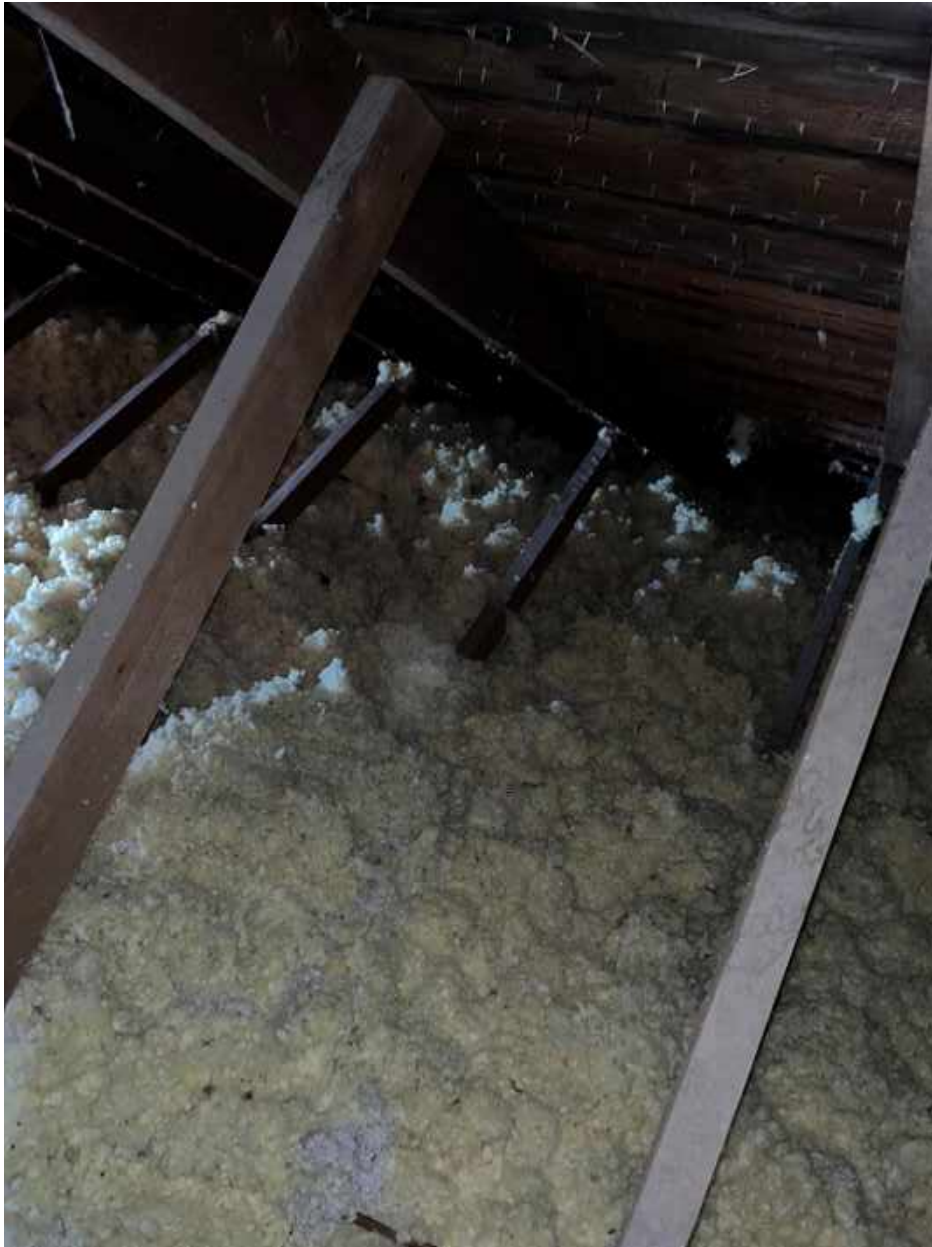
Normal Mice Activity:

It is completely normal to find evidence of mice activity at most homes, especially country homes. Set traps or otherwise address the mice. Be sure to maintain a full seal at the building envelope to prevent wildlife entry. That includes maintenance of ridge caps and valleys at the metal roofing system over the years.

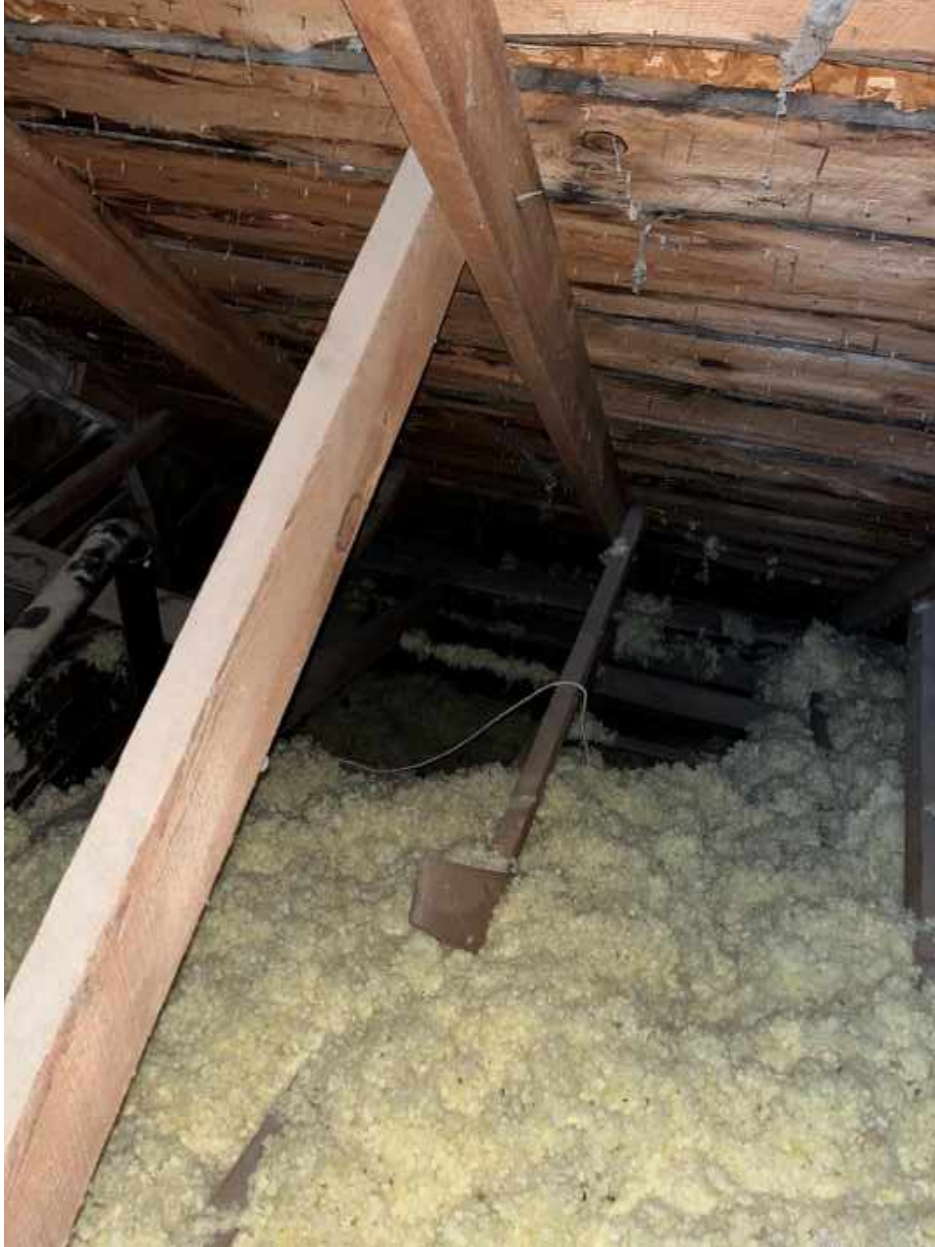
Adding Fasteners at The Roof Members:

While the assembly is stable, it is recommended that fasteners be added at member junctions, including where only one nail has been used.

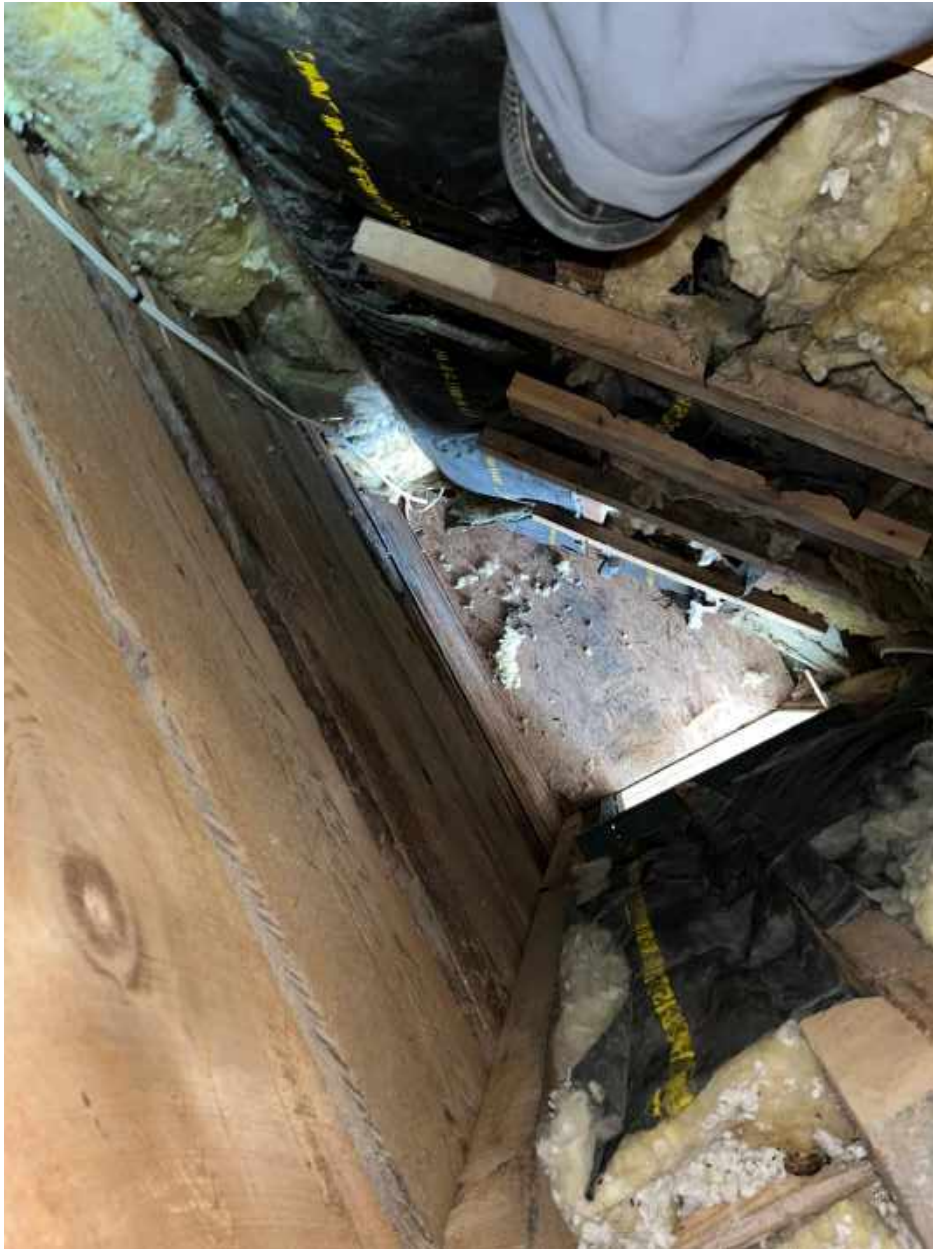
Improvements to Attic 'Ladder':

The attic access ladder comprises horizontal two-by-fours that have been nailed to studs. It is difficult to fully assess the safety of the ladder, but it was stable when loaded by this inspector. It would be prudent to add fasteners and/or hardware to ensure safety.

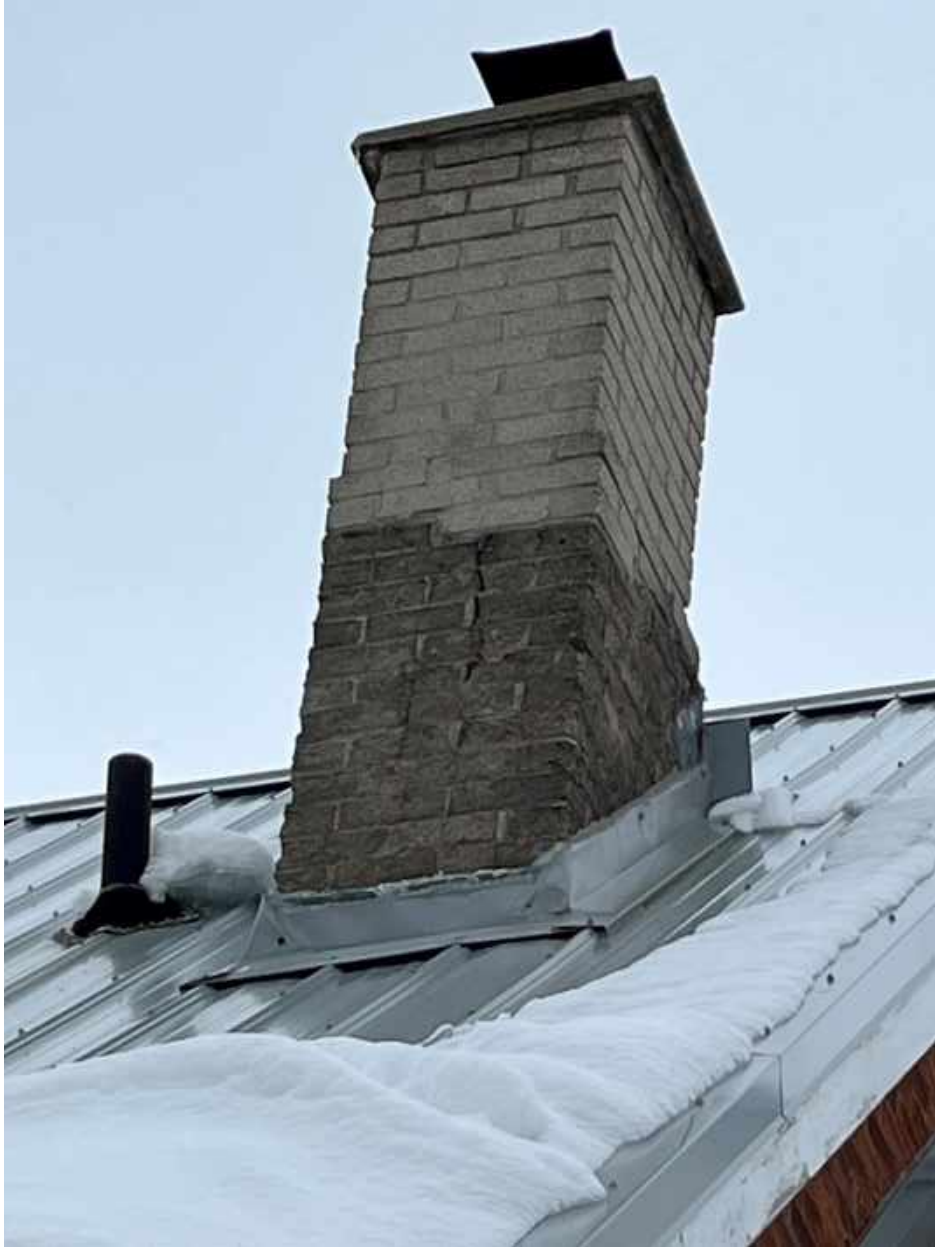
Seal Crack at Right Side of Chimney:

The obvious open crack at the right side of the masonry chimney should be fully sealed to prevent further degradation.

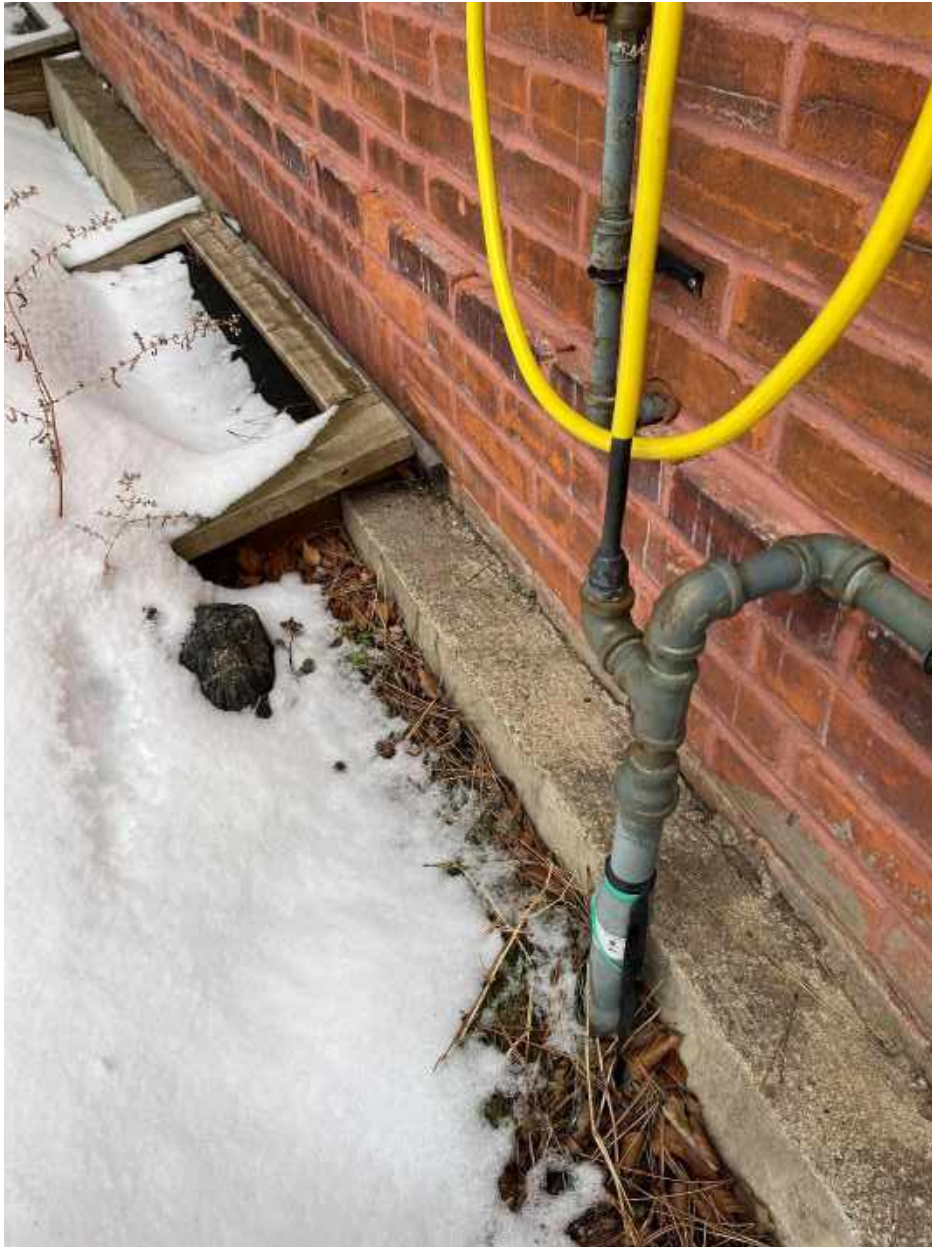
Protecting Top of Concrete Foundation:

It is recommended that a concrete sealer product be applied to the exposed top of the concrete at the eight foundation, to prevent long-term degradation. Caulking the joint where the concrete meets the brick system would be a benefit also.

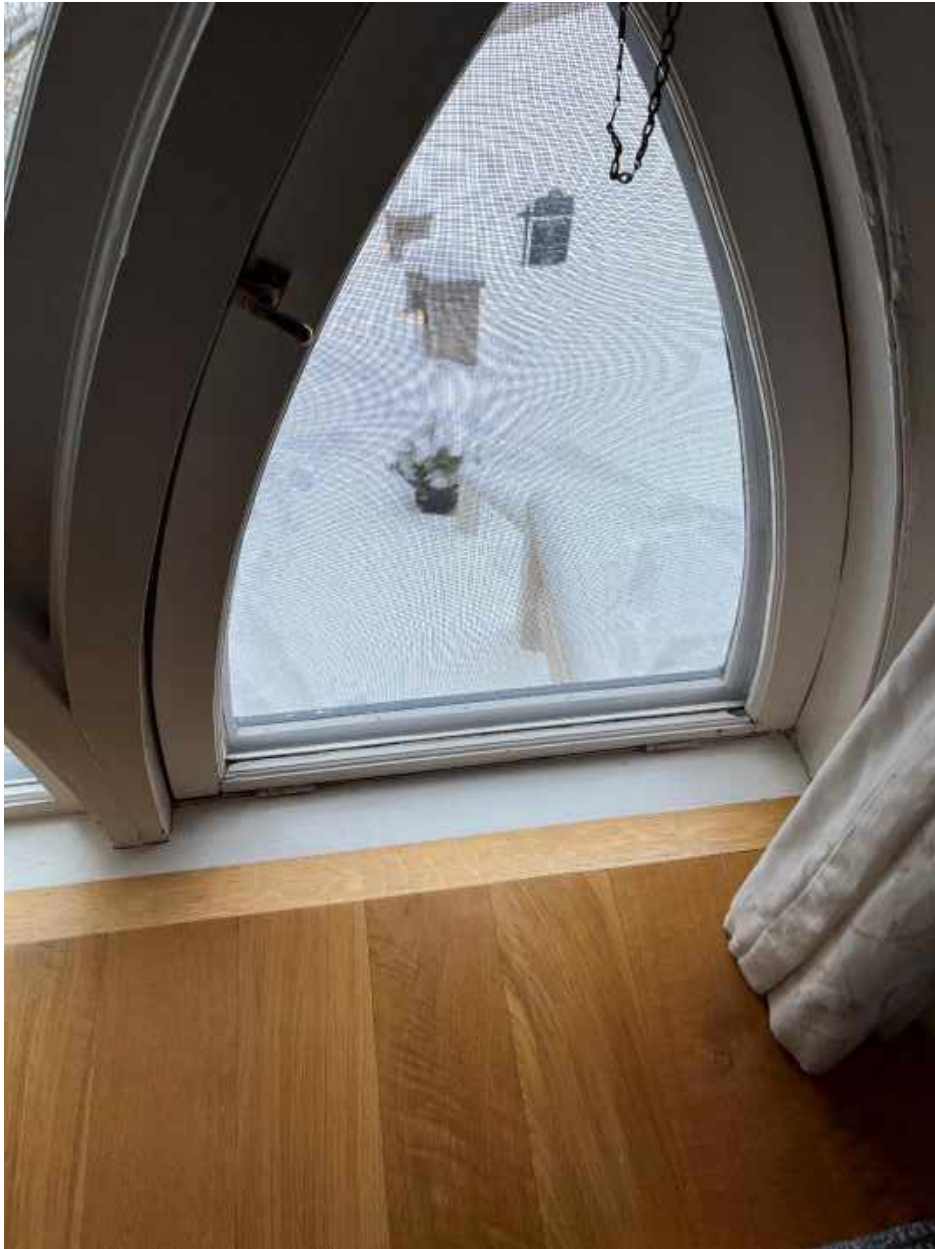
Child/Toddler Falling Hazard:

The window at floor level in the master bedroom presents a falling hazard for children/toddlers. It can be fastened shut if children/toddlers are occupying the home.
