Listing Information Package

**2111 Concession 8 South Nottawasaga Road,
Glen Huron**

This inspection is intended to assess the structure (including foundations, floors, walls and roofs), building envelope (including roofing), mechanical systems (including heating and plumbing), the attic space (including insulation), electrical systems and windows.

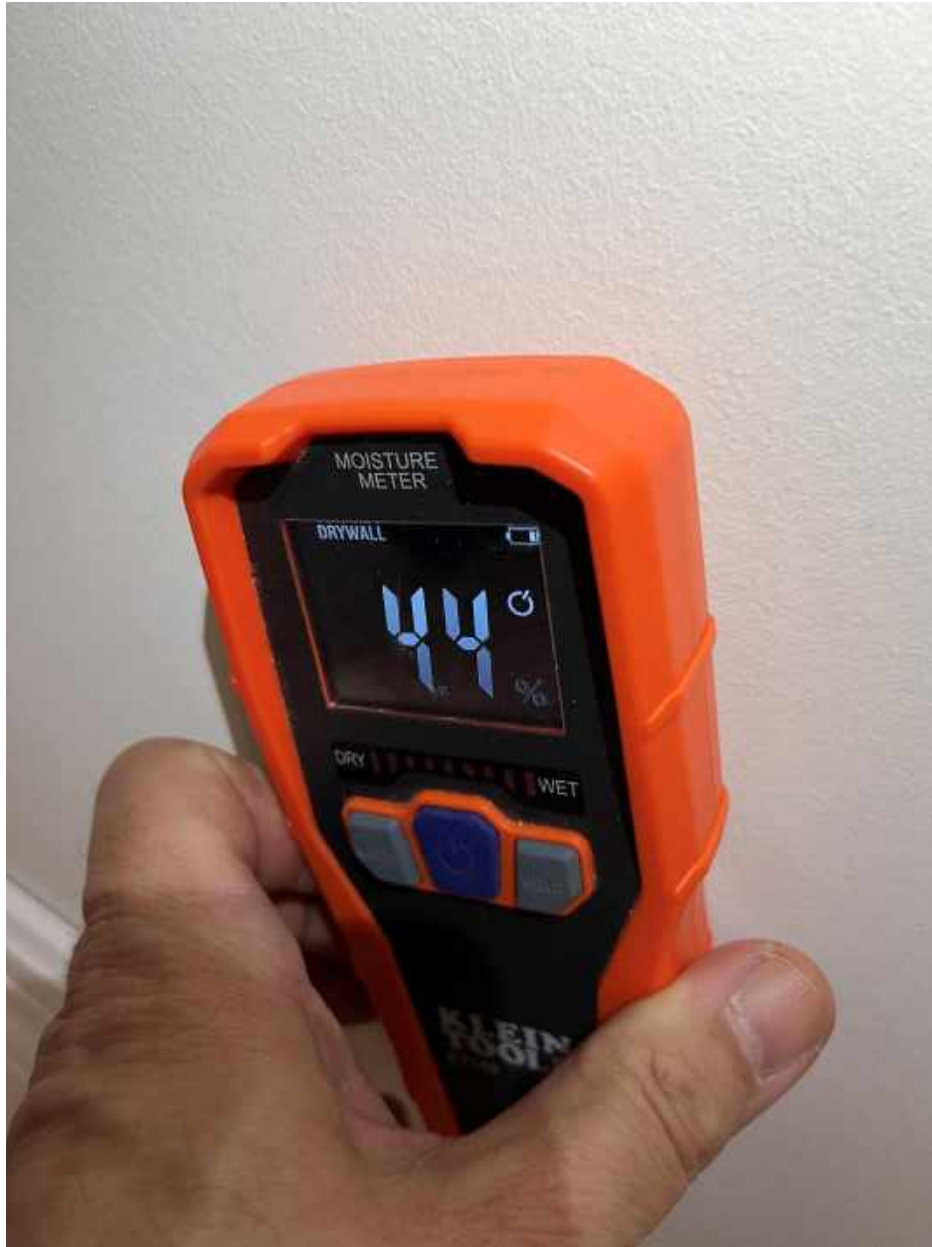
There is no evidence of water infiltration at the foundation level. A very sensitive moisture meter was used. The following photo shows a reading of 4.4 % relative humidity (RH), which means a dry wall assembly.

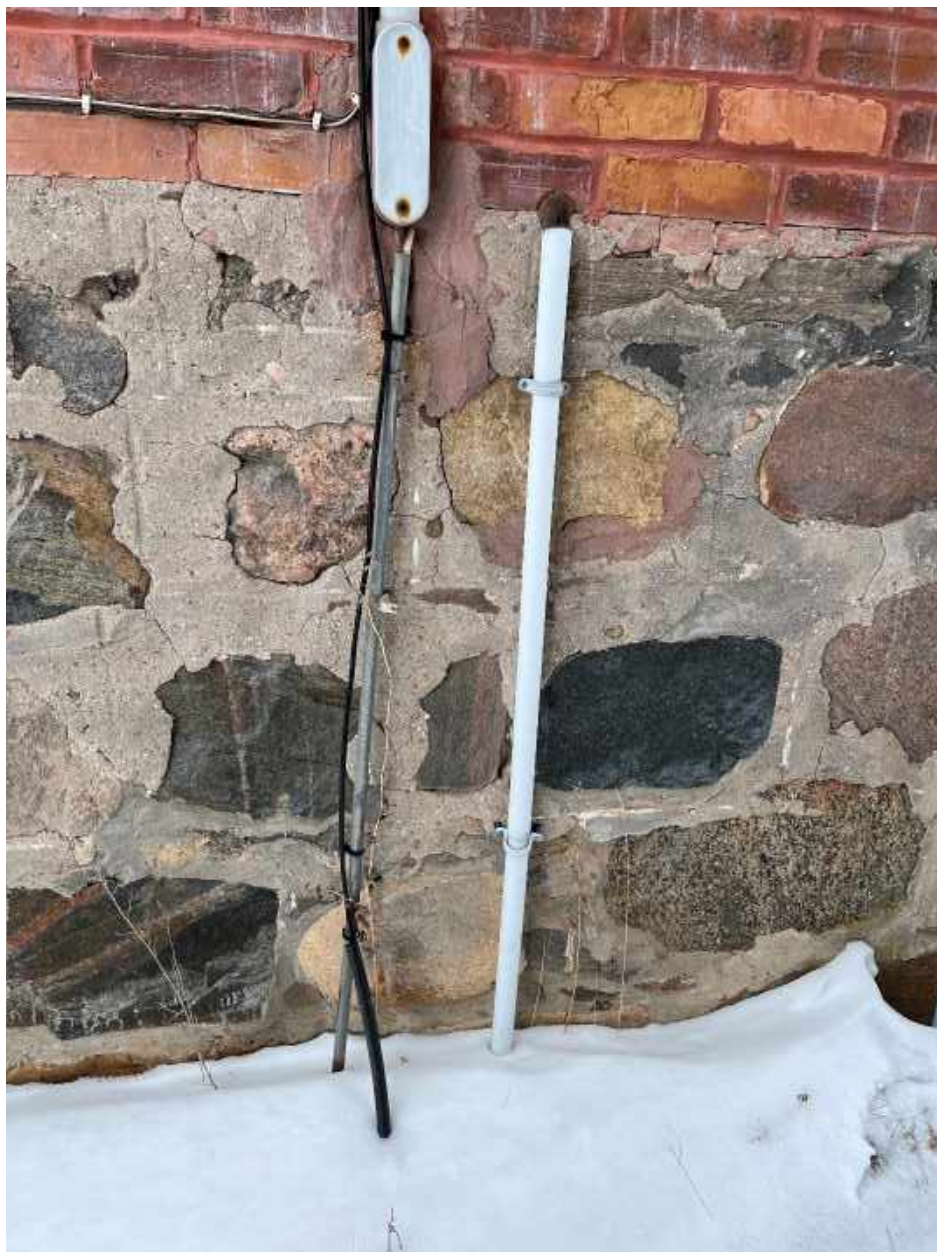
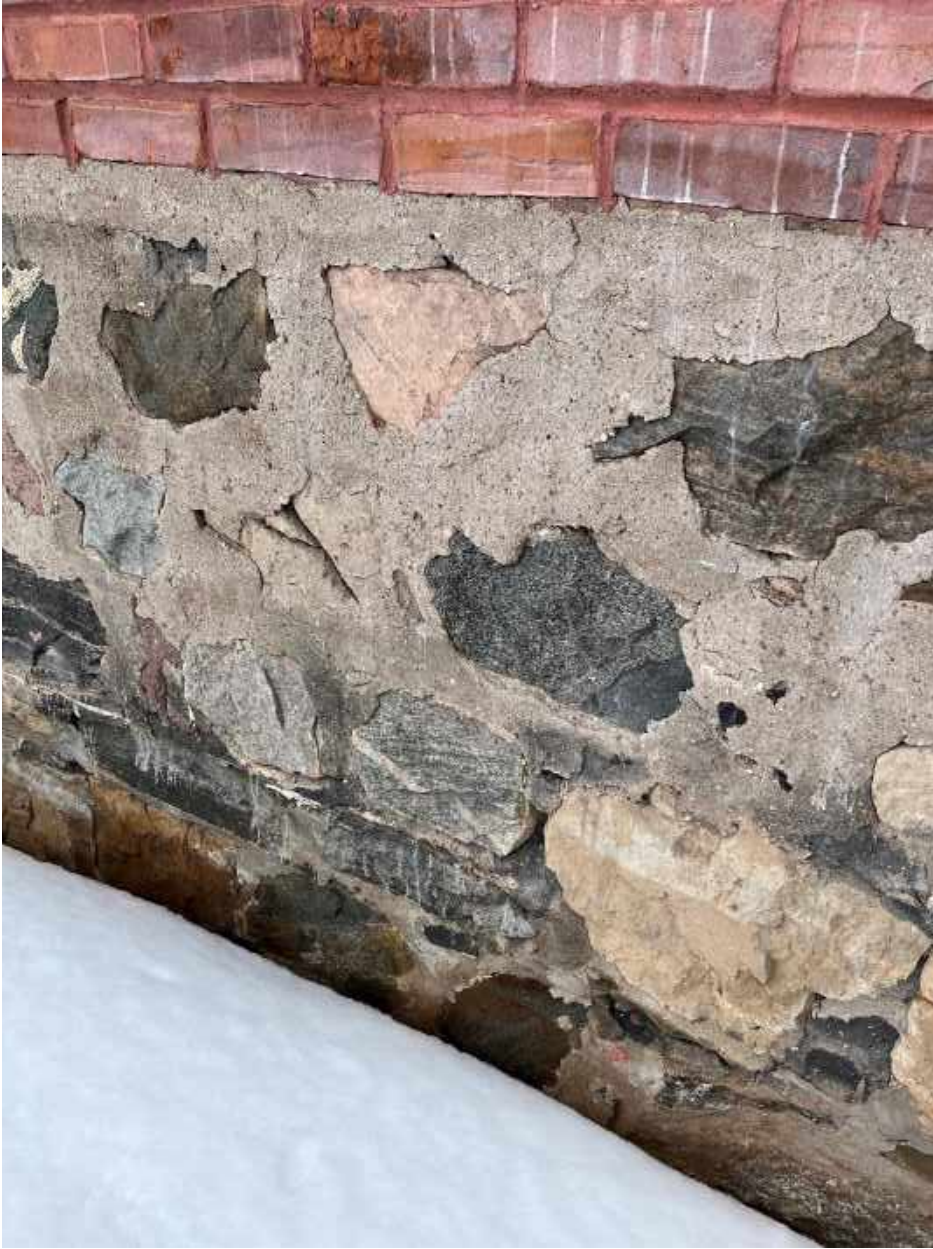
The stone foundation walls are solid, stable, wide and impressive. There is no significant cracking or failure.

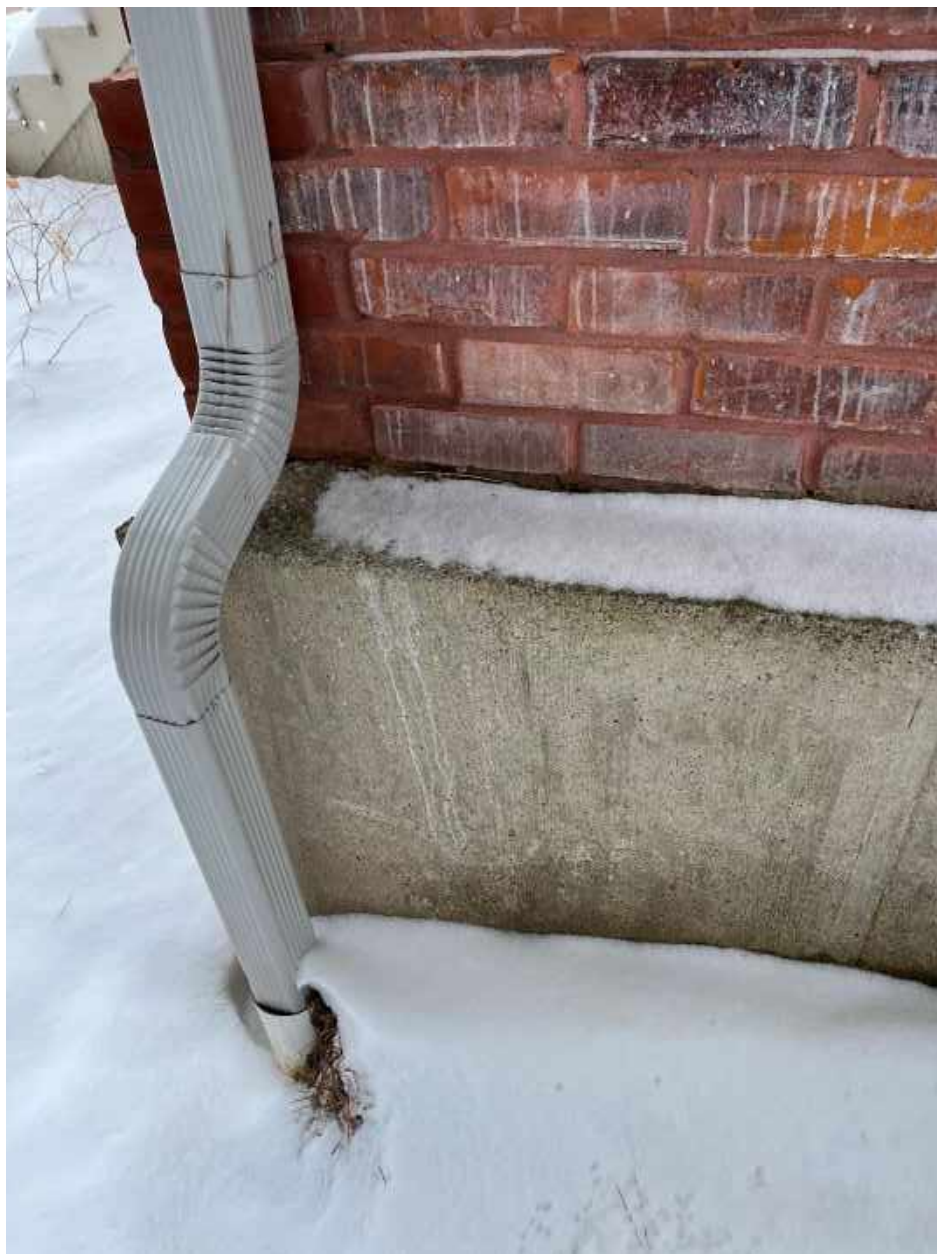
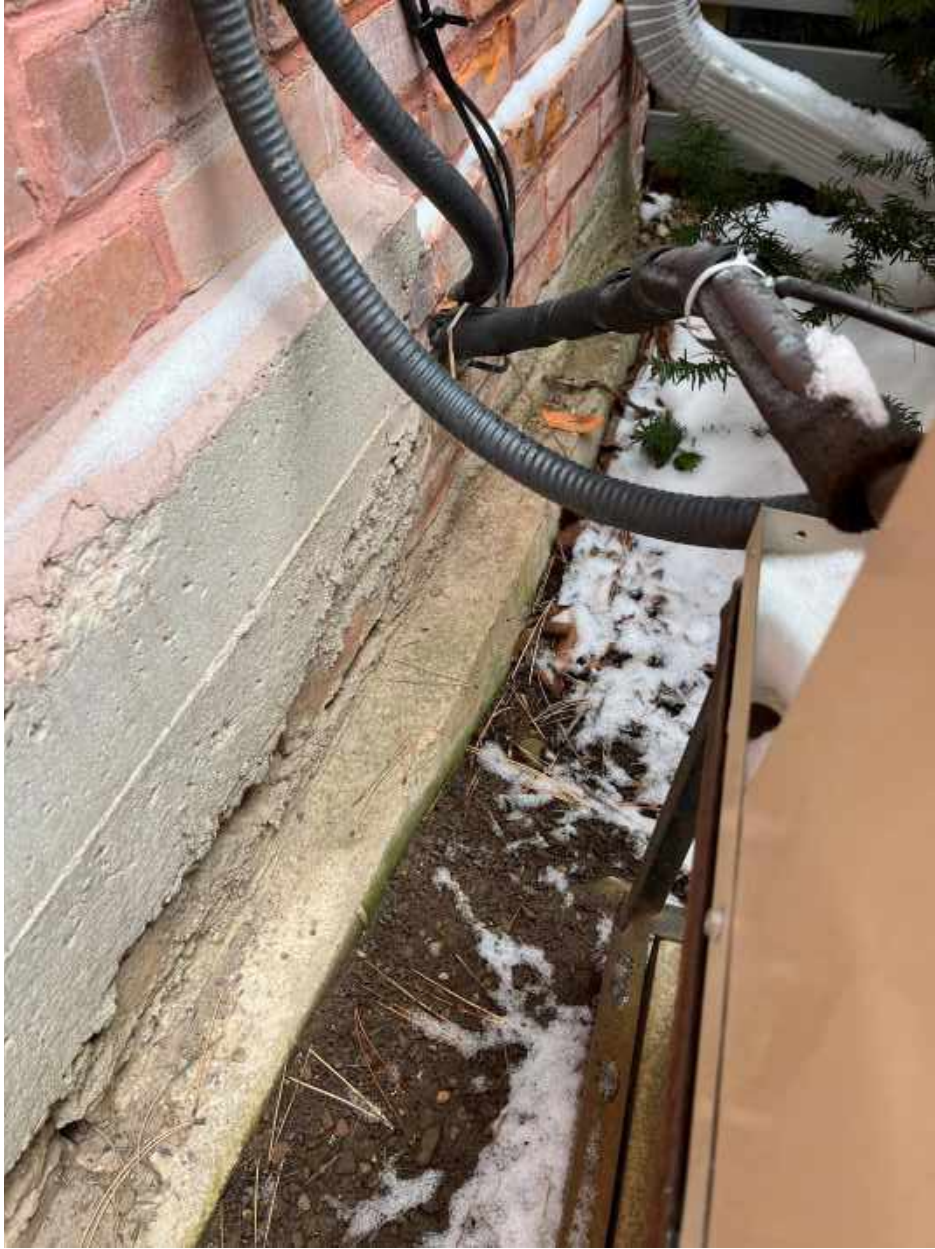
Concrete has been added at the right wall; it is completely stable.

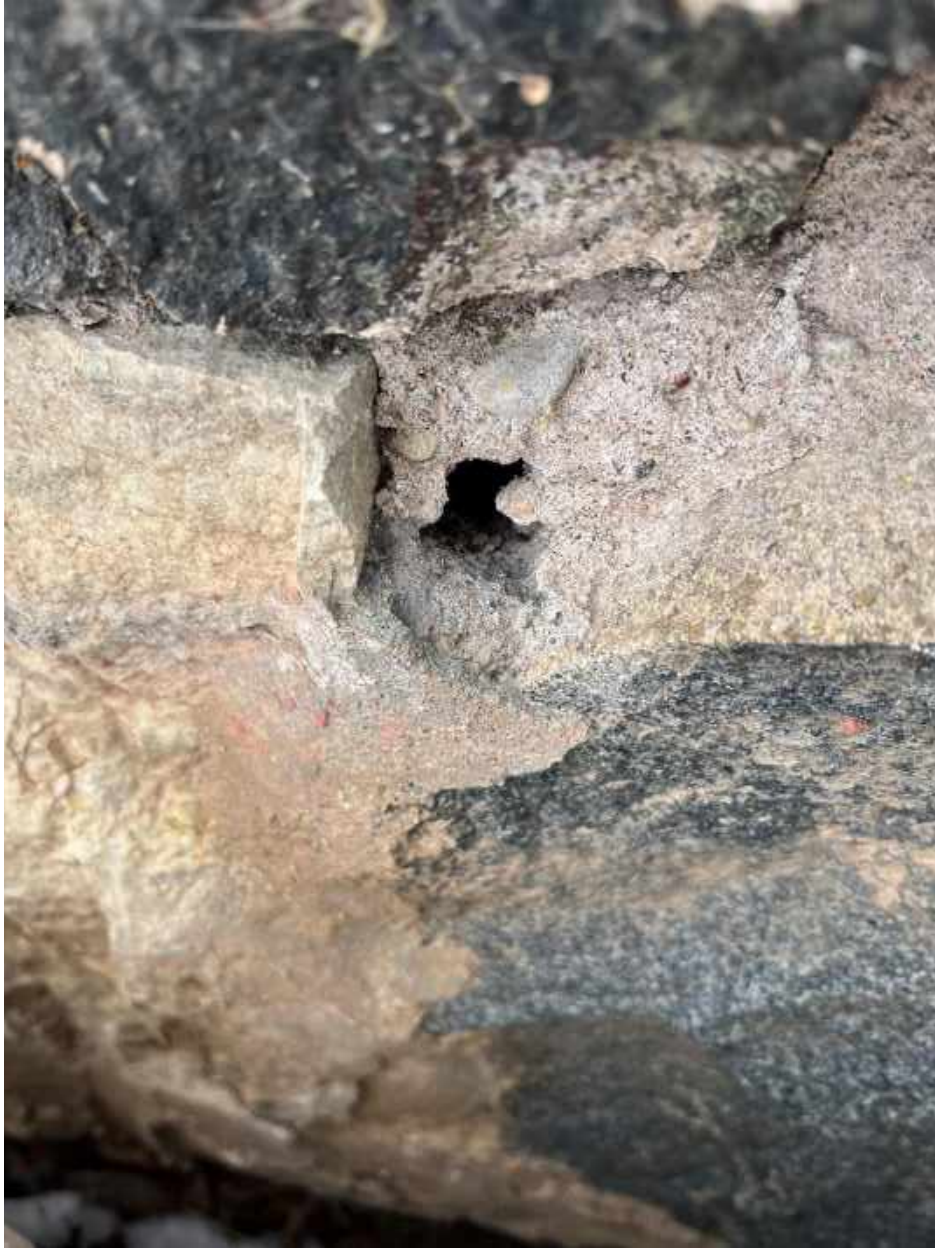
Very minor, non-urgent sealant work – such as a soft mortar or foundation patching compound – would be a minor benefit at the (handful of) openings between the foundation stones near grade.

This work includes openings at the stone concrete junction, at the right foundation.

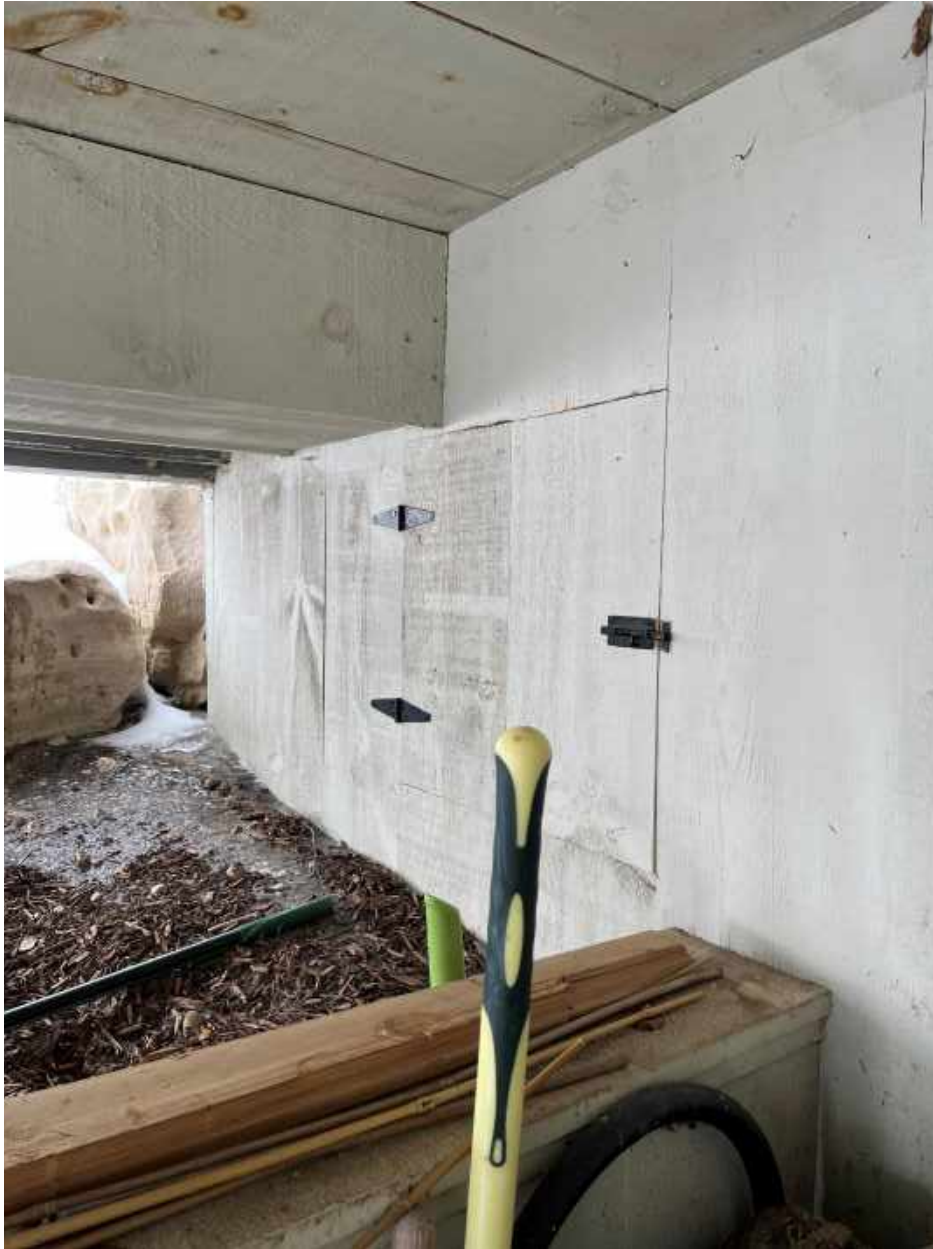
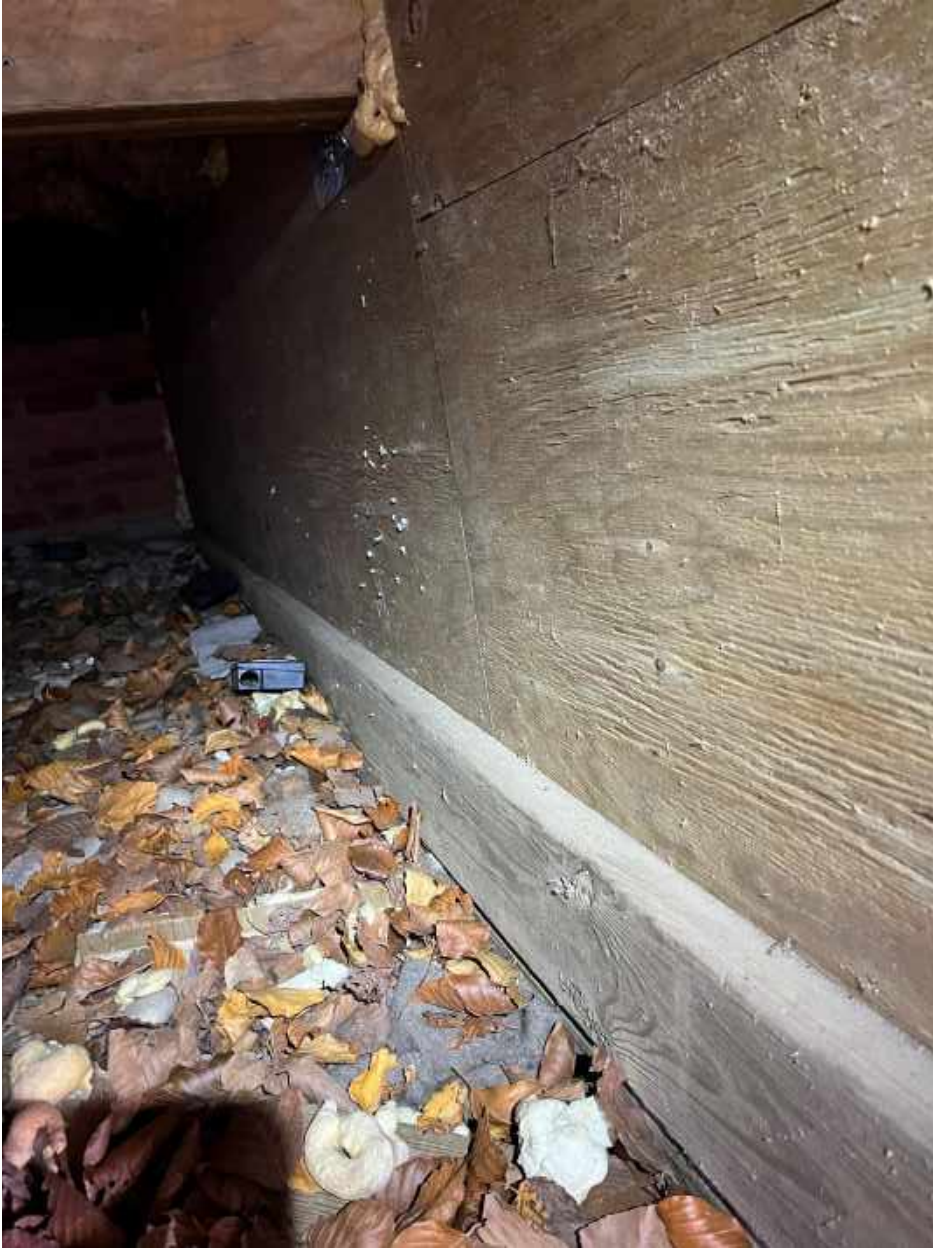
Some Possible Earth/Wood Contact at Skirt Wall Left of Sunroom:

The exact nature of the wall support at the left side of the rear crawlspace is not known to this inspector. It is not known whether any form of waterproofing

system is in place at the right side of the wall under the left perimeter of the rear crawlspace. Long term moisture decay is a possible concern there. Perhaps a as-built information can be obtained by the installer.

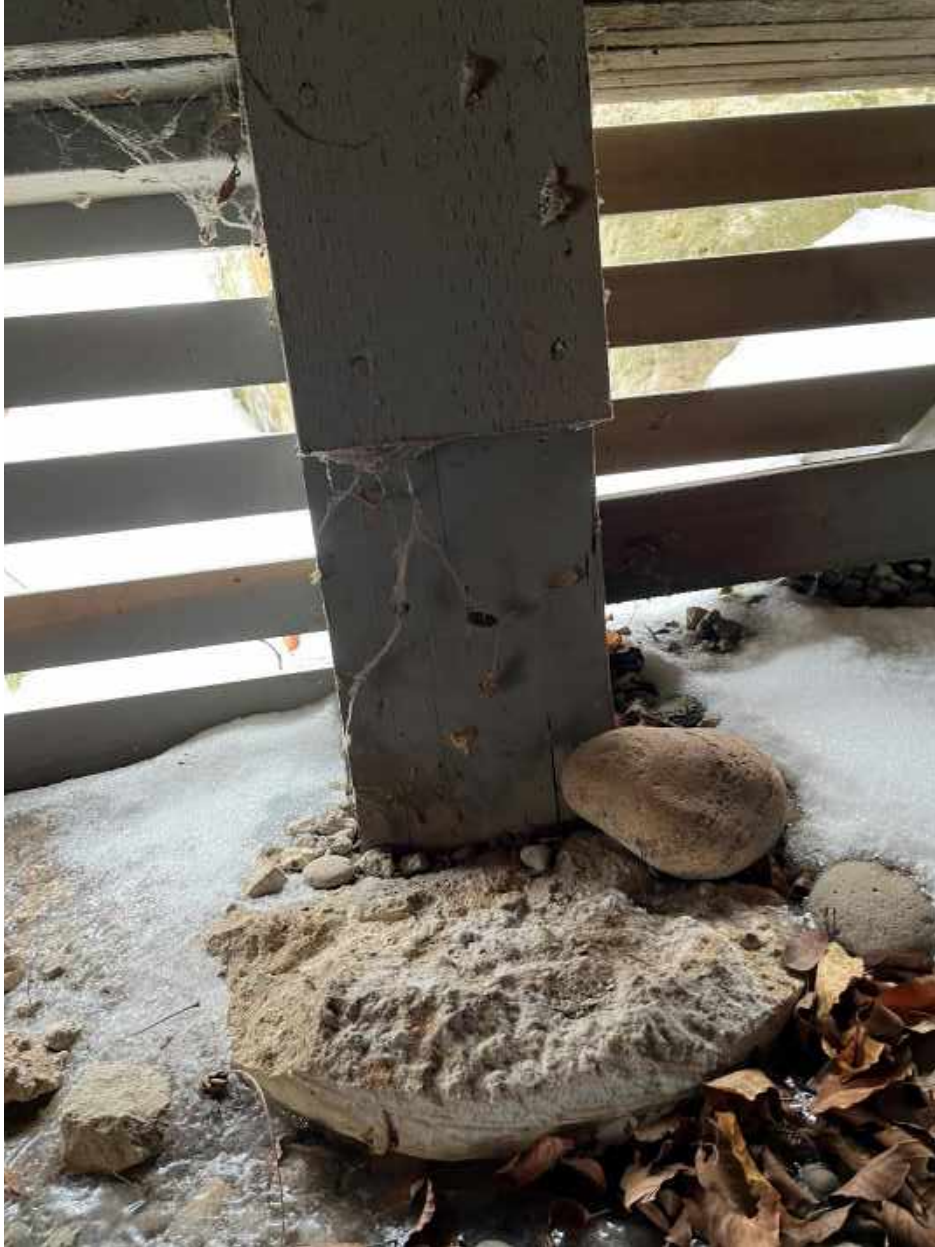
Coating Required Tops of Caissons:

While not critical work, it is recommended that a concrete sealer be added atop the concrete caissons that support the beams in the rear crawlspace.

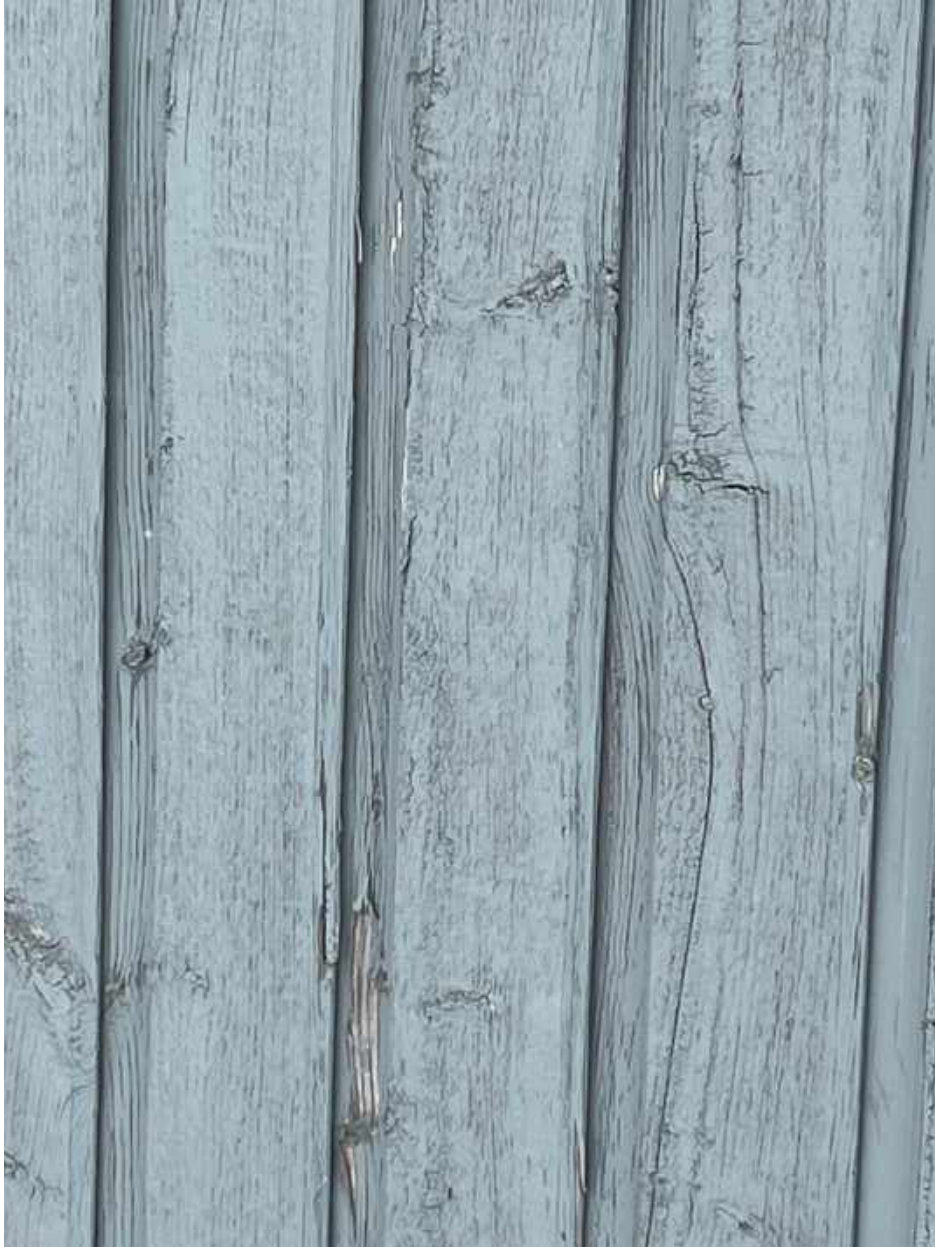
Finishes often deteriorate most quickly at the south side of homes. The rear/south siding here will require re-finishing in the near future, say in the next couple of years.

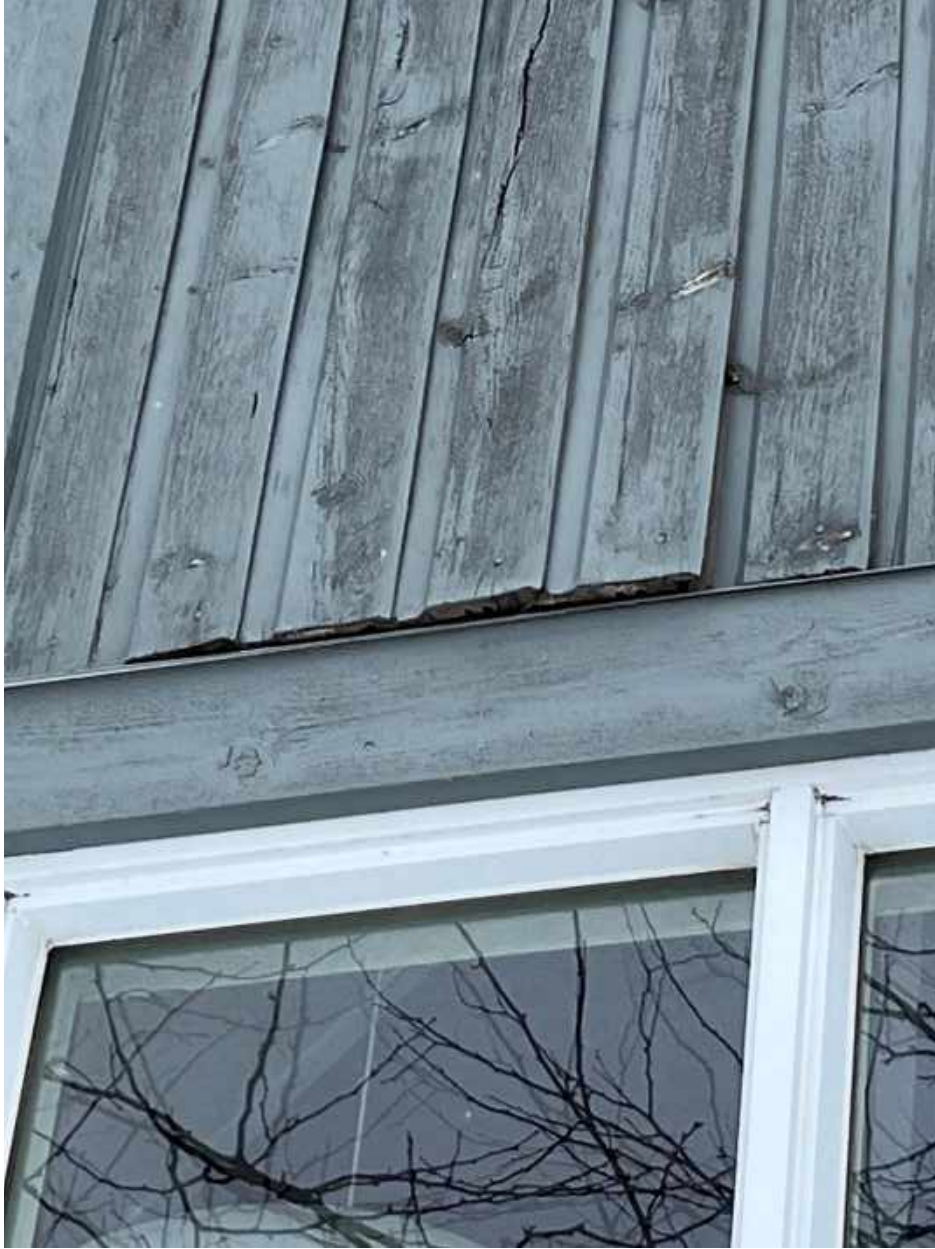
Minor re-fastening is also required.

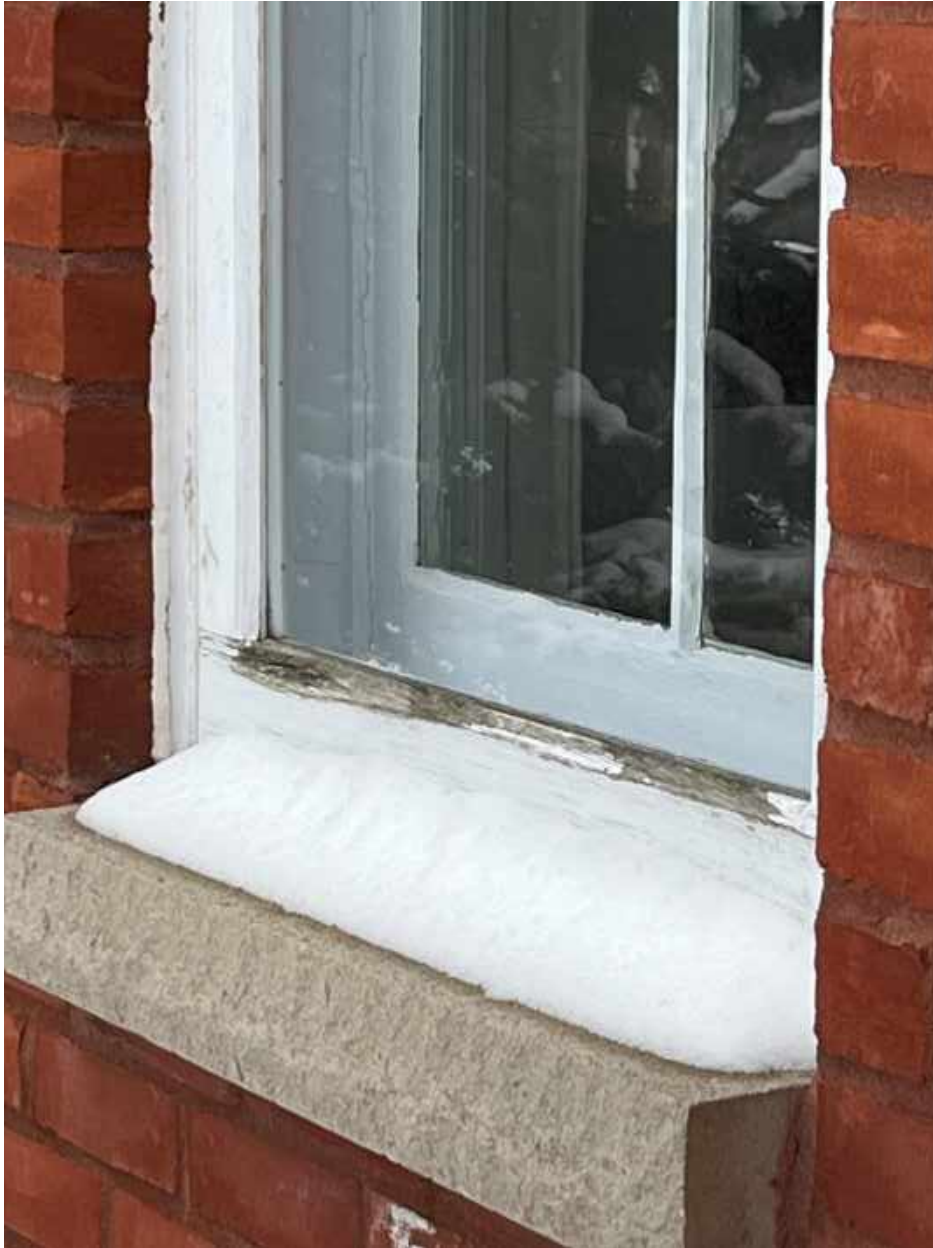
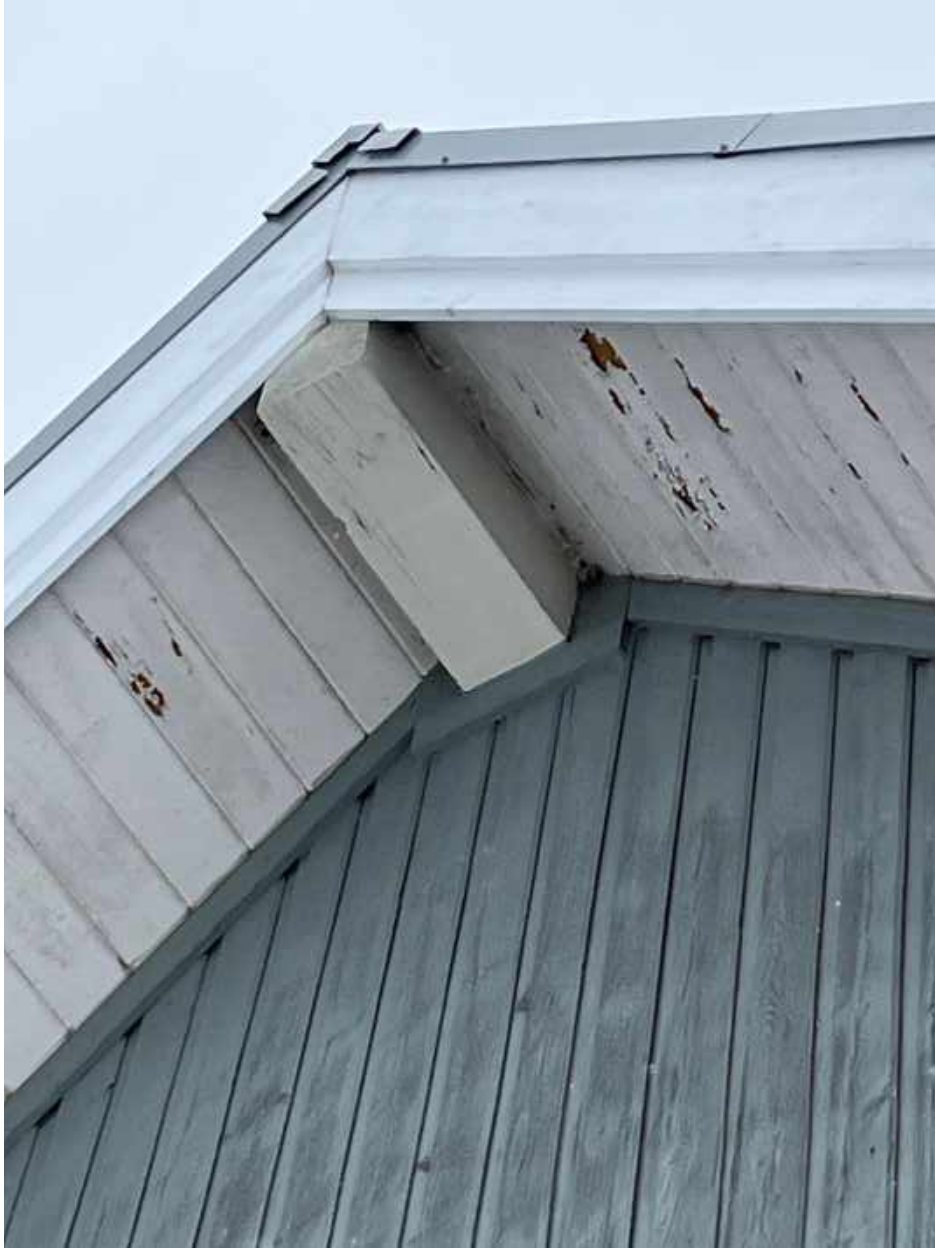
Some re-finishing is obviously required at the exterior window and soffit wood.

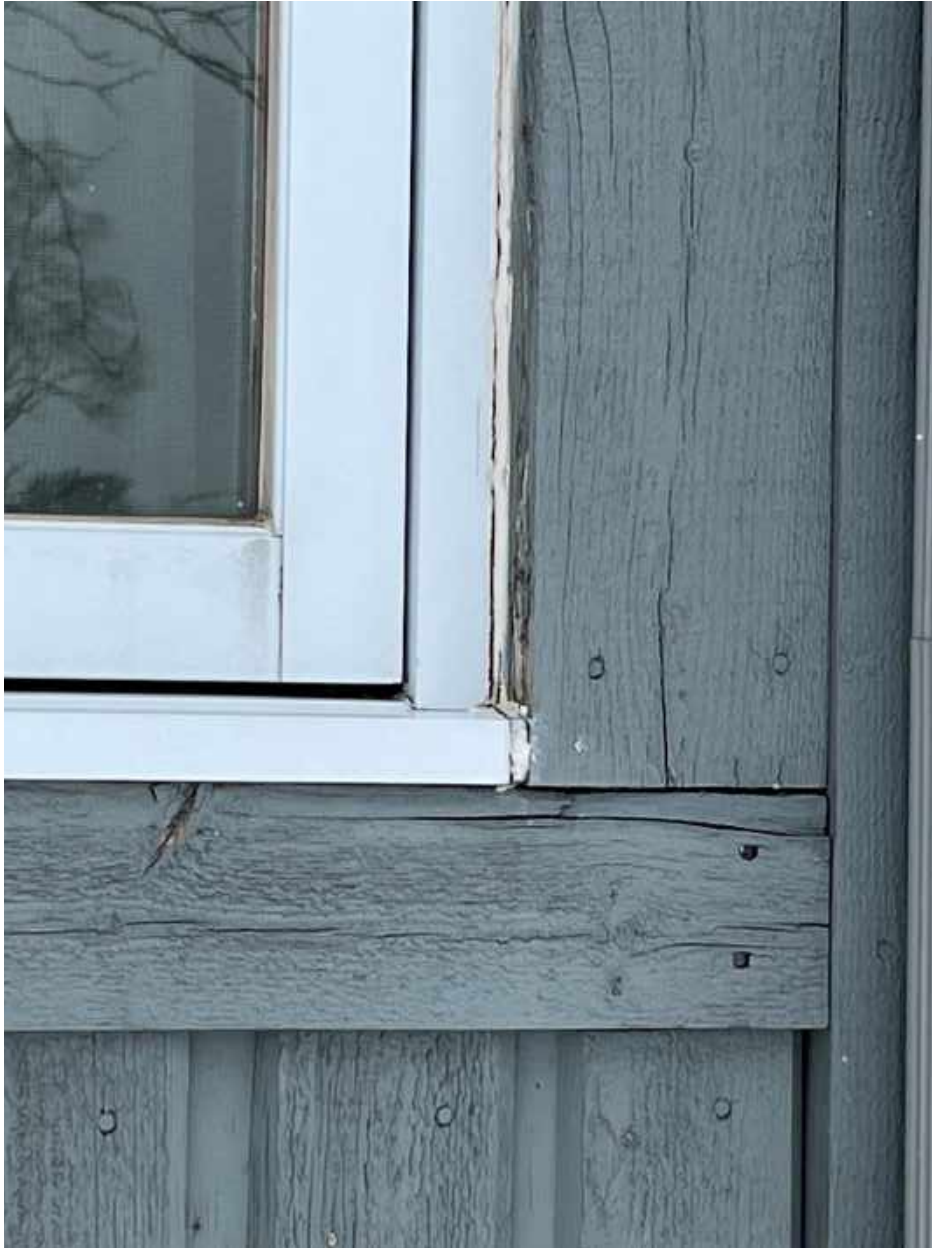
A few open joints should be sealed.

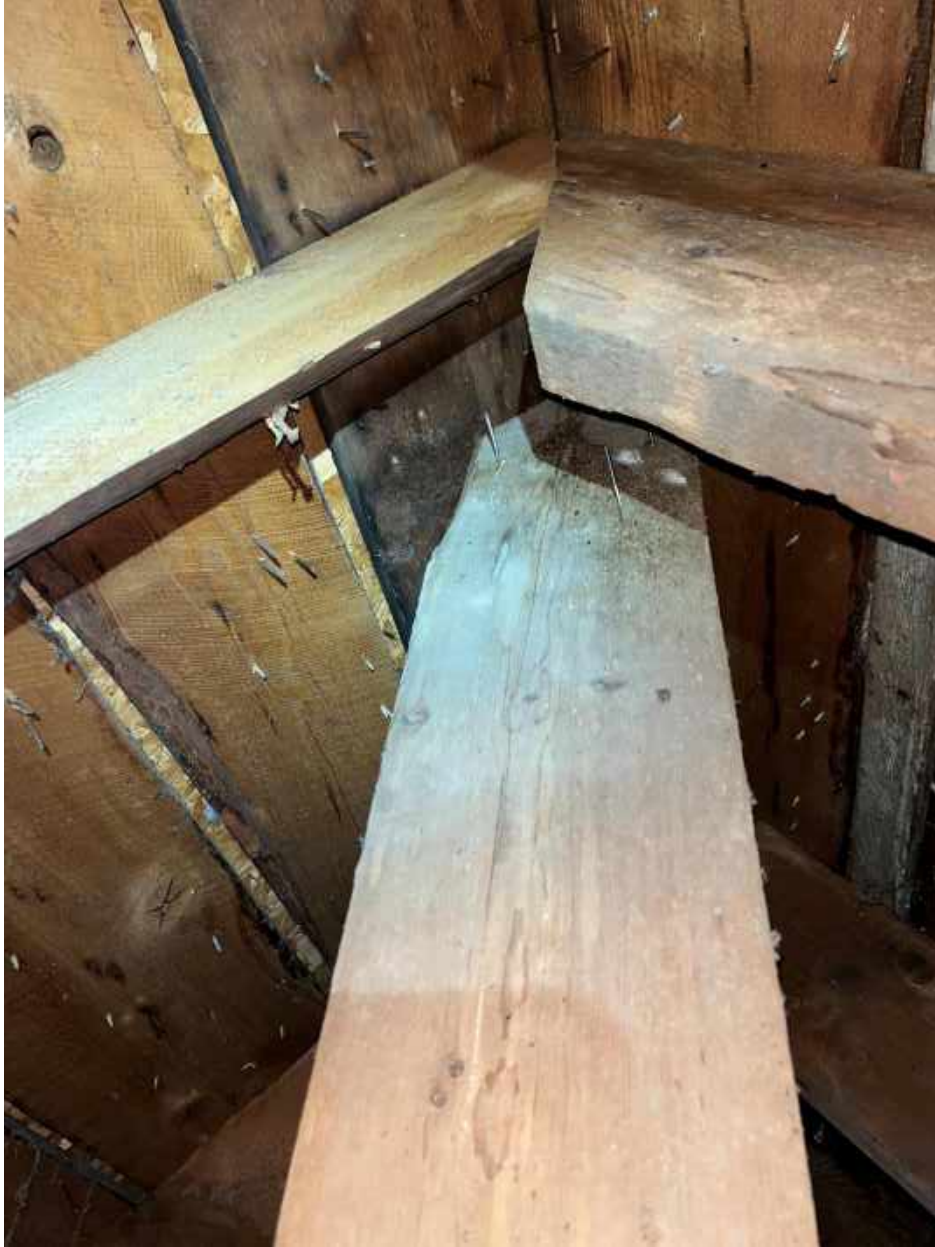
One of the vertical braces has separated from the tops of adjacent rafters, in the middle part of the attic. While not critical work, it should be re-fastened.

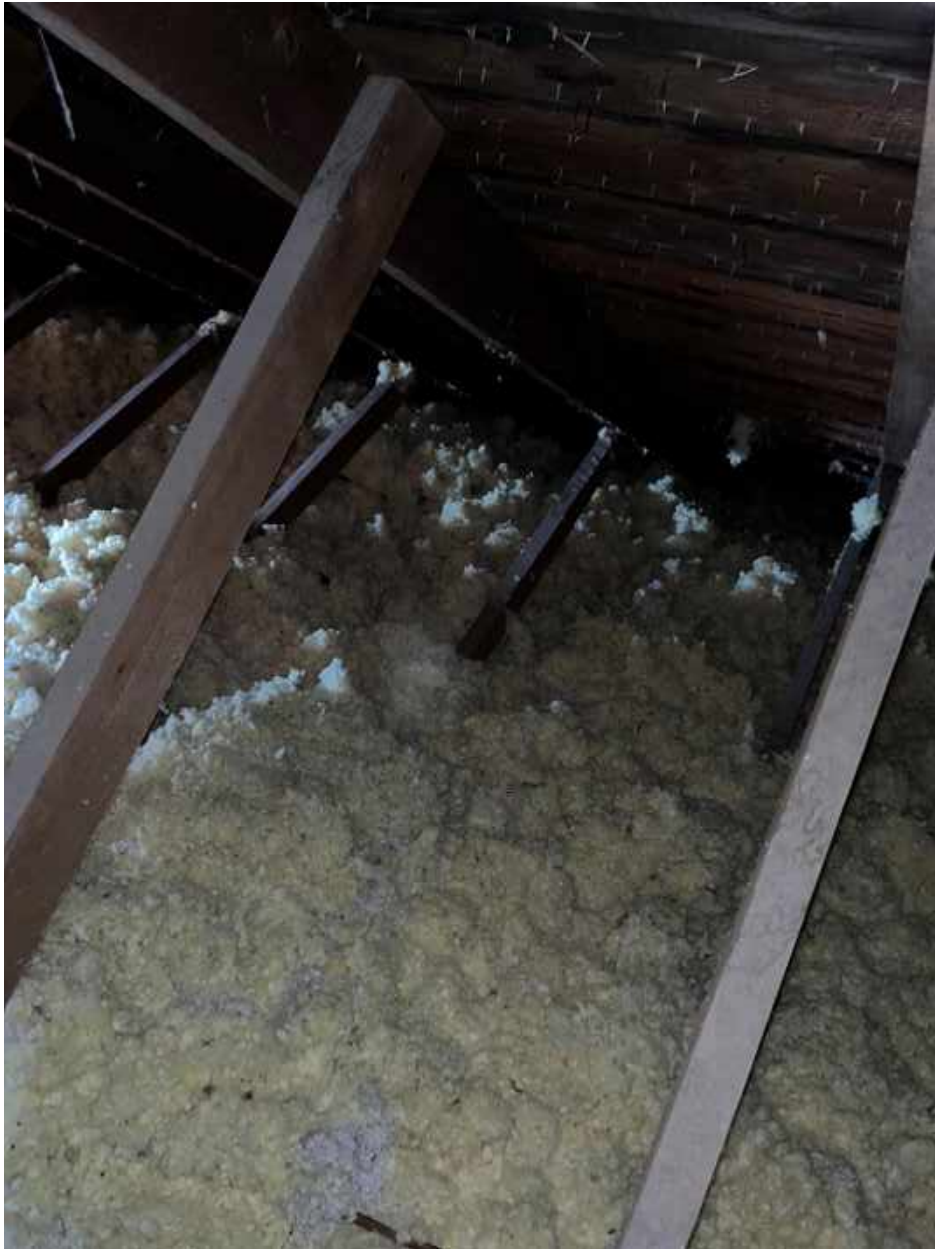
It is completely normal to find evidence of mice activity at most homes, especially country homes. Set traps or otherwise address the mice. Be sure to maintain a full seal at the building envelope to prevent wildlife entry. That includes maintenance of ridge caps and valleys at the metal roofing system over the years.

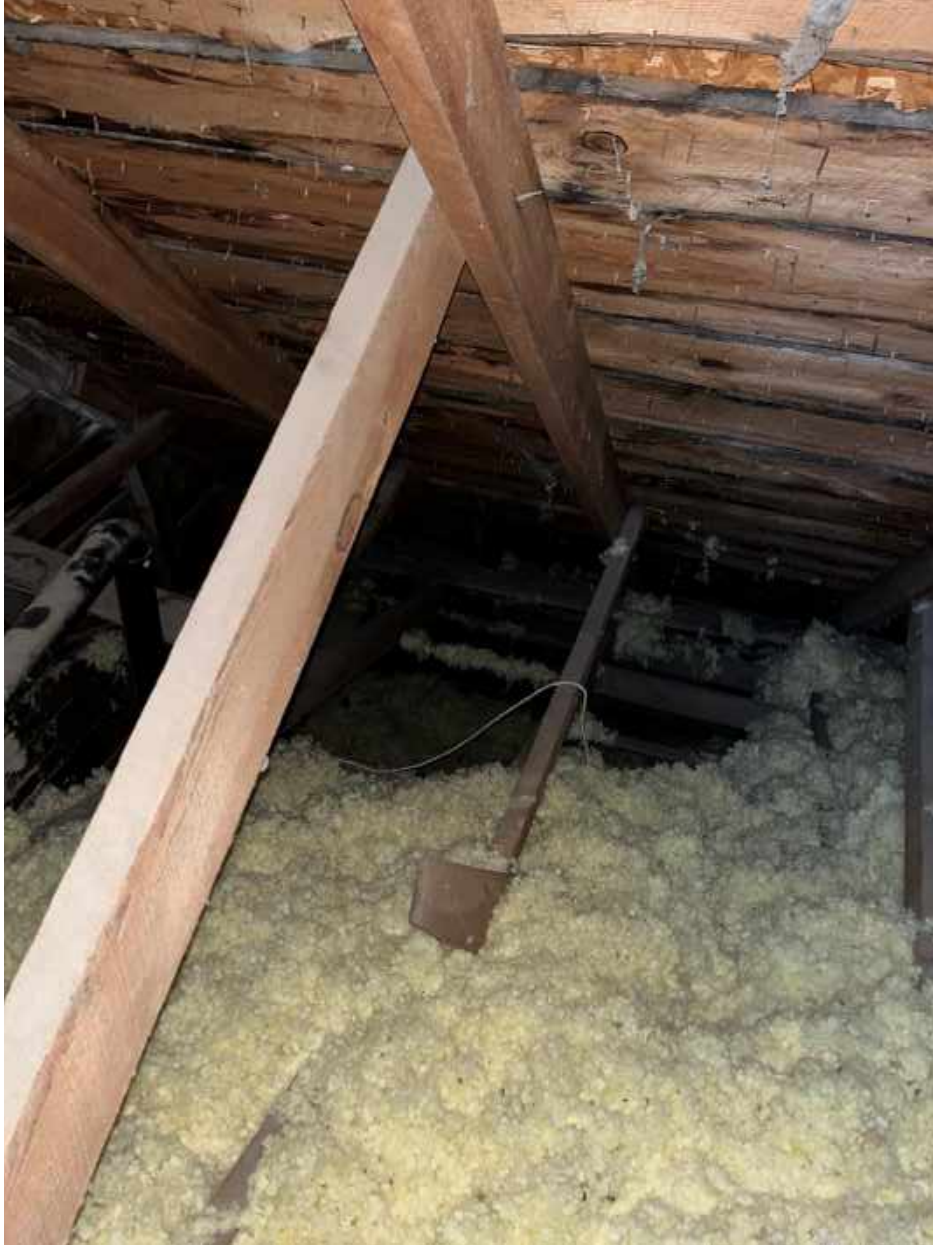
While the assembly is stable, it is recommended that fasteners be added at member junctions, including where only one nail has been used.

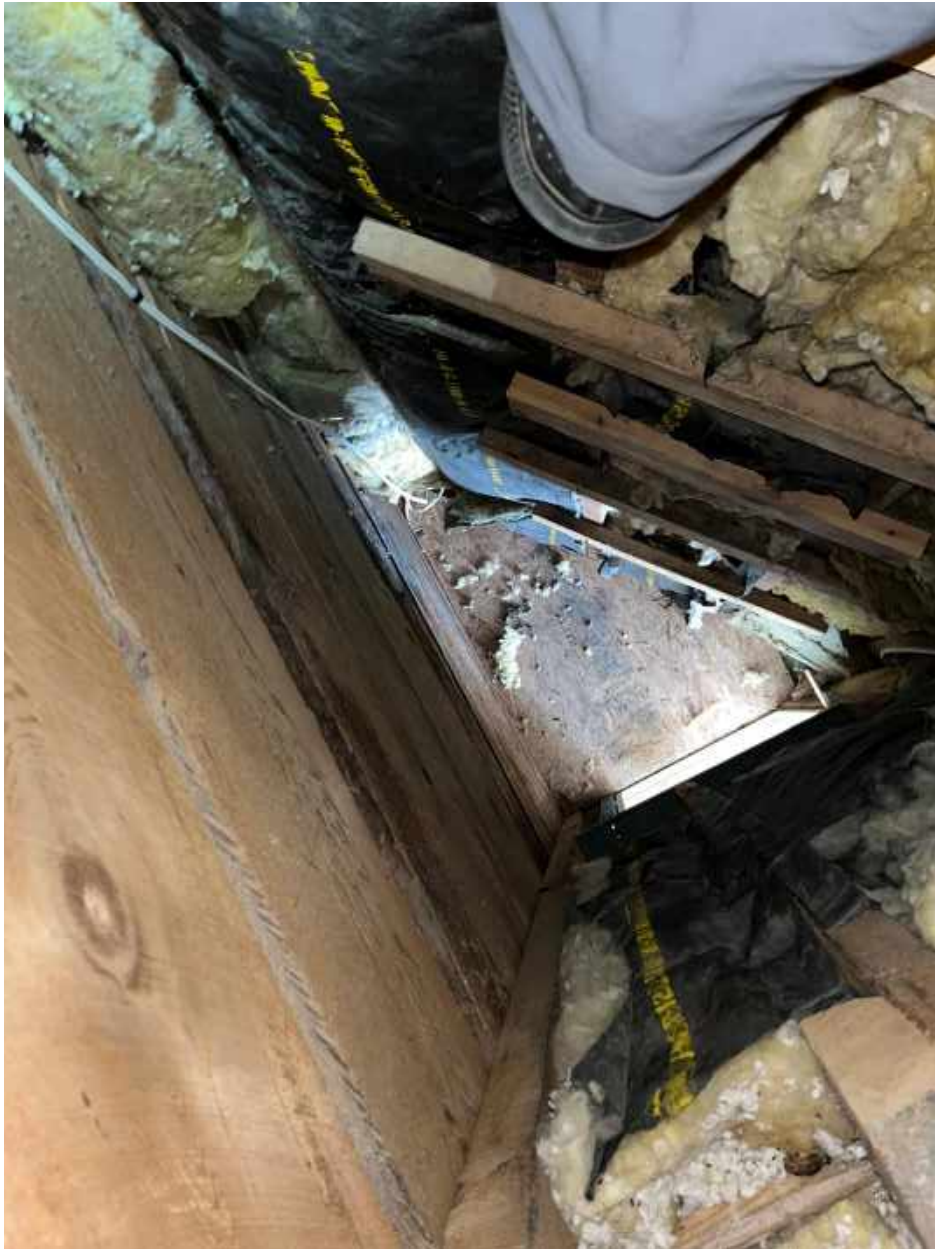
The attic access ladder comprises horizontal two-by-fours that have been nailed to studs. It is difficult to fully assess the safety of the ladder, but it was stable when loaded by this inspector. It would be prudent to add fasteners and/or hardware to ensure safety.

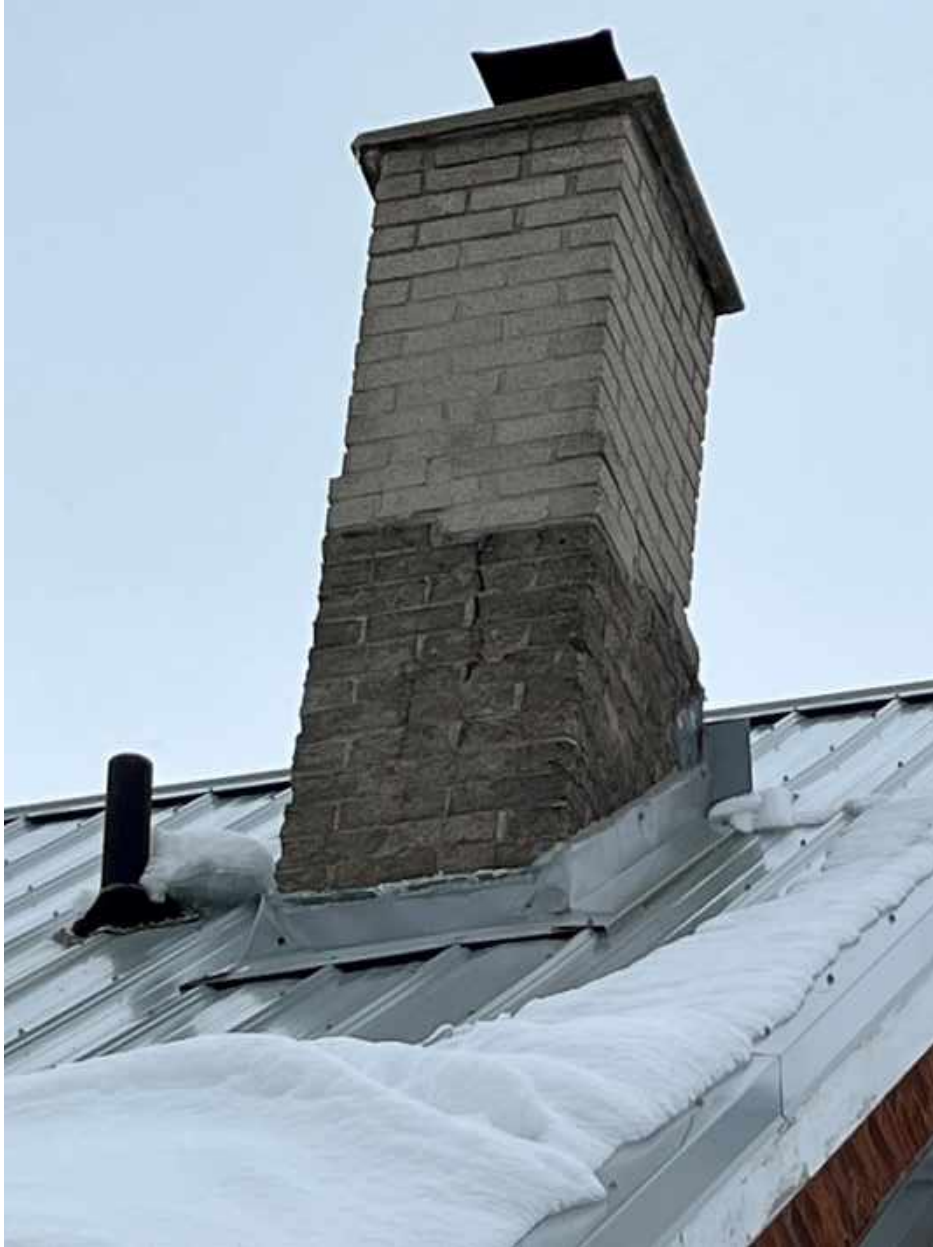
The obvious open crack at the right side of the masonry chimney should be fully sealed to prevent further degradation.
