Listing Information Package

**2111 Concession 8 South Nottawasaga Road,
Glen Huron**

This inspection is intended to assess the structure (including foundations, floors, walls and roofs), building envelope (including roofing), mechanical systems (including heating and plumbing), the attic space (including insulation), electrical systems and windows.

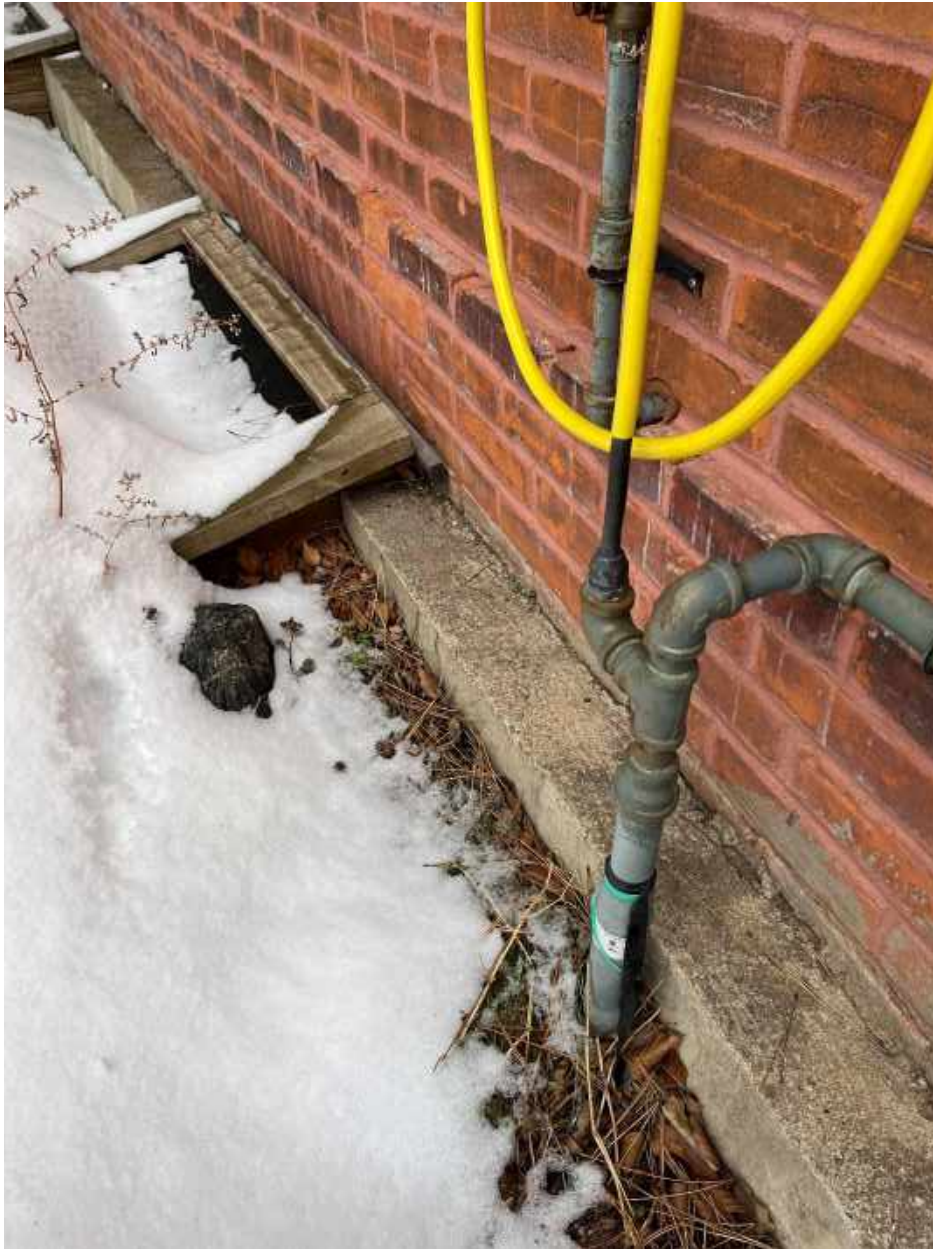
It is recommended that a concrete sealer product be applied to the exposed top of the concrete at the eight foundation, to prevent long-term degradation. Caulking the joint where the concrete meets the brick system would be a benefit also.

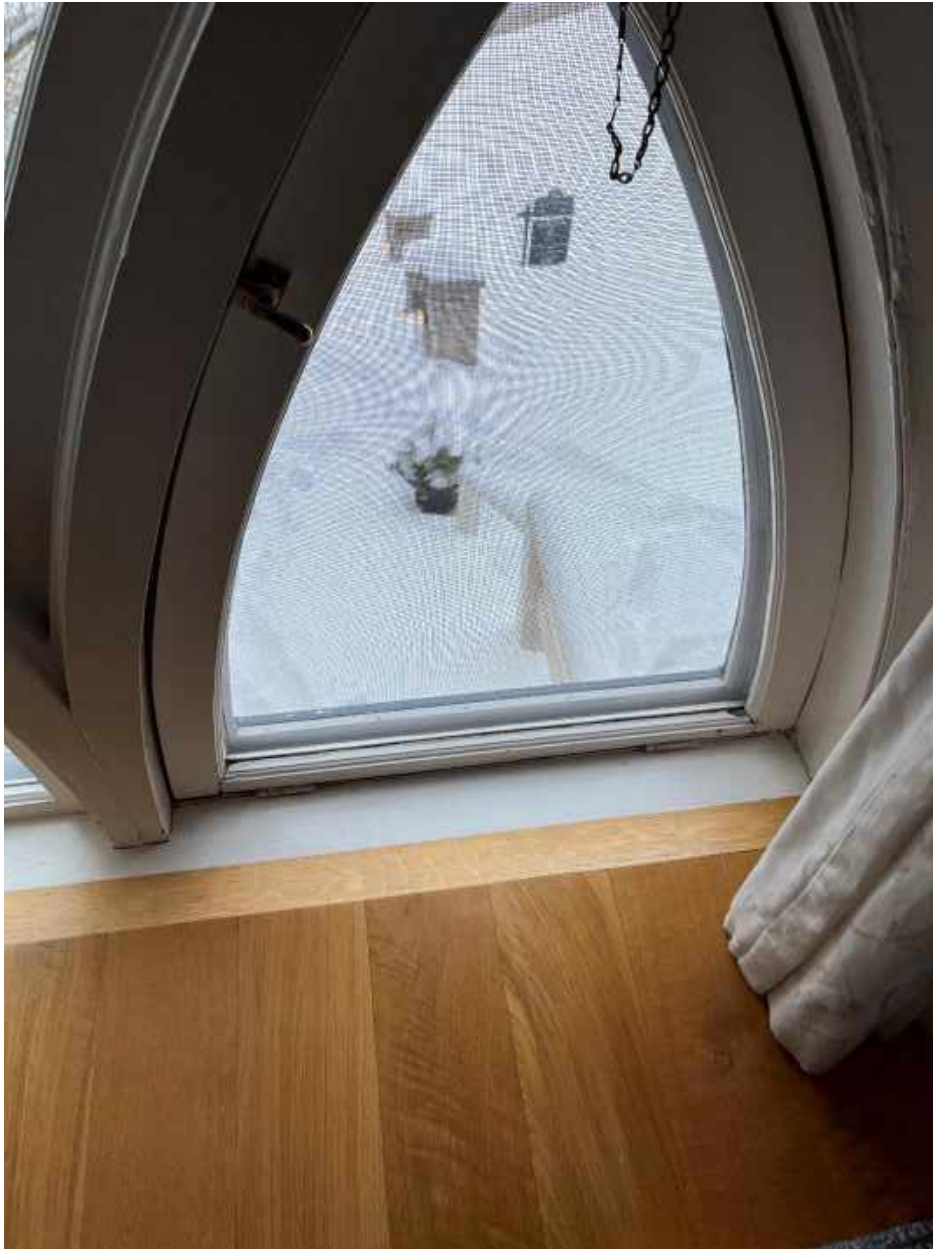
The window at floor level in the master bedroom presents a falling hazard for children/toddlers. It can be fastened shut if children/toddlers are occupying the home.
