Listing Information Package

234 Third Street, Collingwood

This inspection is intended to assess the structure (including foundations, floors, walls and roofs), building envelope (including roofing), mechanical systems (including heating and plumbing), the attic space (including insulation), electrical systems and windows.

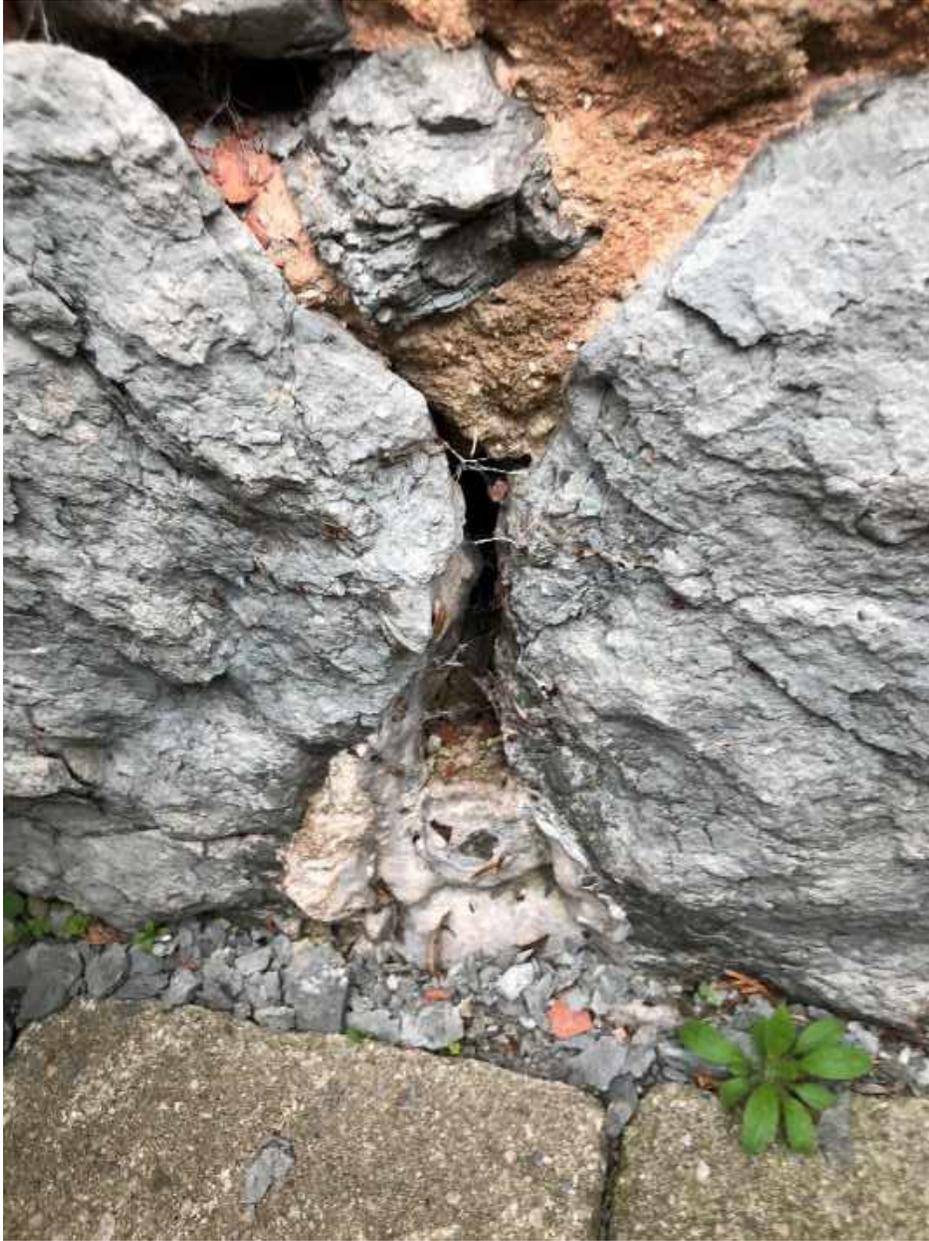
Minor Opening Outside Face at Right Foundation – While not ‘required’ work, it would be a benefit to seal the minor opening, such as by using foam insulation or a masonry patching product.

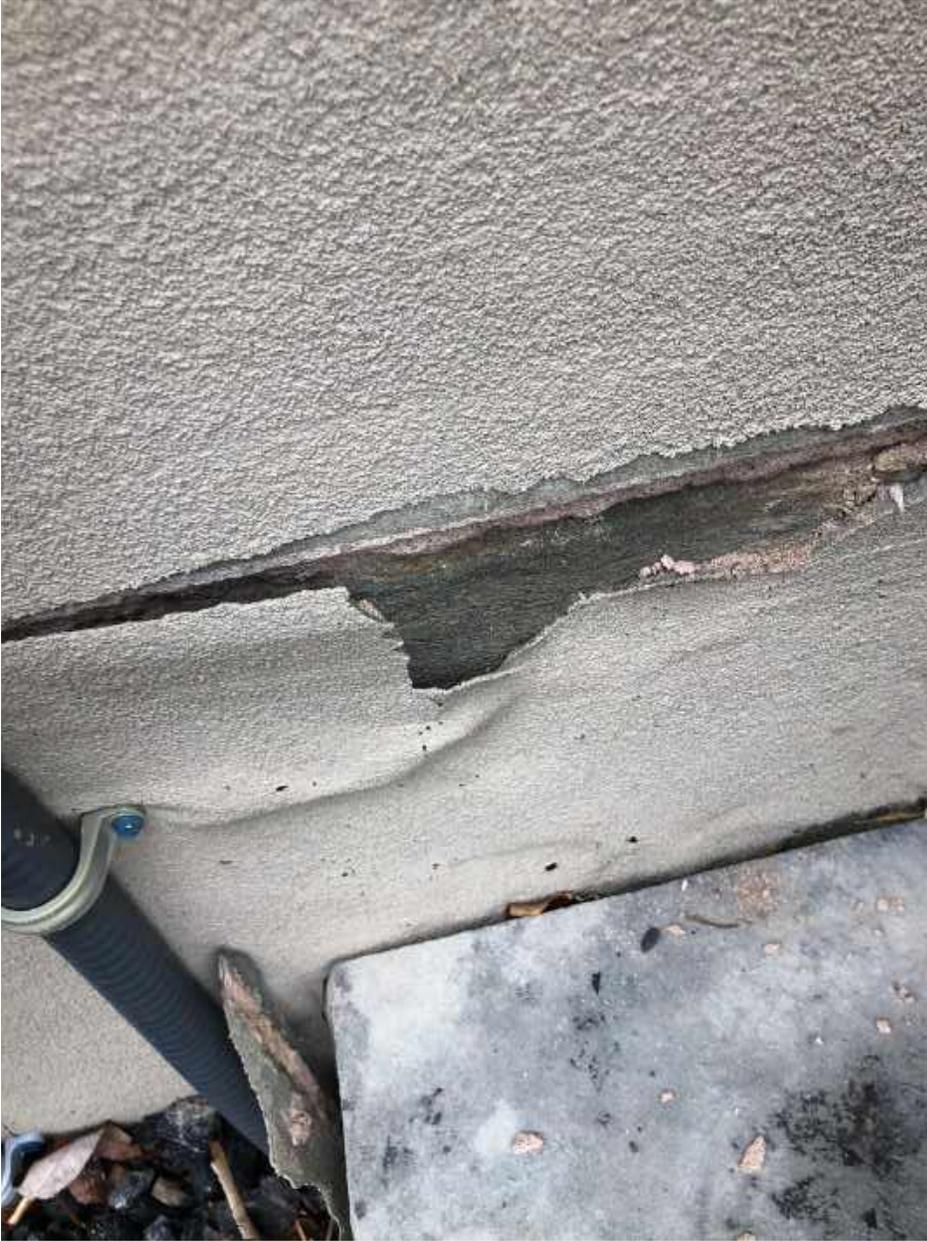
Repairs are required at the stucco-like parging system at the outside face of the right foundation wall.

The stucco-like parging is not likely a waterproofing system; it is likely decorative. Minor repairs are required, as noted above, but the coating is stable overall.

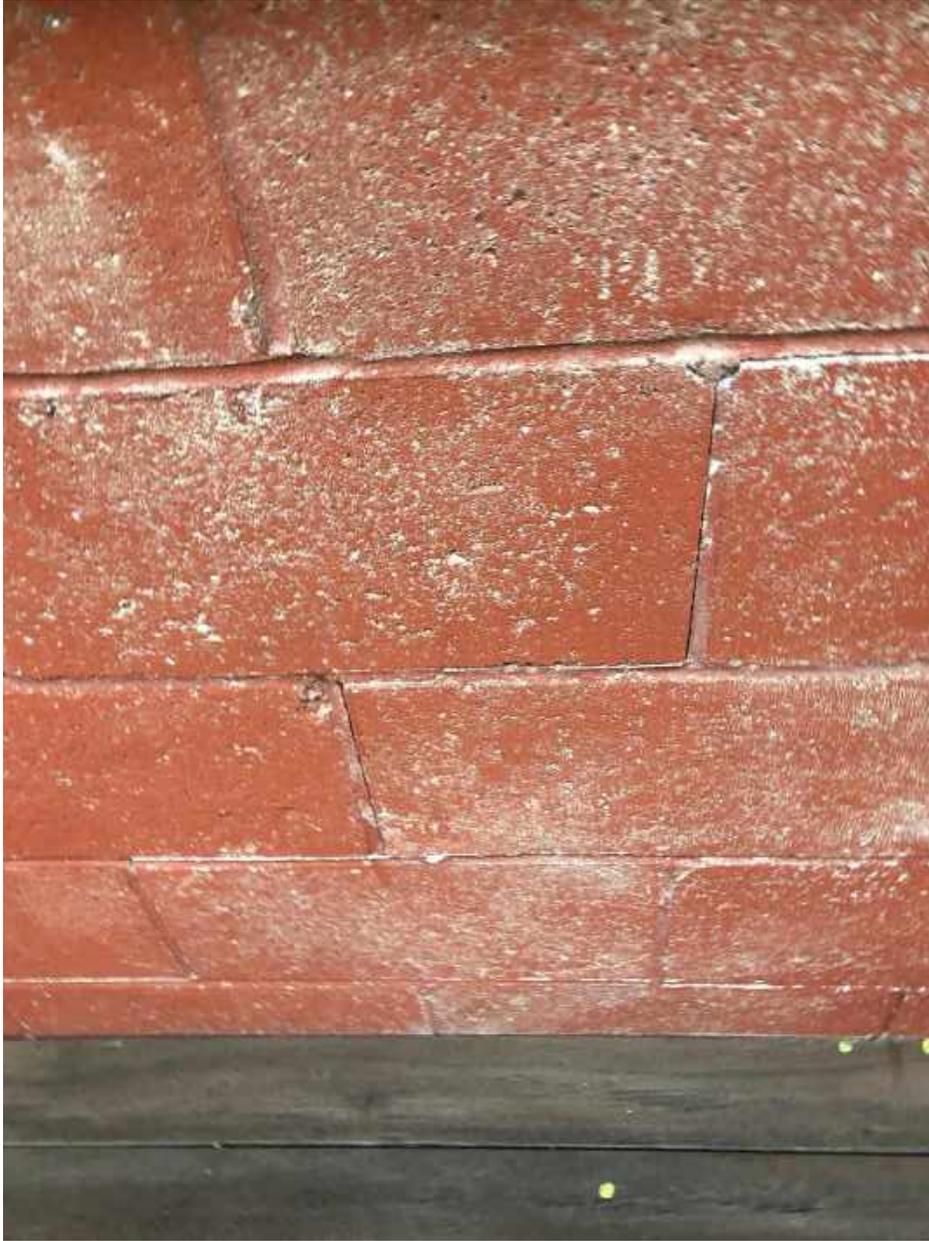
One normal settlement/stress crack is observable at the left garage foundation wall. While not critical work, it would be a minor benefit to apply a flexible sealant or water proofing compound to the crack, above grade only.

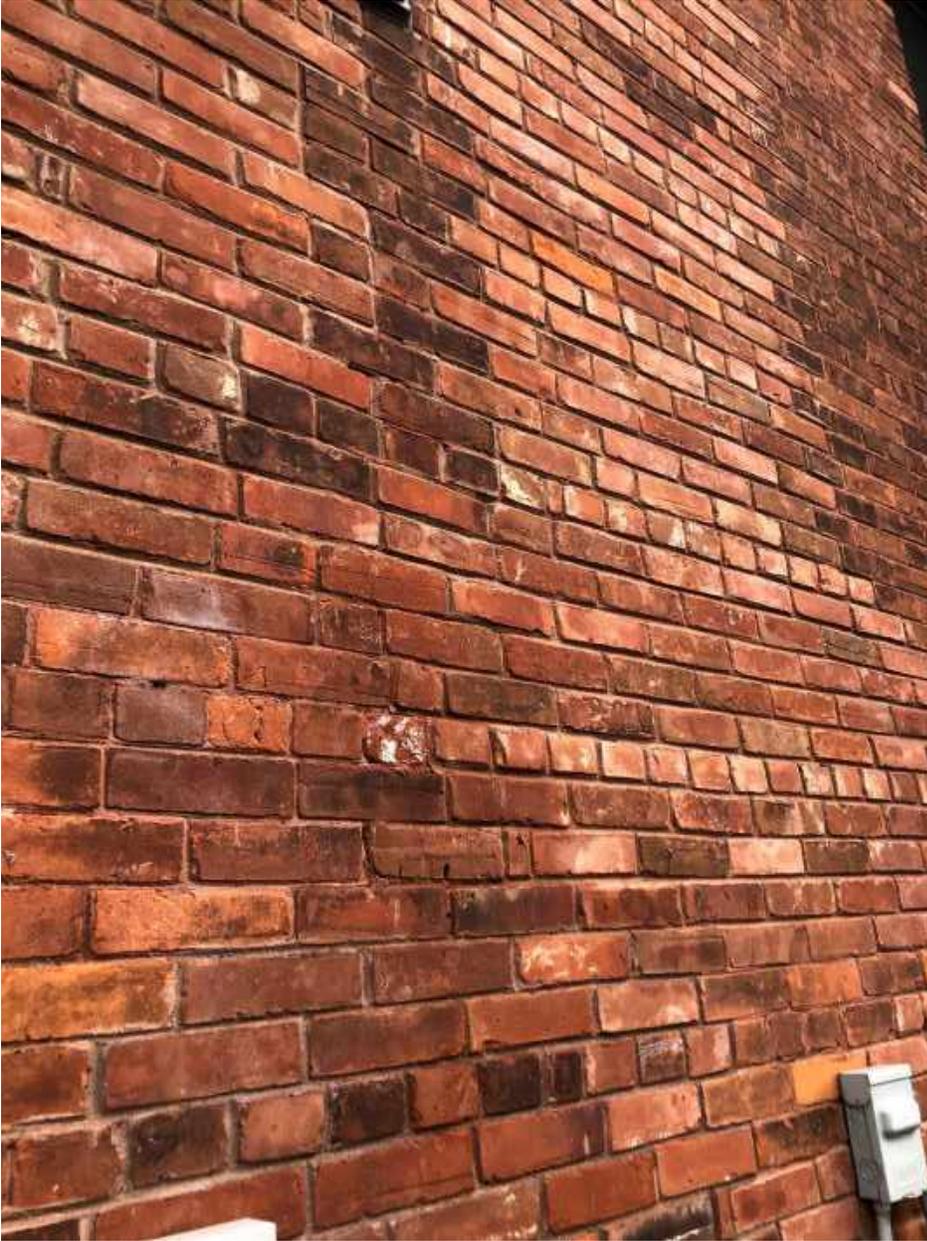
Minor water damage was observed at a few locations, but no action is required. Patching or coating work can be carried out if desired to prevent long-term degradation.

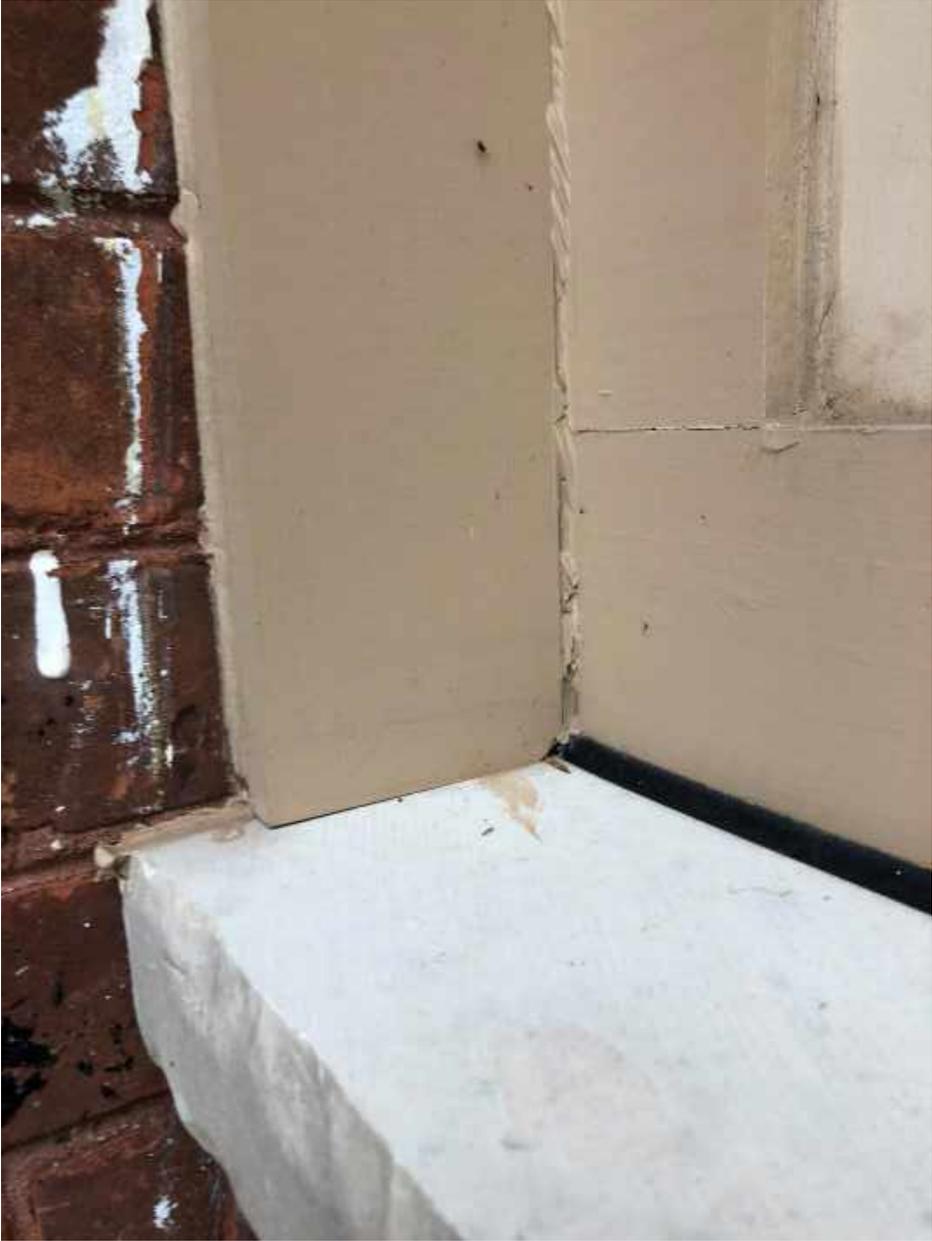
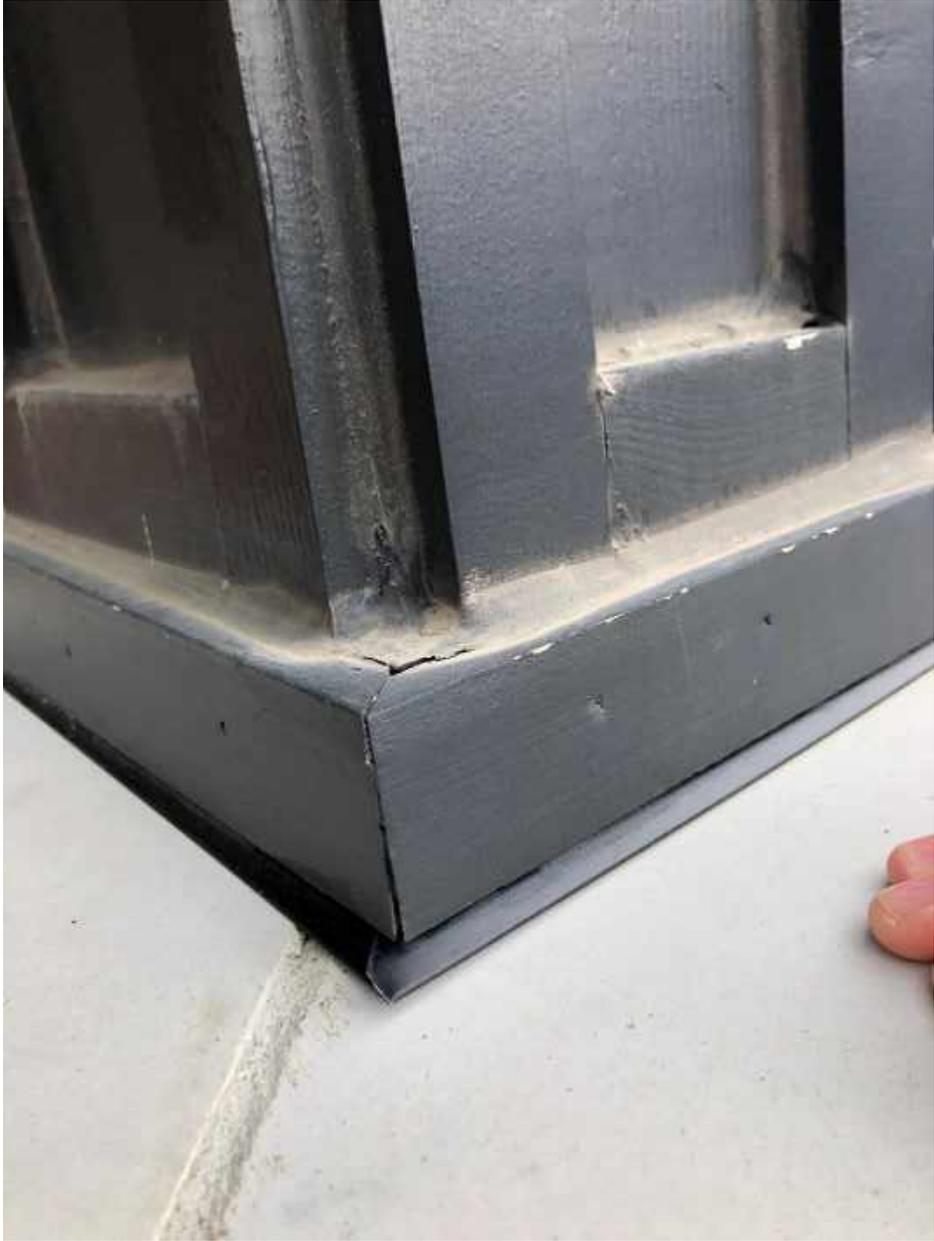
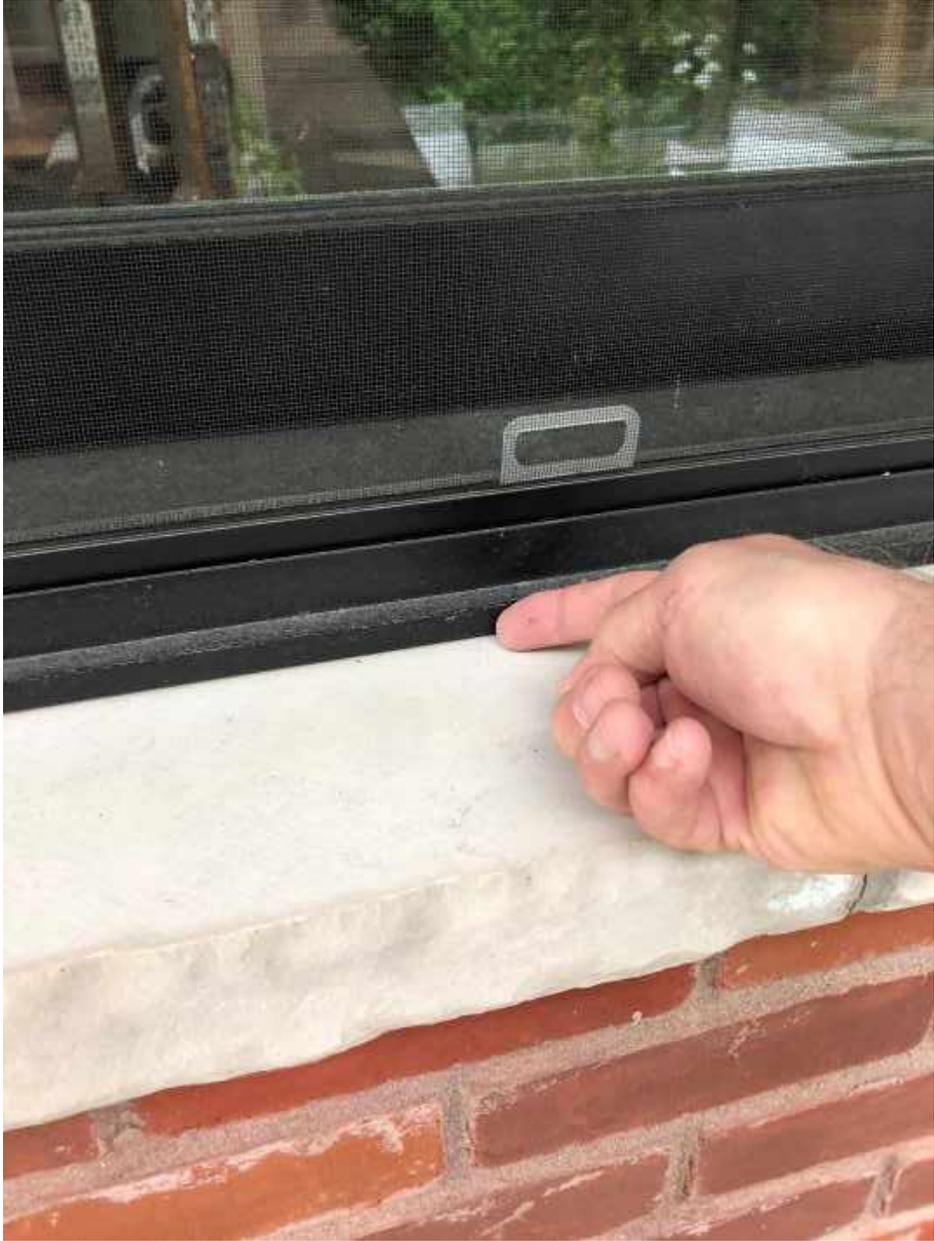
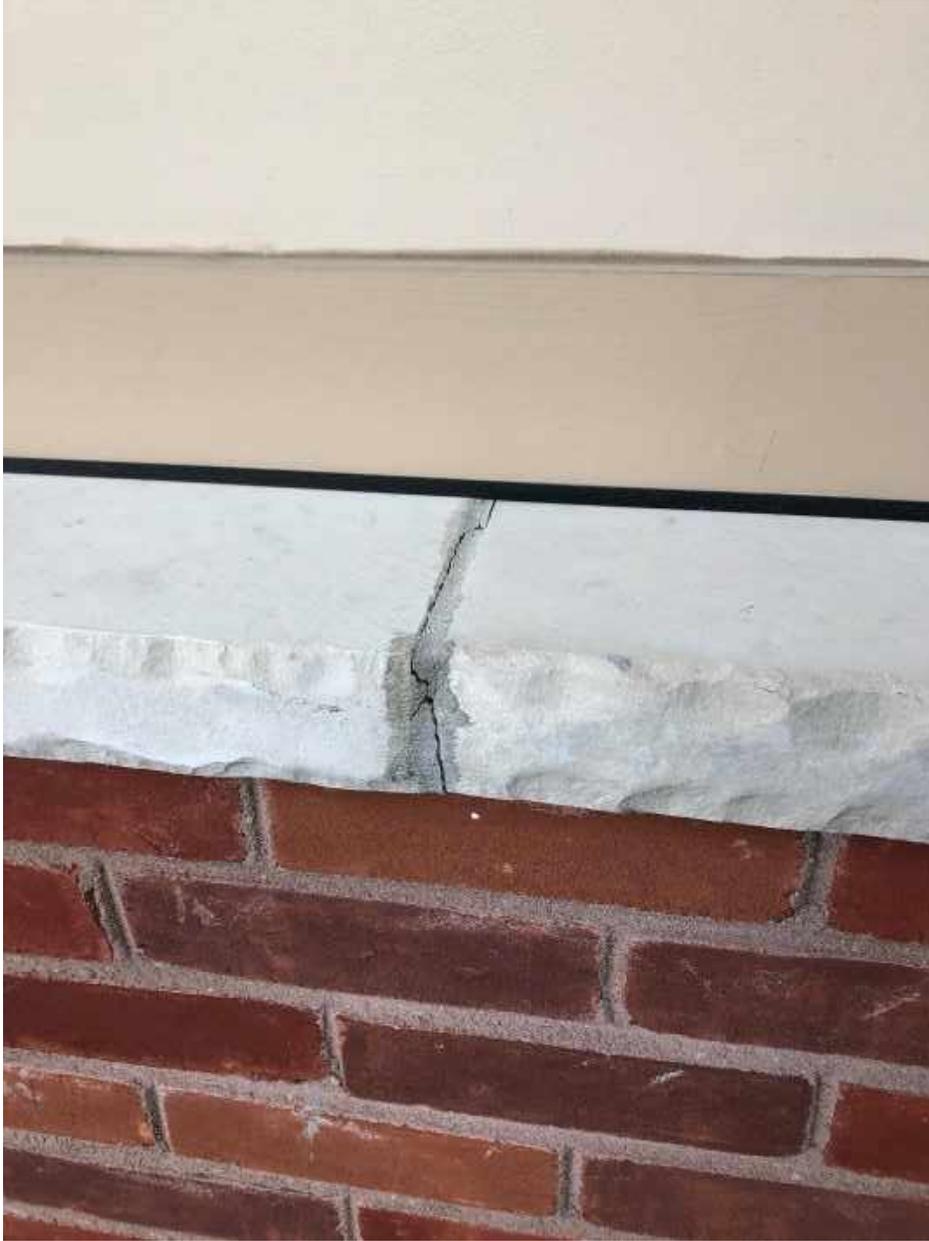
Caulking is required at a number of locations, including at a few open joints, and at horizontal mortar joints in the masonry sills.

Be sure to maintain all caulking at joints around windows, and at the entire building envelope.

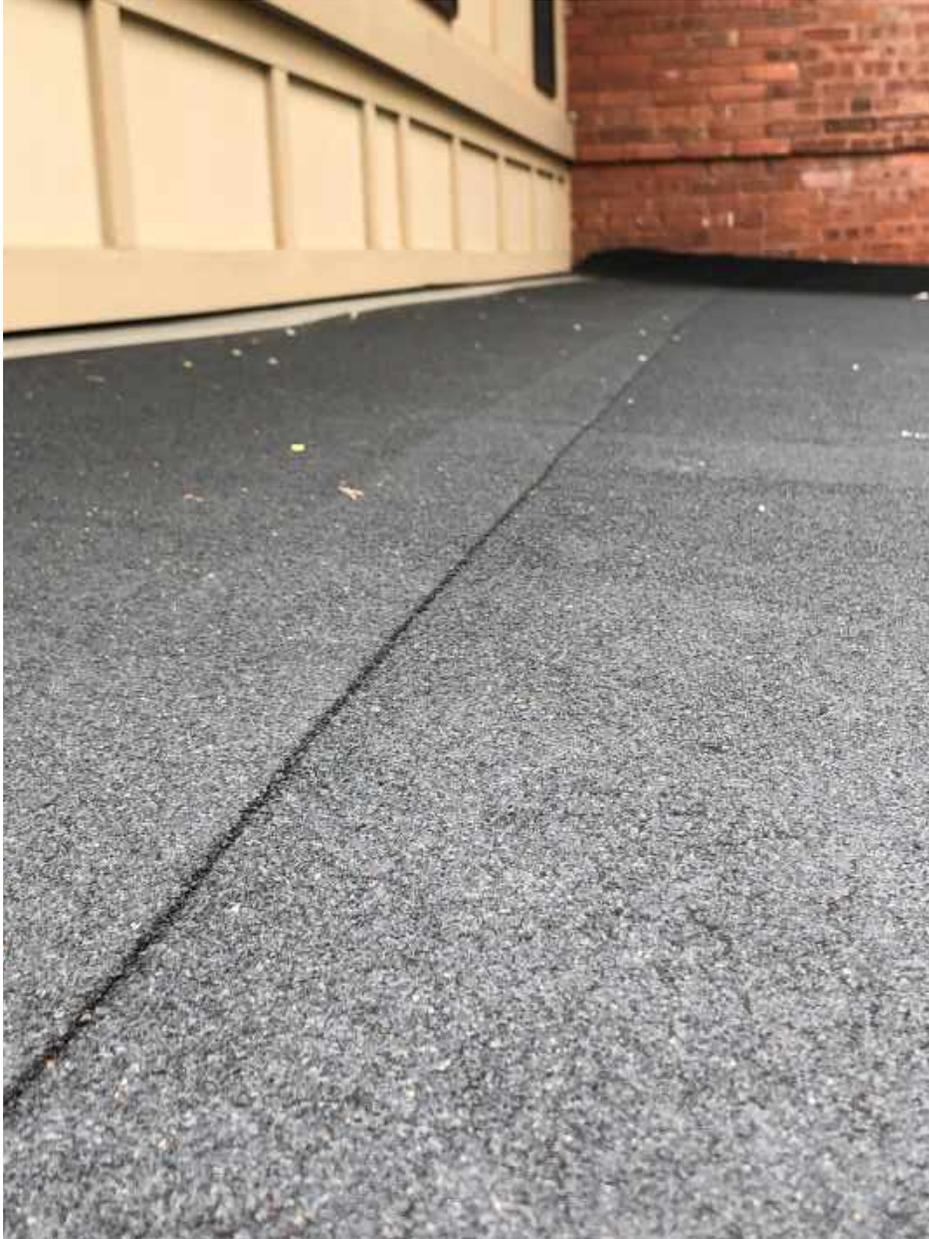
Membrane Roof - Some cracking is observable at the flat membrane roof; work will likely be necessary there in the next few years.

Some cracking is observable at the flat membrane roof; work will likely be necessary there in the next few years.

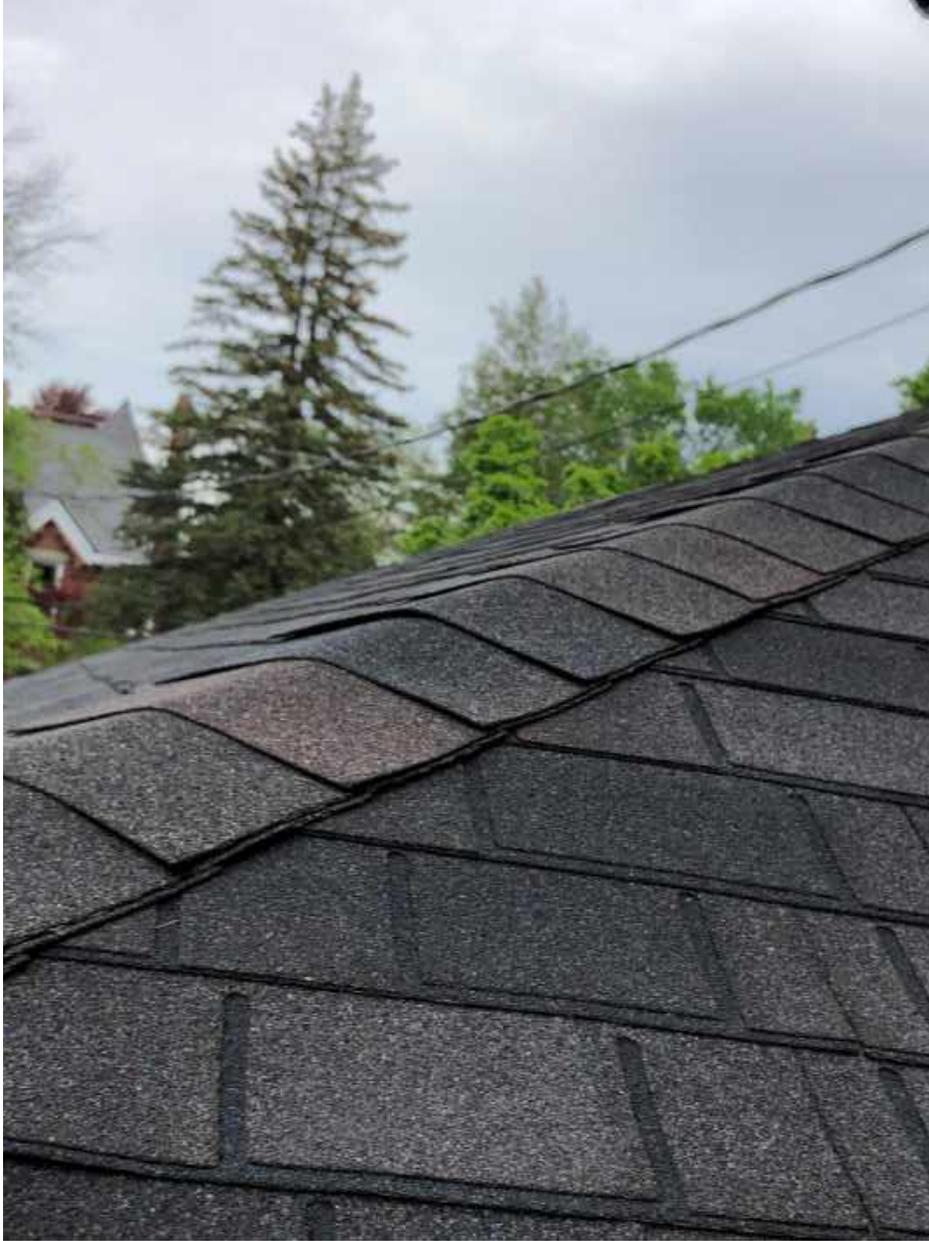
A dozen or so nails were not fully sunk at the shingles. The nails should be fully sunk, and all shingles should be fully seated, to prevent shingles from blowing off the roof. Be sure to invite a roofer to execute that work.

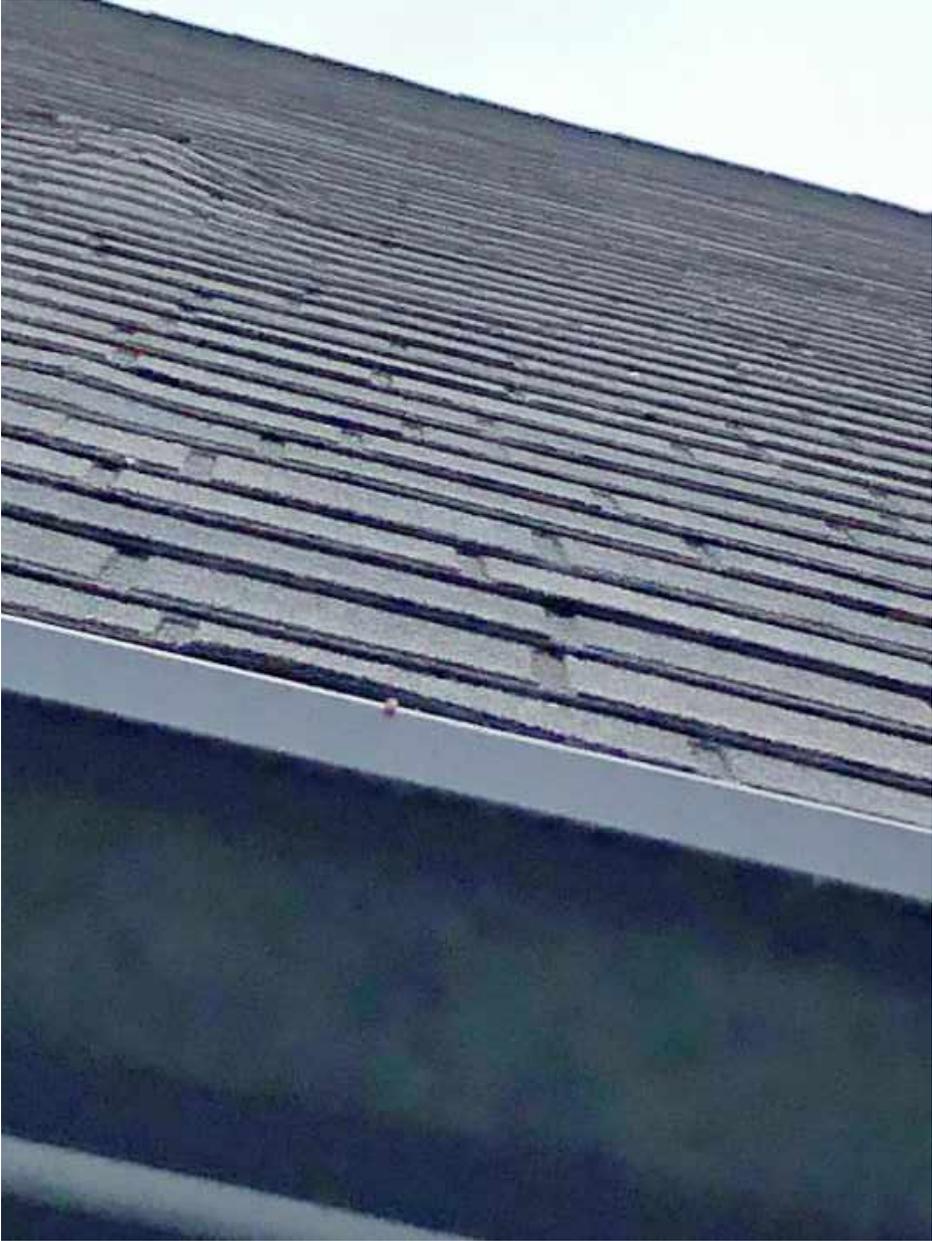
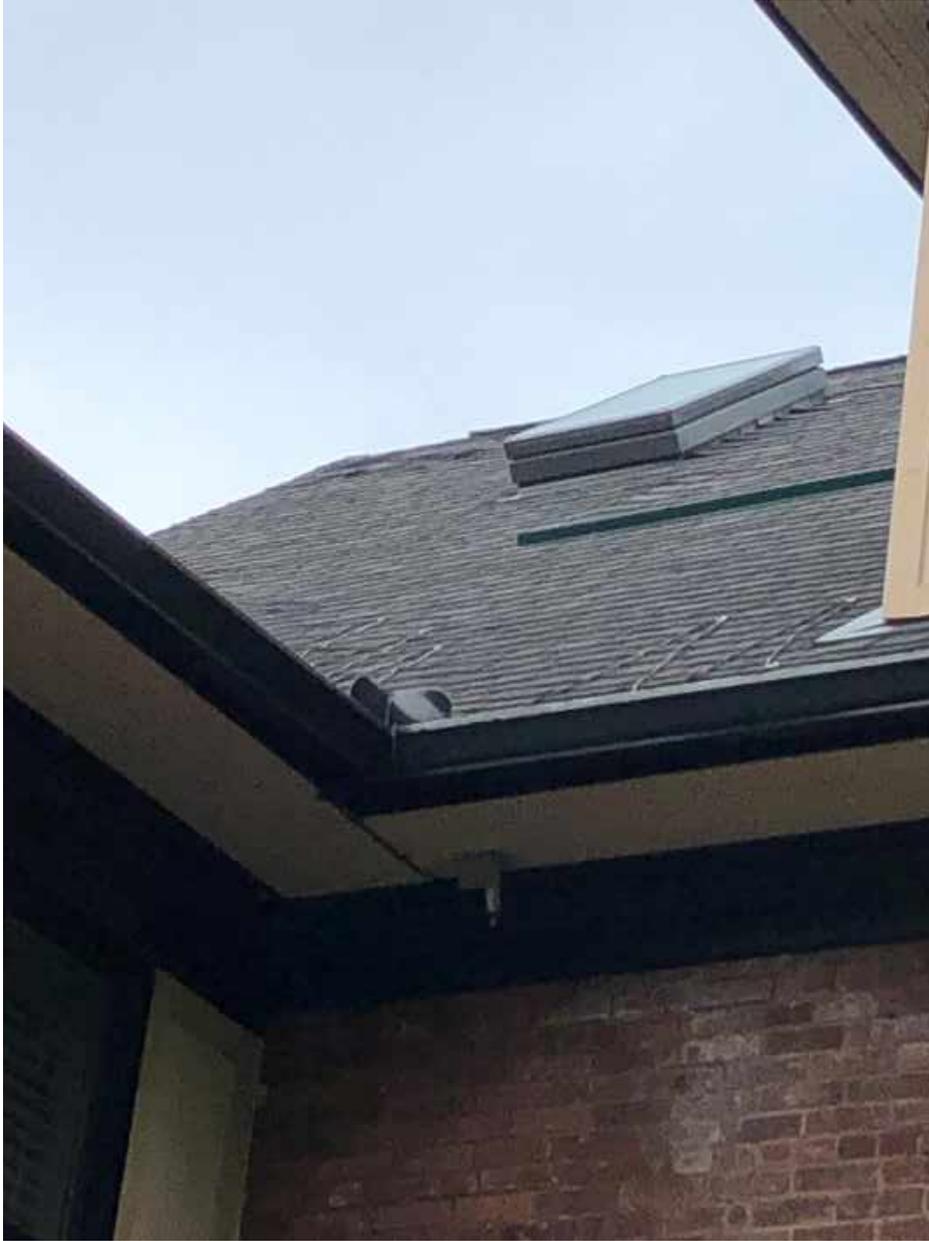
Minor Roof Repairs – It appears at least one shingle has blown off the roof at the upper part of the rear slope, and a number of shingles are not fully seated. A qualified roofer should be invited to replace any missing shingles and fully seat the shingles that are not fully seated. Minor fastening is also required at one of the rear junction (metal) flashings.

There appears to be a possible 'bulge' in the shingle surface at the high part of the rear, high slope, and it appears a shingle or two may be missing.

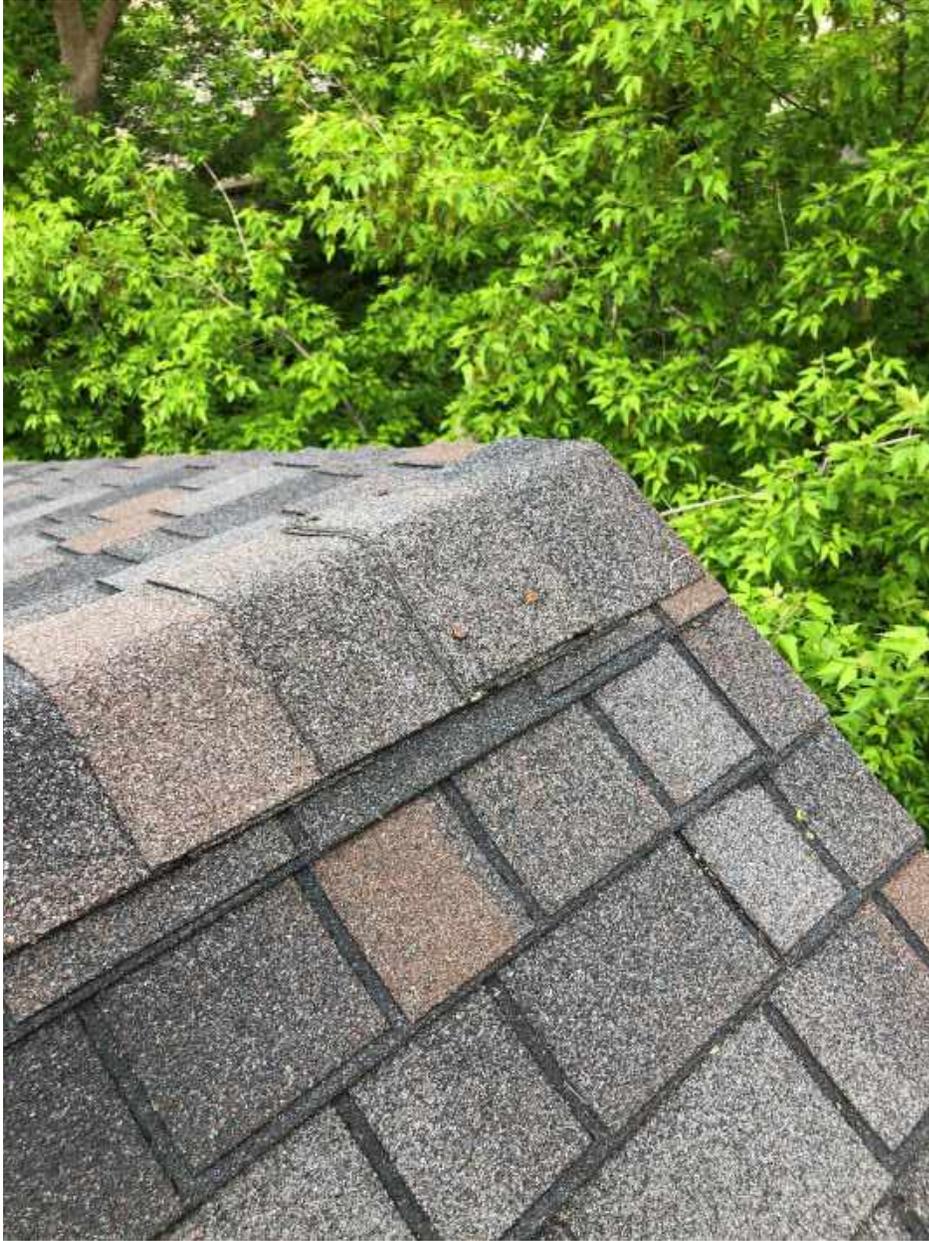
A number of cap shingle nail heads require caulking.

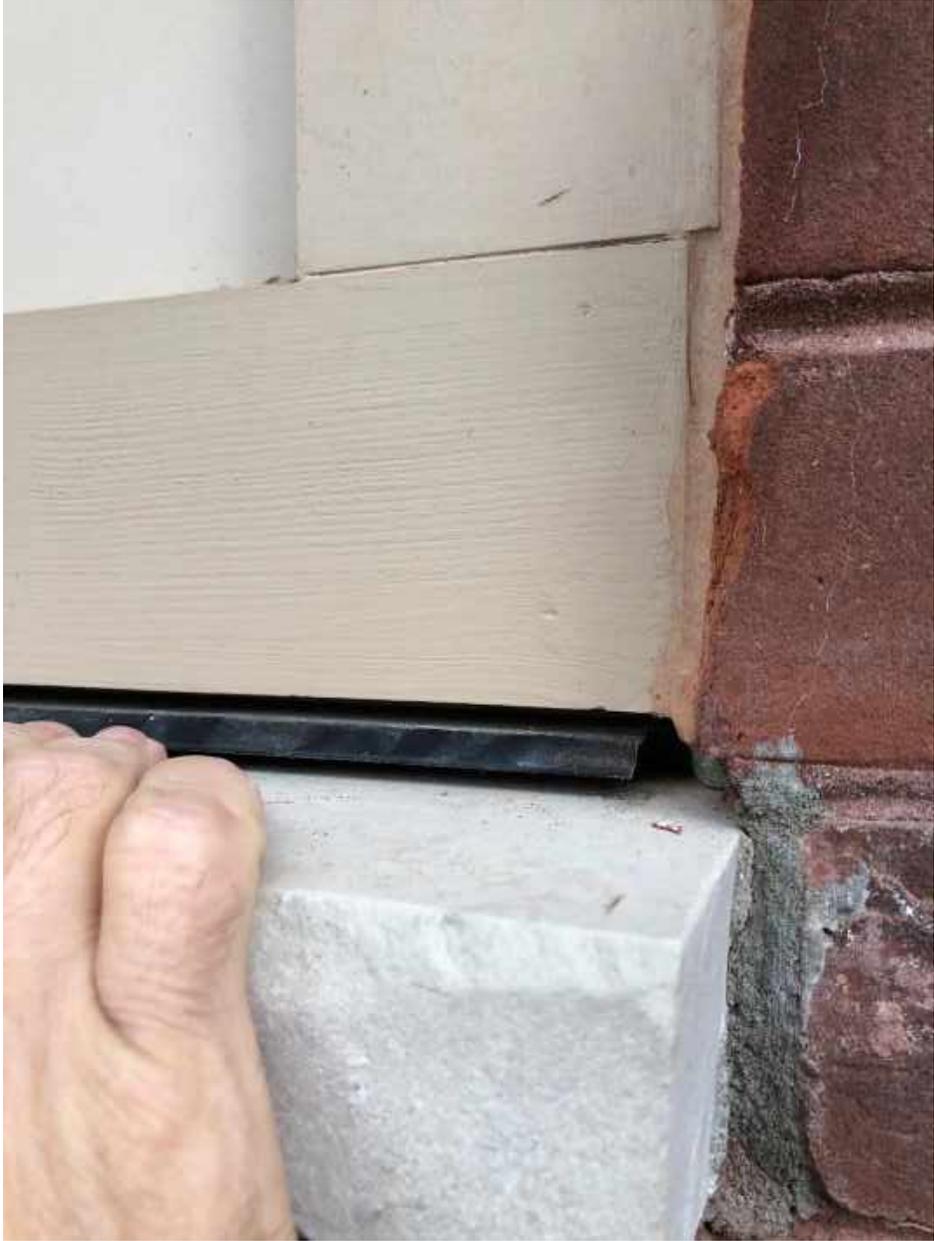
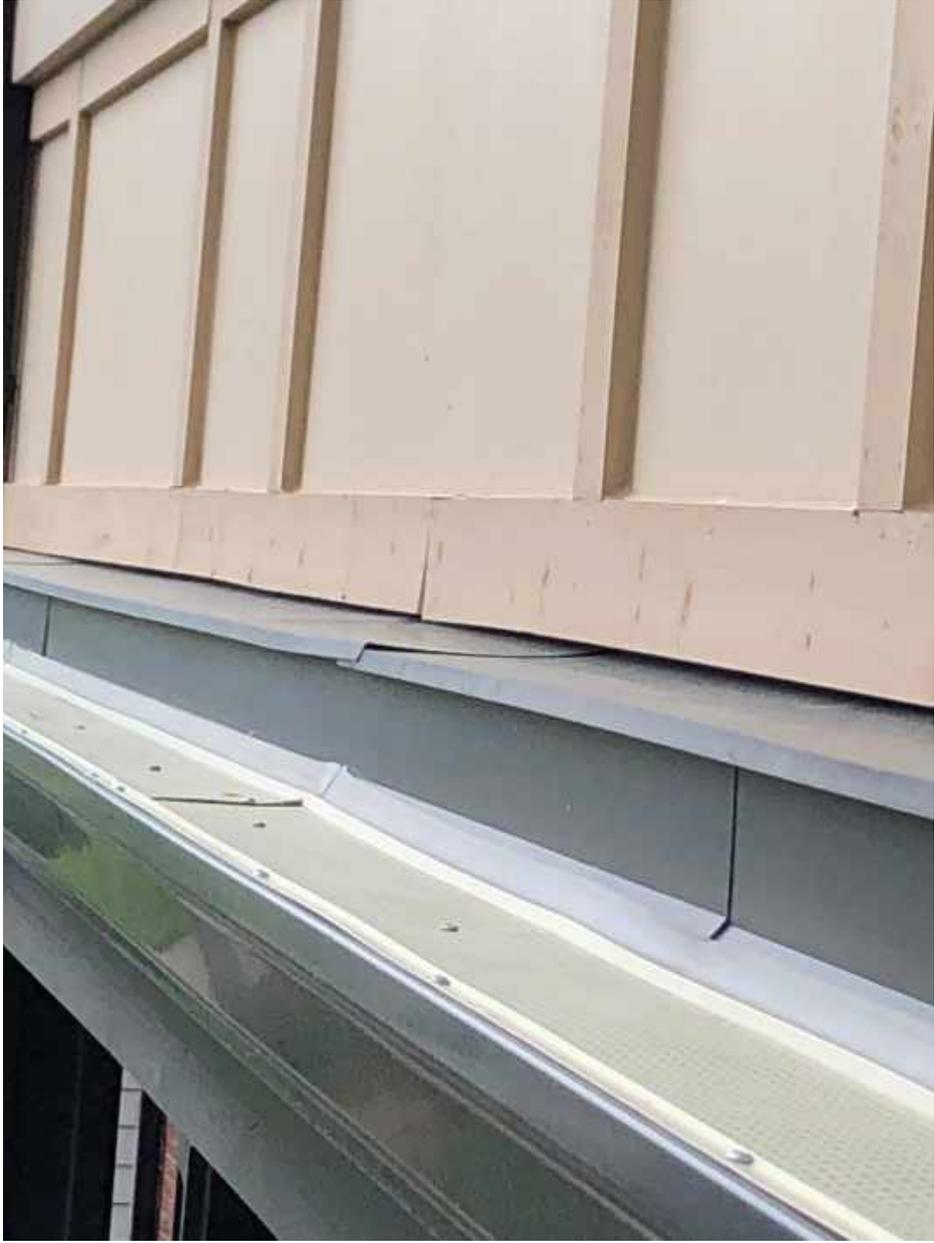
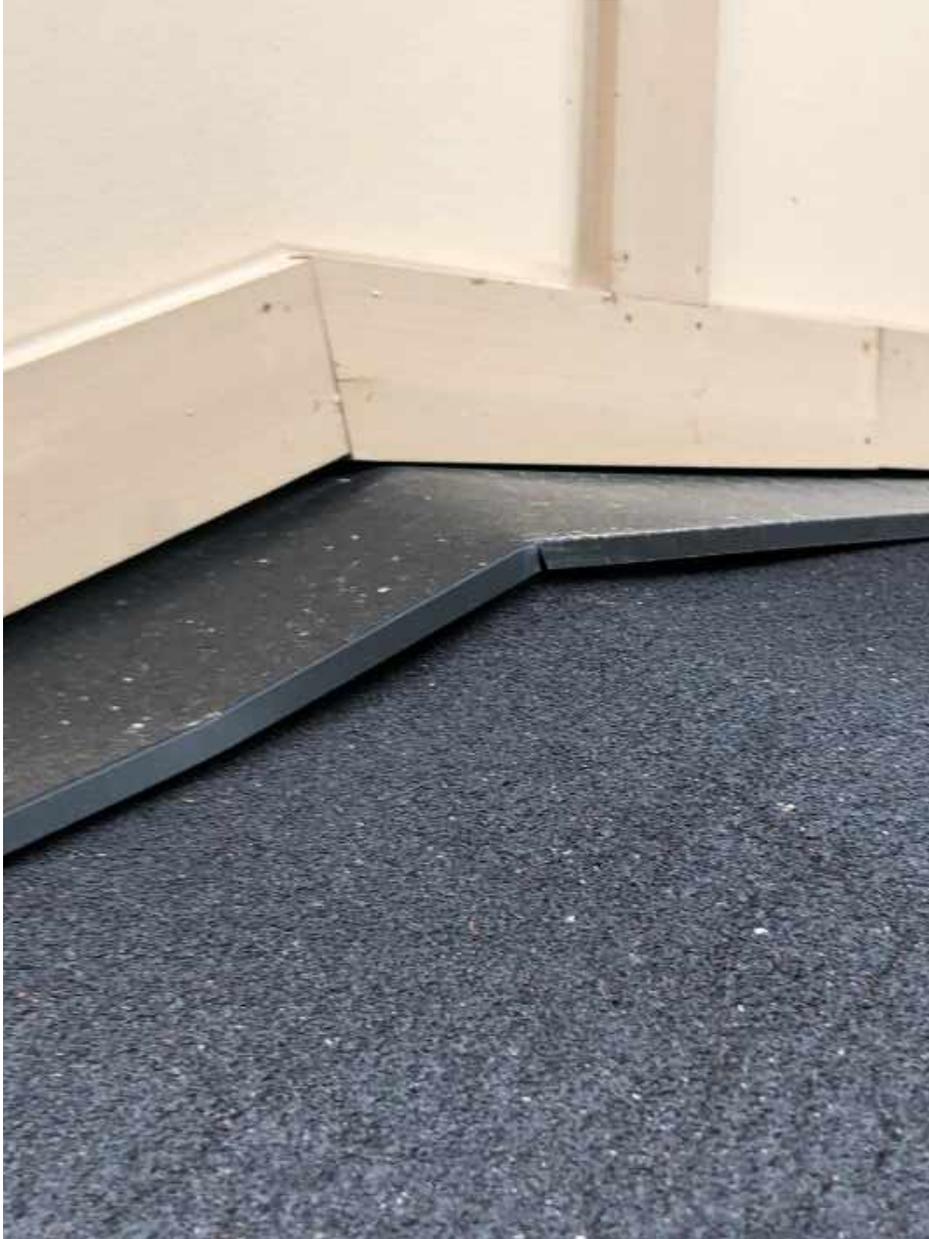
Some fastening or gluing is required at junction flashings, including at a rear junction flashing, as shown below. The roofer who is addressing shingle issues should be invited to carefully inspect and fasten and seal all flashings, as required. See the Roofing section.

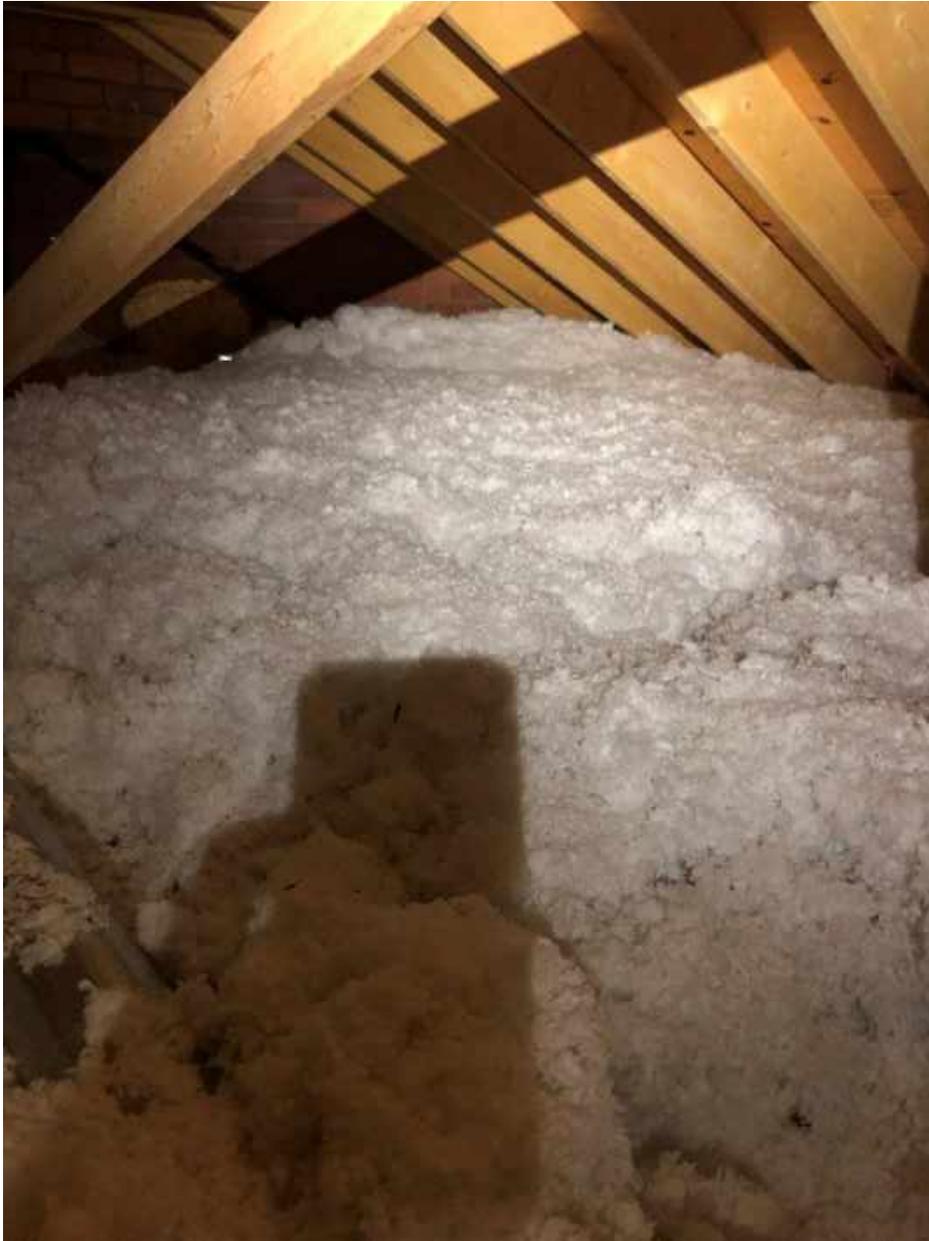
The insulation in the left, low attic is loose glass fibre to a depth that matches today's building code requirement of R60, and greatly exceeds the building code requirement at the time of construction (R40).

It has been disturbed somewhat by mice. Set traps or otherwise address the mice. Most attics in Ontario exhibit signs of mice. Fully sealing open joints at junctions at the building envelope will help prevent future mice entry.
