**8 Victoria Street, Flesherton**

# Inspection Report

## AmeriSpec Move in Ready

**Property Address:**  
8 Victoria Street  
Flesherton Ontario N0C 1E0

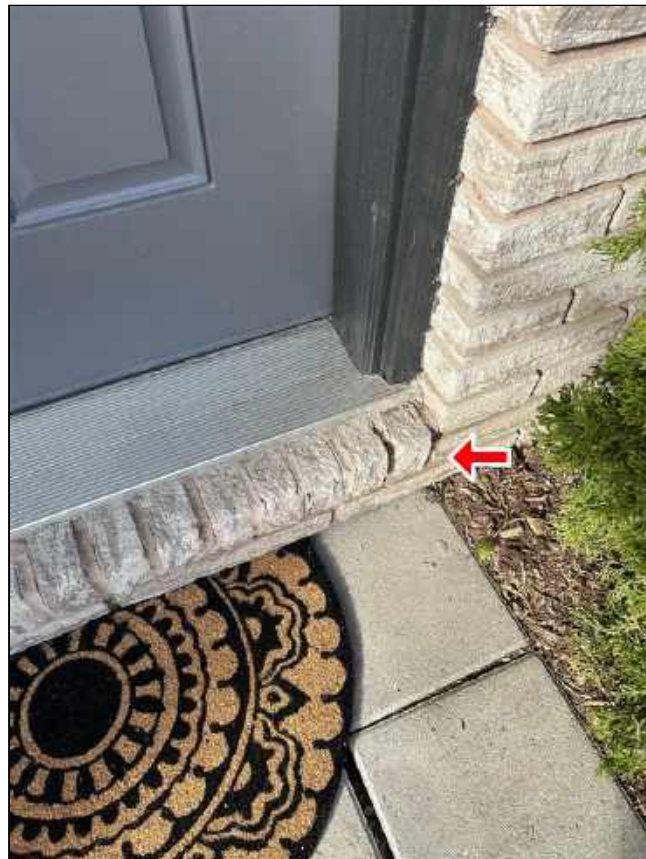
**1.5** Deteriorated brick noted on the front entry door sill. Recommend repair to prevent further deterioration.

1.5 Item 1(Picture) door sill condition

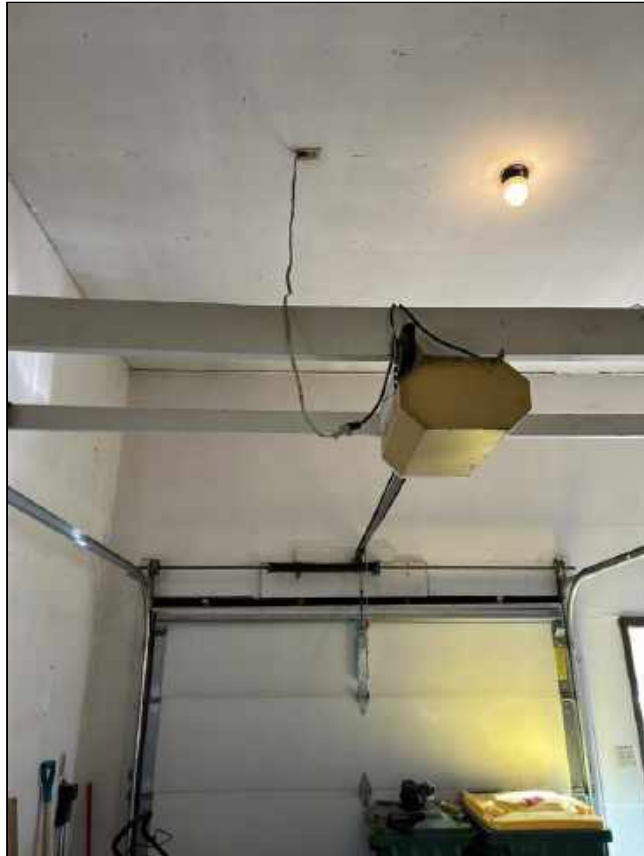
**3.4** It is recommended all garage doors be equipped with a safety reverse device to reverse the direction of the door if it should meet any resistance on the way down (important safety where children are present). Some older units may not have these safety reverse devices present. Buyer may wish to consider upgrading as a safety enhancement. Door opener is wired with an extension cord. Client should consider installation of a dedicated receptacle that can be plugged in directly as a safety upgrade.

3.4 Item 1(Picture) older opener with extension cord wiring

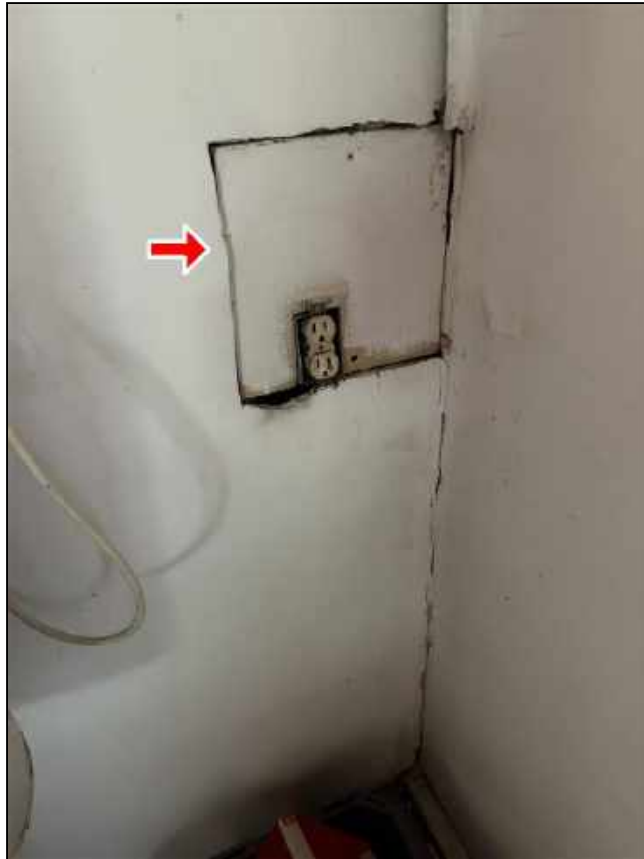
**3.7 (1)** Openings observed between the garage and home which compromises the fire rating of this wall and may permit carbon monoxide to enter the living space of the home. We recommend properly sealing all joints, holes and other openings.

3.7 Item 1(Picture) openings

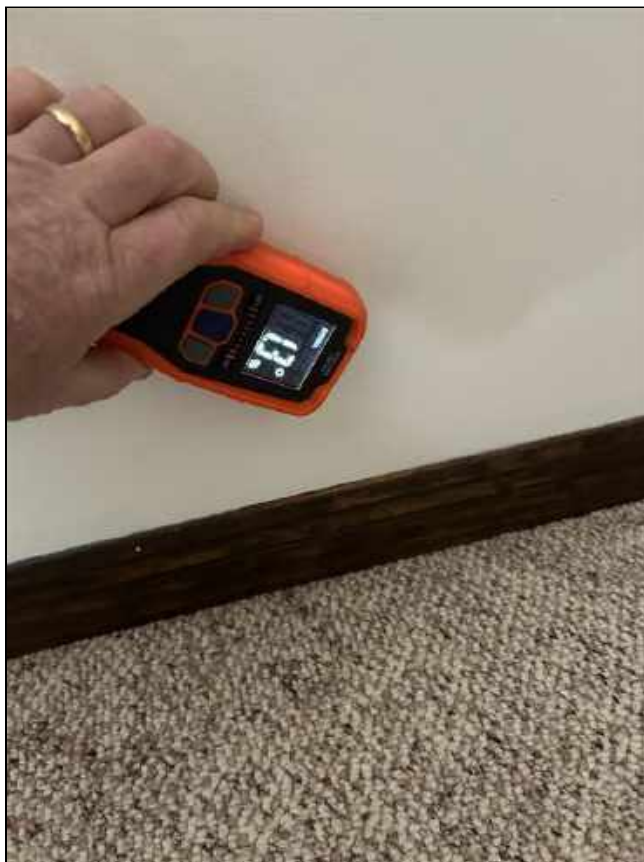
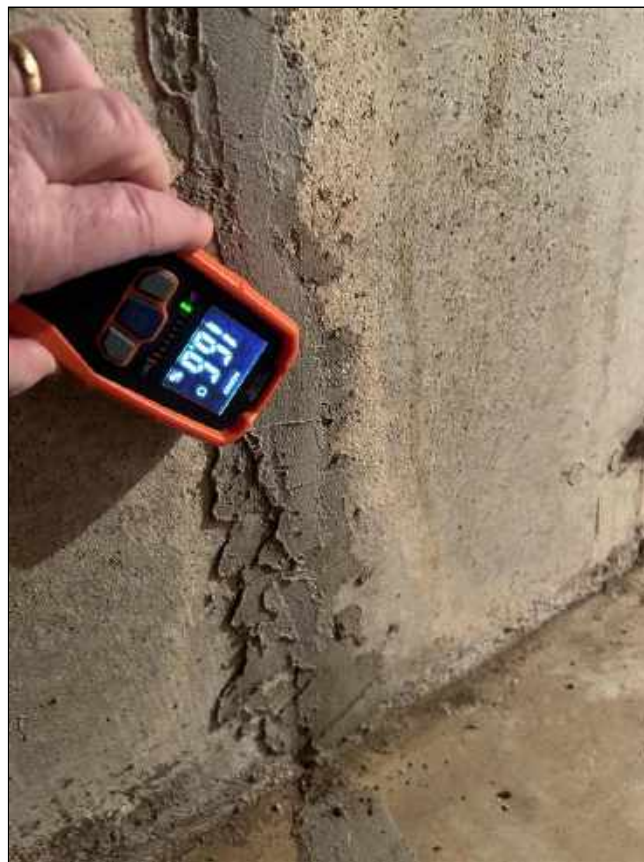
**4.3** The basement walls were inspected for the presence of moisture at visibly accessible areas through non-intrusive means using thermal imaging, a moisture meter, touch, and visual inspection. No evidence of active moisture was noted in the visibly accessible areas of the basement walls.

4.3 Item 1(Picture) normal moisture reading

4.3 Item 2(Picture) normal moisture level

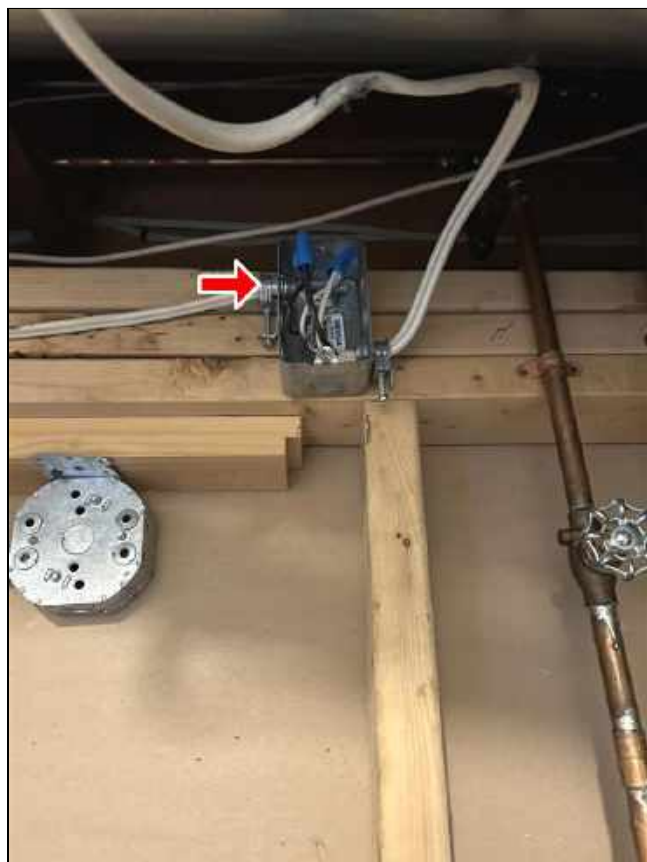
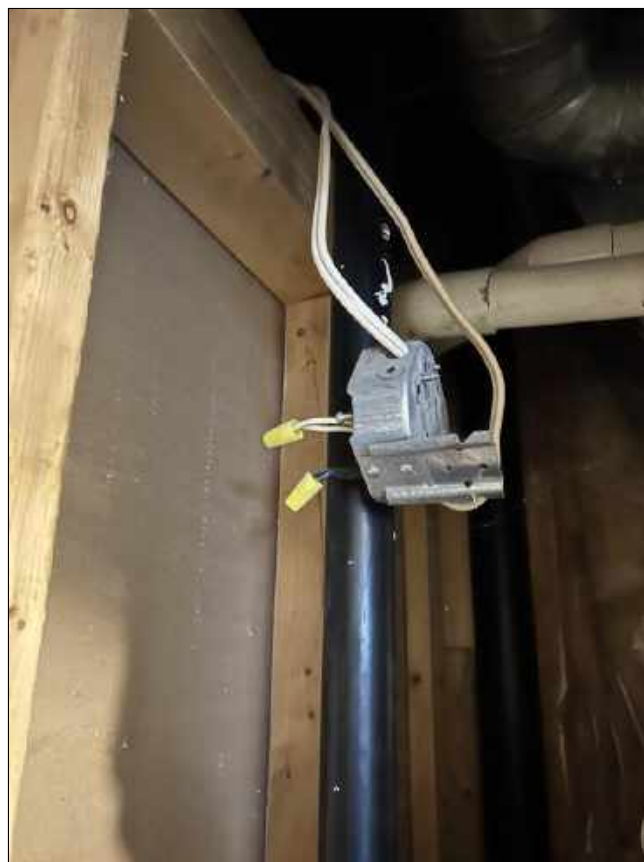
**4.10** Open and loose junction box(s) were observed in the basement furnace room. Whenever an electric wire is cut and reconnected, the 'splice' should be encased in a covered junction box to prevent shocks and separation of the splice.

4.10 Item 1(Picture) open J box

4.10 Item 2(Picture) loose J box

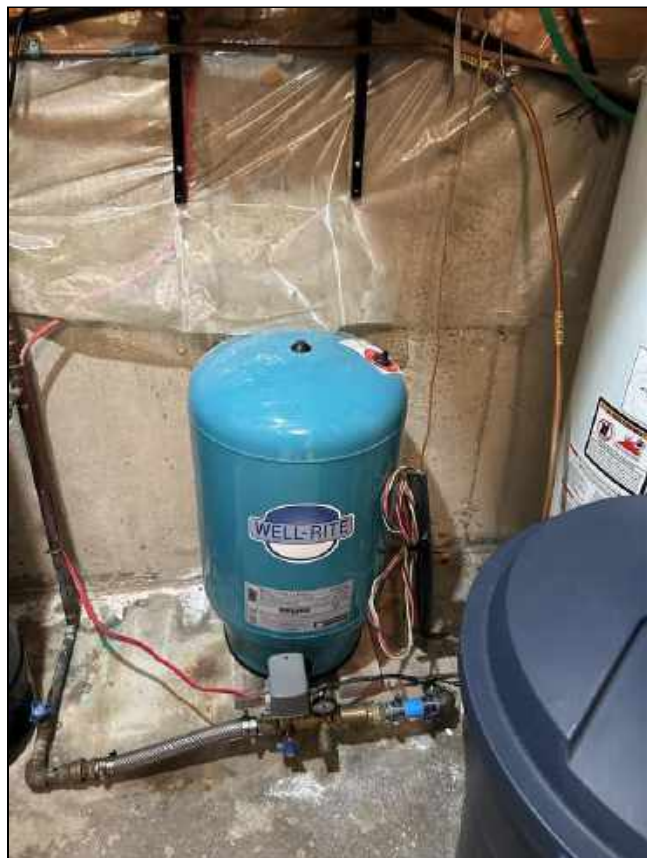
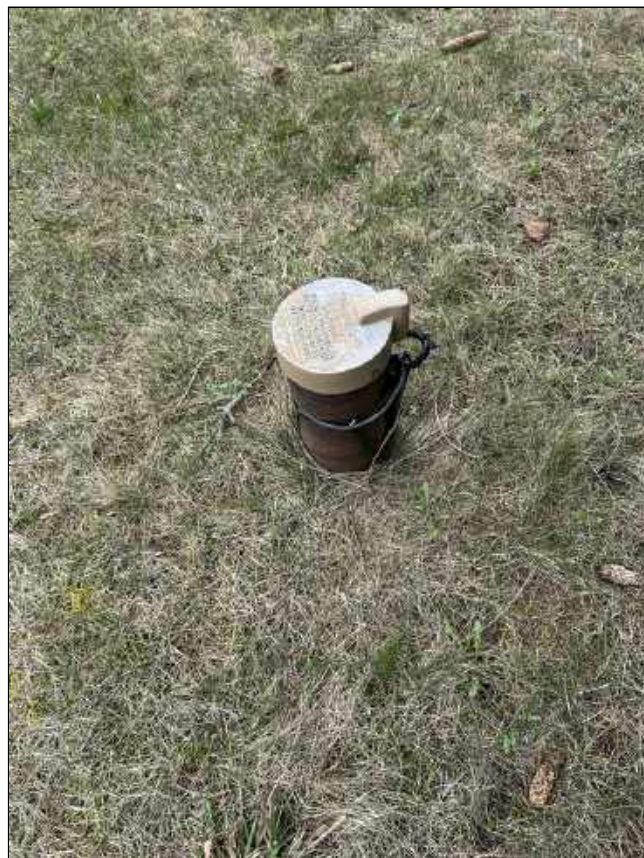
- Water supply to this property appears to be provided by a well. Due to the inaccessible nature of this system, only the above ground equipment can be reviewed. Sub-surface or concealed components are not within the scope of this inspection. If a detailed review of this system or water quality testing is desired, qualified personnel should be consulted prior to closing to perform these tests.

5.0 Item 1(Picture) well equipment

5.0 Item 2(Picture) drilled well

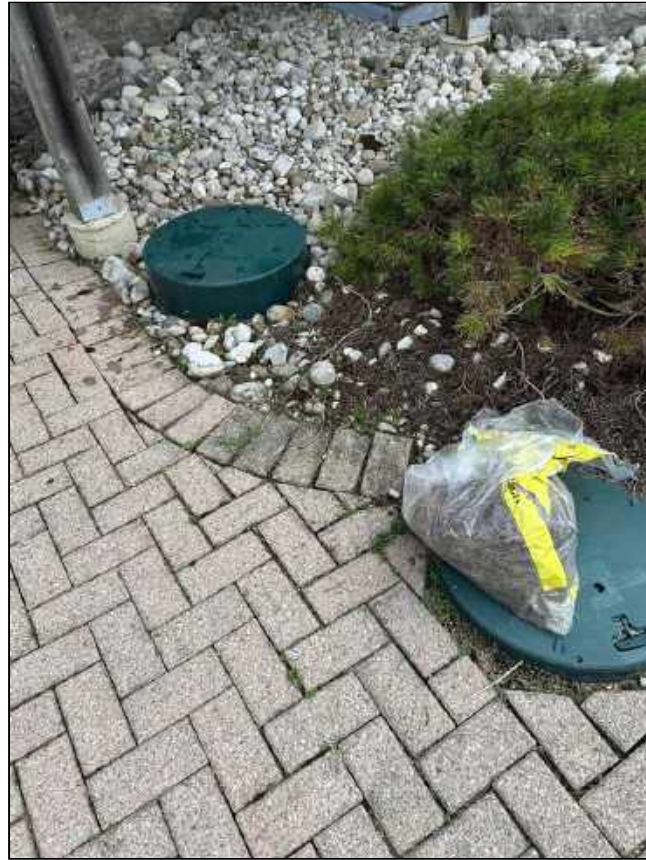
**5.1 (2)** Waste disposal system appears to be private on-site waste disposal. A well designed, constructed, installed and maintained concrete, fiberglass or plastic tank should last up to 50 years. We recommend consulting with the vendor regarding the current age of the system. Due to the inaccessibility of the septic tank, leach field, and other components of the private sewage system, review of the septic system is not within the scope of this inspection. For further information regarding septic systems and how they operate, please refer to the Septic Systems Ask the Inspector Article found at <http://www.amerispec.ca>. Septic systems should be inspected annually and the tank should be pumped every 2 to 4 years, depending on the usage rate and if necessary undigested sludge and scum should be removed. It is recommended that an inquiry be made to the vendor in order to obtain prior pumping and servicing records.

5.1 Item 1(Picture) septic lids

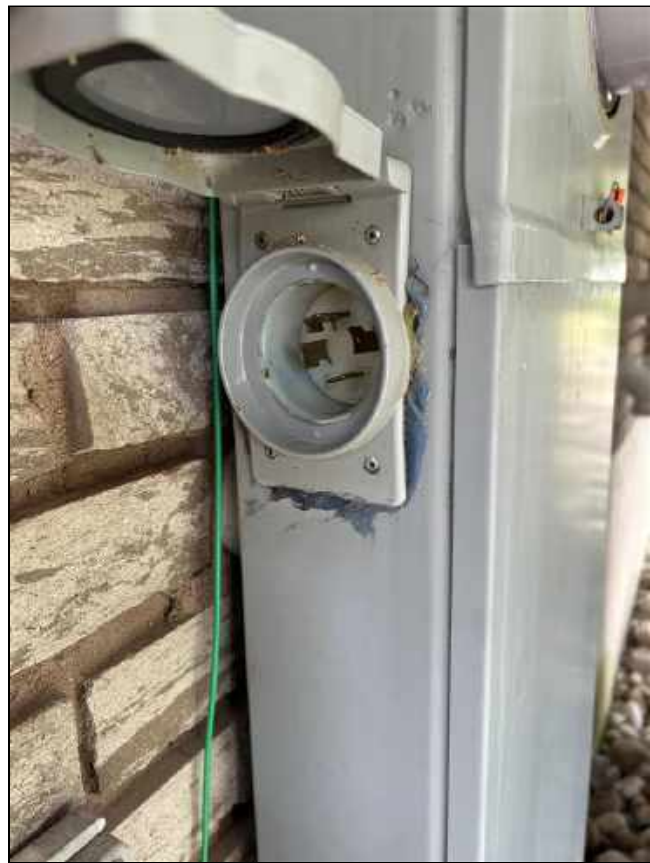
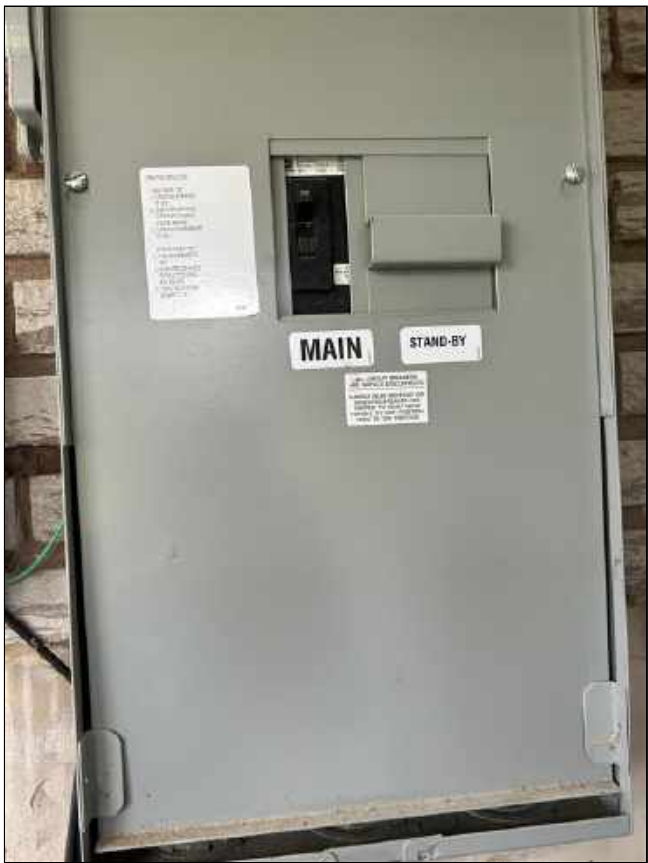
6.0 Inspected. Standby generator plug and transfer switch installed.

6.0 Item 1(Picture) generator plug

6.0 Item 2(Picture) transfer switch

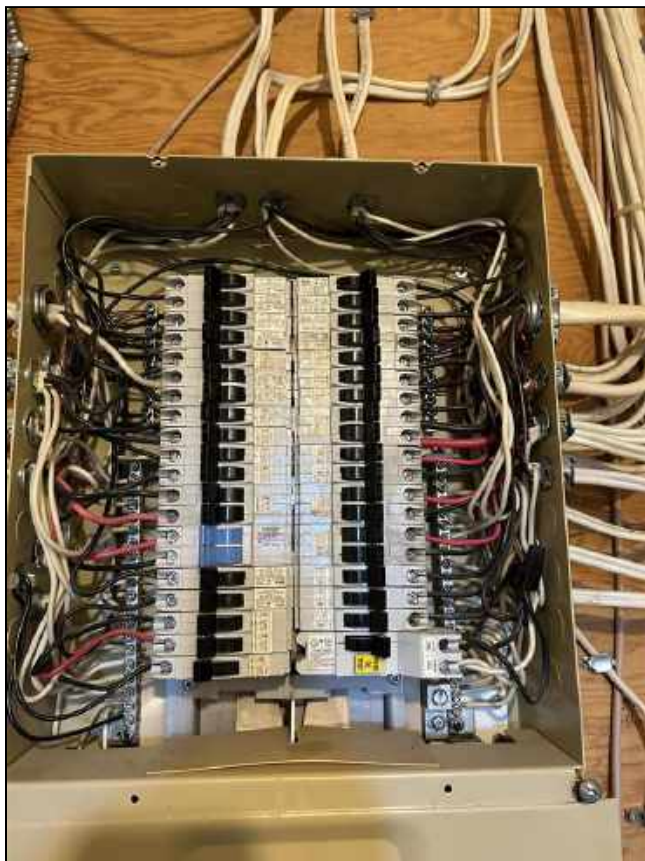
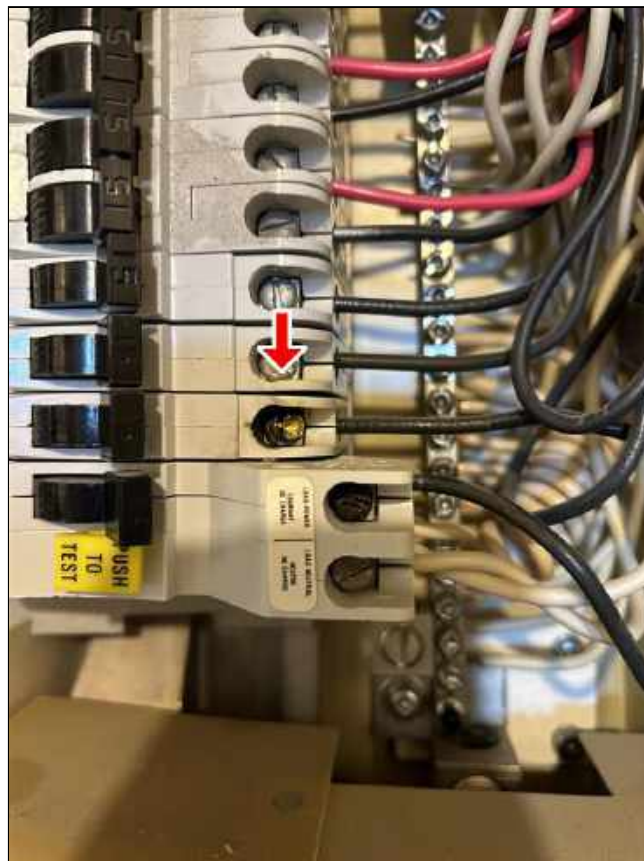
6.2 (1) Damaged breaker noted. Recommend further review and repair or replacement by a licensed electrician.

6.2 Item 1(Picture) main panel

6.2 Item 2(Picture) damaged breaker

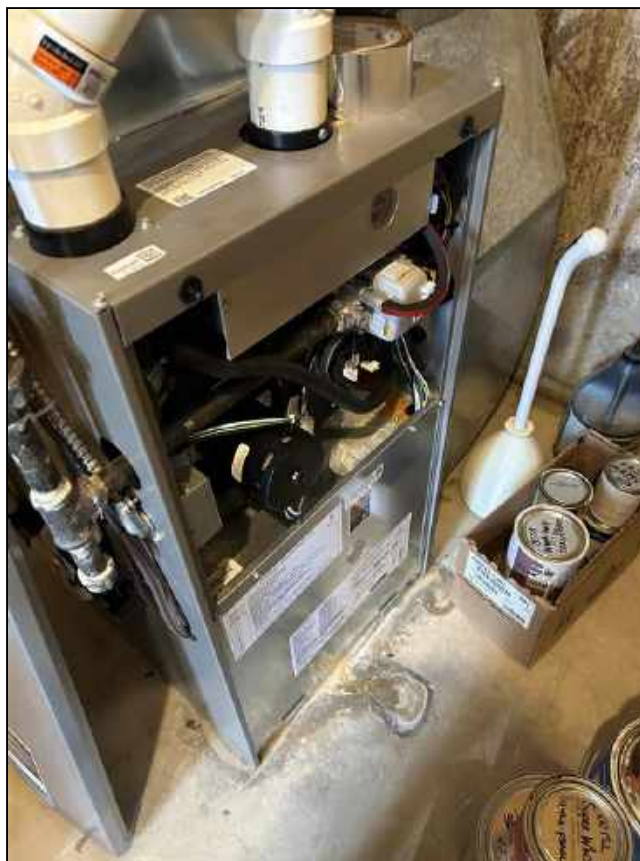
**7.0 (1)** The gas furnace was tested using normal operating controls and functioned properly at time of inspection. Rust was present in the unit from a previous condensate leak.

7.0 Item 1(Picture) furnace condition

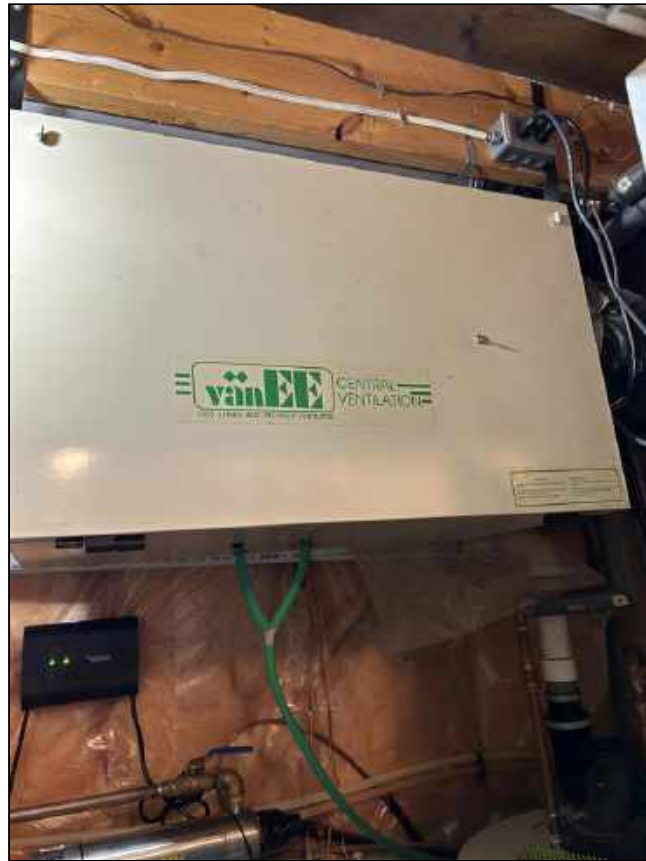
**7.8 (1)** The home is equipped with an older heat recovery ventilation system (HRVS). The system tested operable at the time of the inspection. HRVS are mechanical ventilation systems that provide controlled ventilation to homes. This type of system delivers a continuous supply of fresh air into the home, while venting stale, humid indoor, along with household pollutants, to the exterior of the home. While in operation, the HRV will extract heat from the outgoing stale air (cool air in the summer), and use it to preheat (or cool) the incoming fresh air. The stale air then gets exhausted to the exterior of the home. As a result of this process, significantly less energy is required to heat (or cool in summer) the incoming air. Your filters and core of the HRV should be cleaned according to manufacturer's directions and serviced annually. If you are not comfortable doing it yourself, contact a technician accredited by the Heating, Refrigeration and Air Conditioning Institute of Canada (HRAI). Make sure the technician you call has been trained by the manufacturer of your HRV. You can find additional information on maintaining your HRV at this site [http://www.cmhc-schl.gc.ca/en/co/maho/gemare/gemare\\_004.cfm](http://www.cmhc-schl.gc.ca/en/co/maho/gemare/gemare_004.cfm)

7.8 Item 1(Picture) HRV

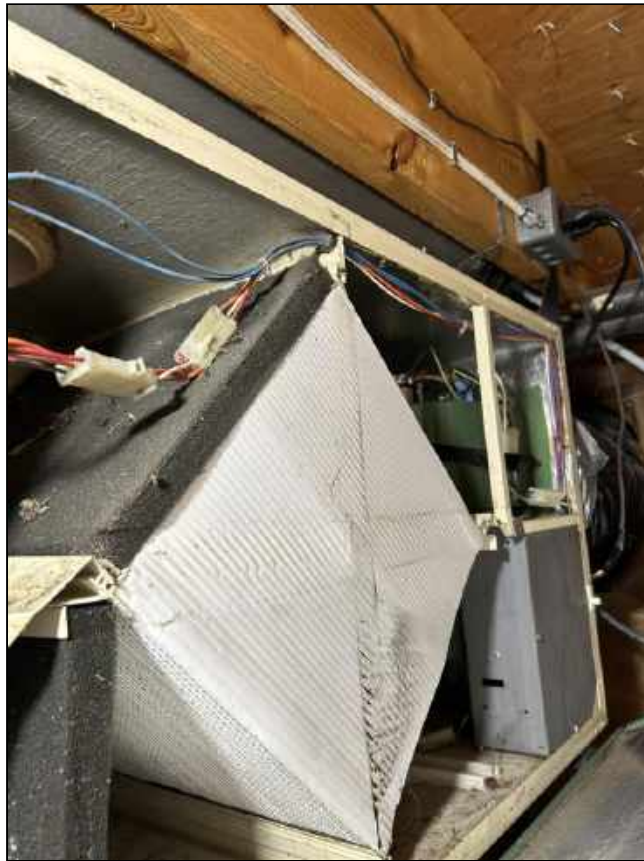
**7.8 (2)** Older unit with dirty filters noted. Suggest having this unit professionally cleaned and tuned to ensure proper and efficient operation.

7.8 Item 2(Picture) filter conditions

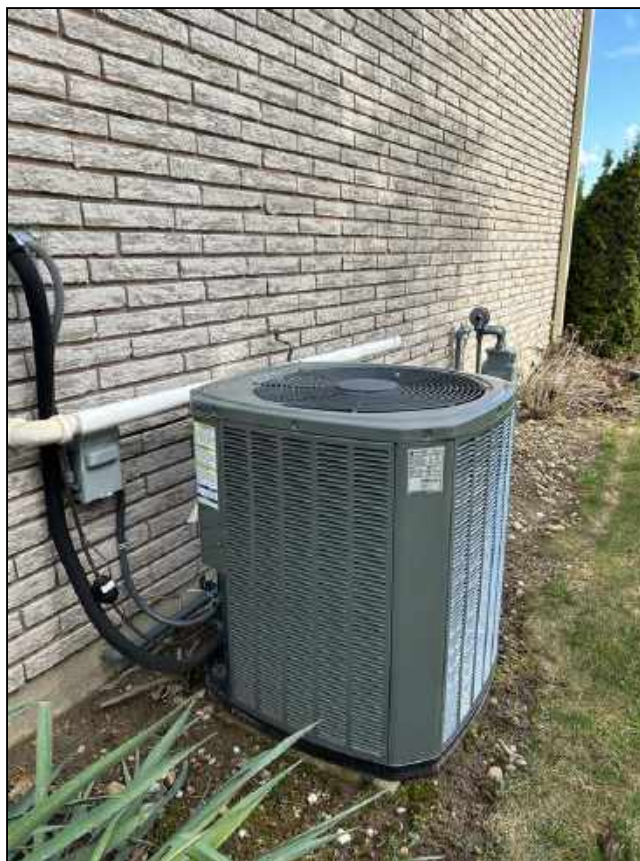
**8.0** As most manufacturers warn against operating air conditioning units when the outside temperature is below 60 degrees, this unit was not tested. Recommend referring to the Sellers Disclosure Statement regarding the condition of this unit.

8.0 Item 1(Picture) air condenser

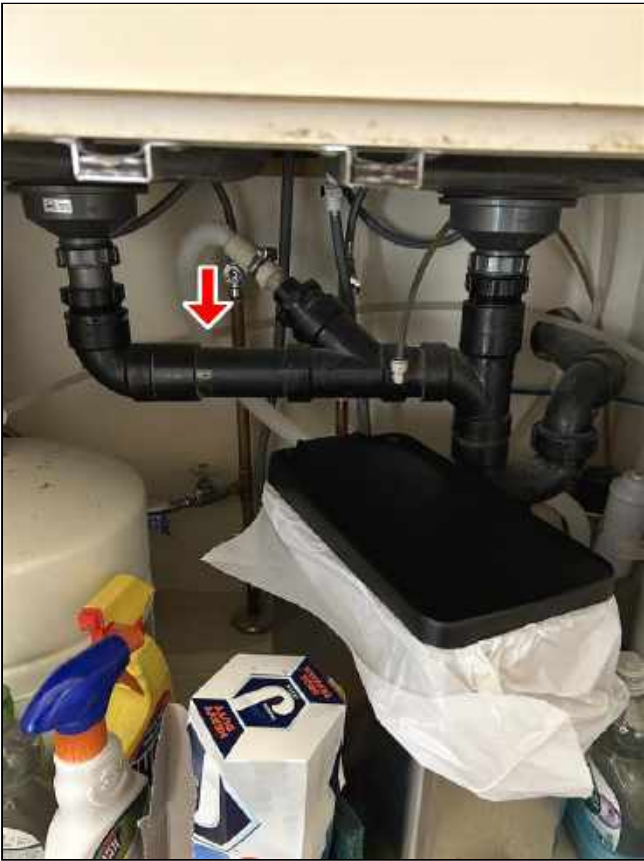
10.8 Inadequate drain slope noted. We recommend drain corrections to ensure proper flow.

10.8 Item 1(Picture) drain slope

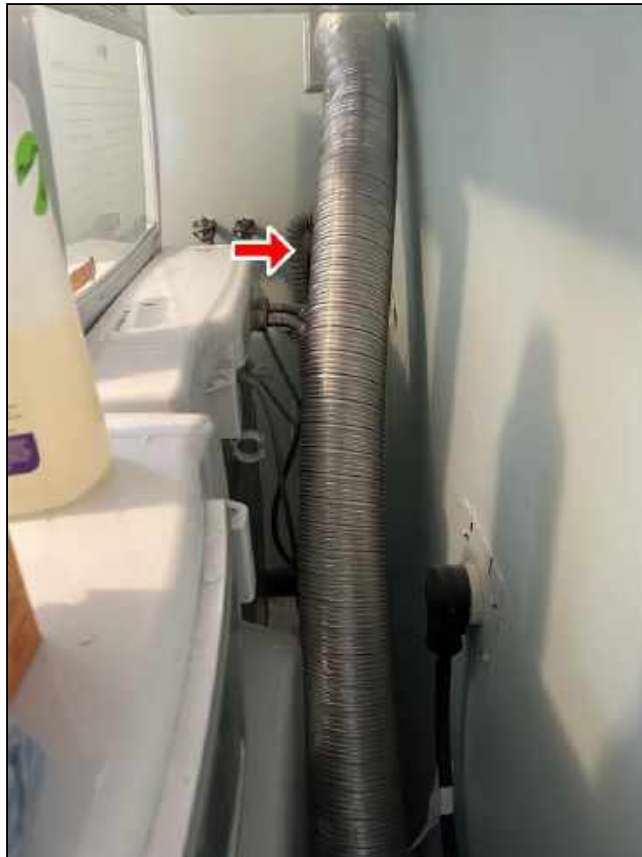
**12.8** The gas dryer is not properly vented. Venting of a gas dryer should consist of rigid metal duct that is taped (not screwed) together. We recommend vent corrections be completed to ensure safety.

12.8 Item 1(Picture) gas dryer vent

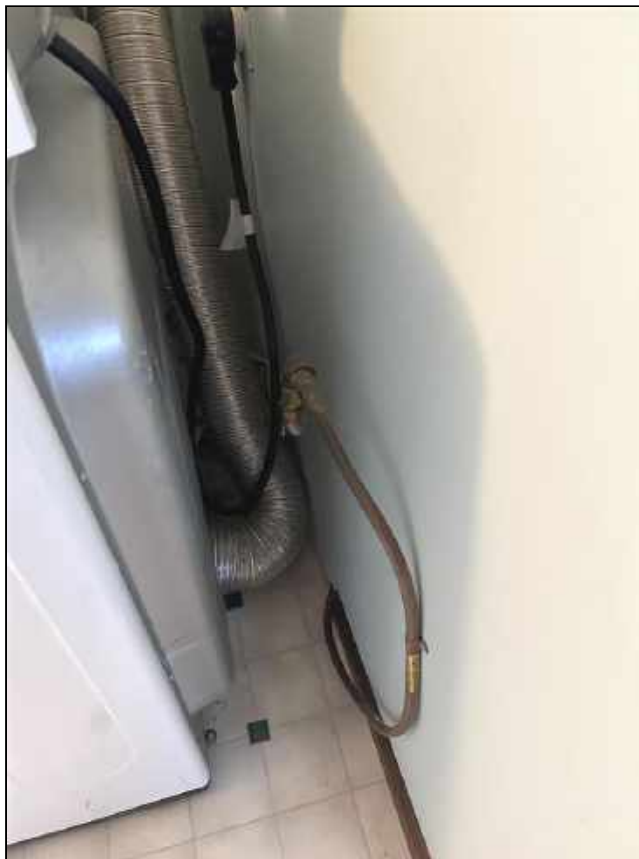
**12.9** Older flexible connector observed on the dryer. Suggest replacing with an upgraded flexible gas connector for enhanced safety.

12.9 Item 1(Picture) gas connection

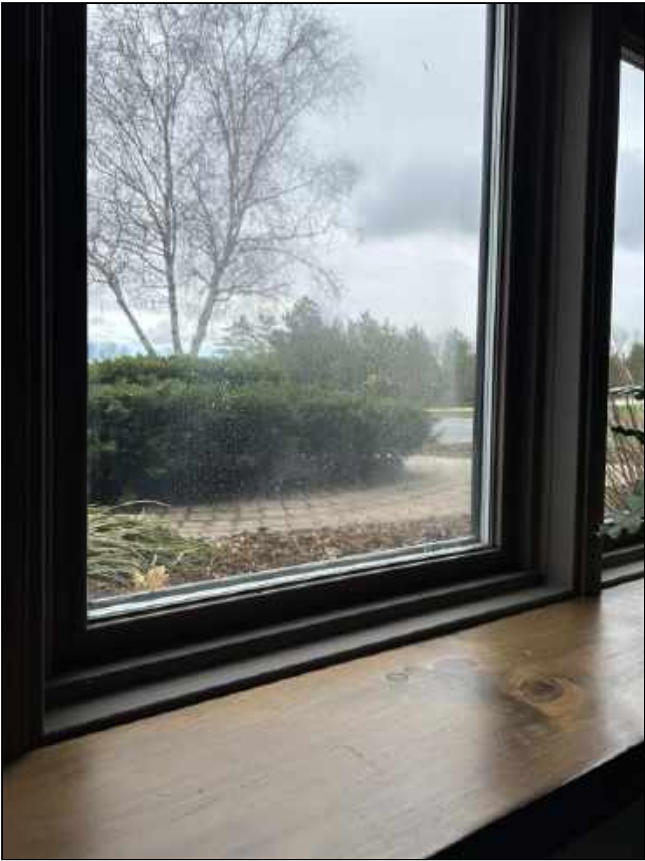
13.5 Fog and condensation was noted in the double glazed insulated window panes. This indicates a broken seal which will reduce visibility and the insulating capability of this window. To restore visibility and regain the insulating capability, replacement of this window pane is required.

13.5 Item 1(Picture) foggy window

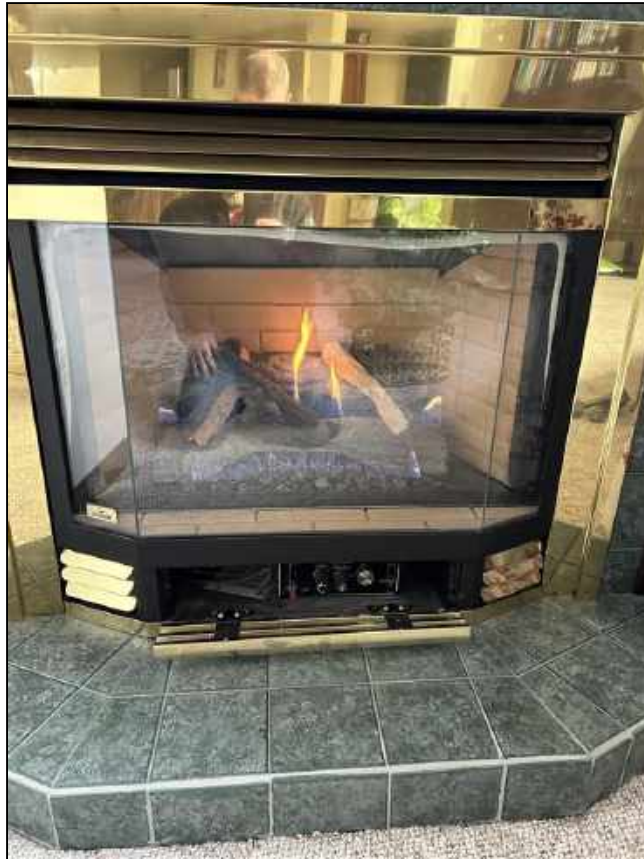
**13.8** The gas fireplace tested operable using the normal operating controls.

13.8 Item 1(Picture) gas fireplace condition

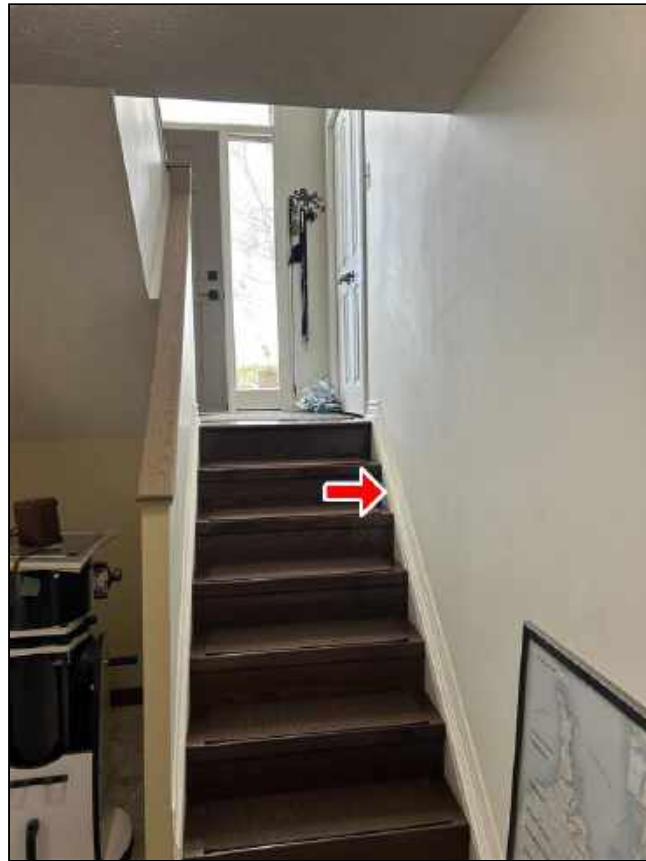
**13.9** No railings noted, recommend installing handrails for safety.

13.9 Item 1(Picture) missing railing

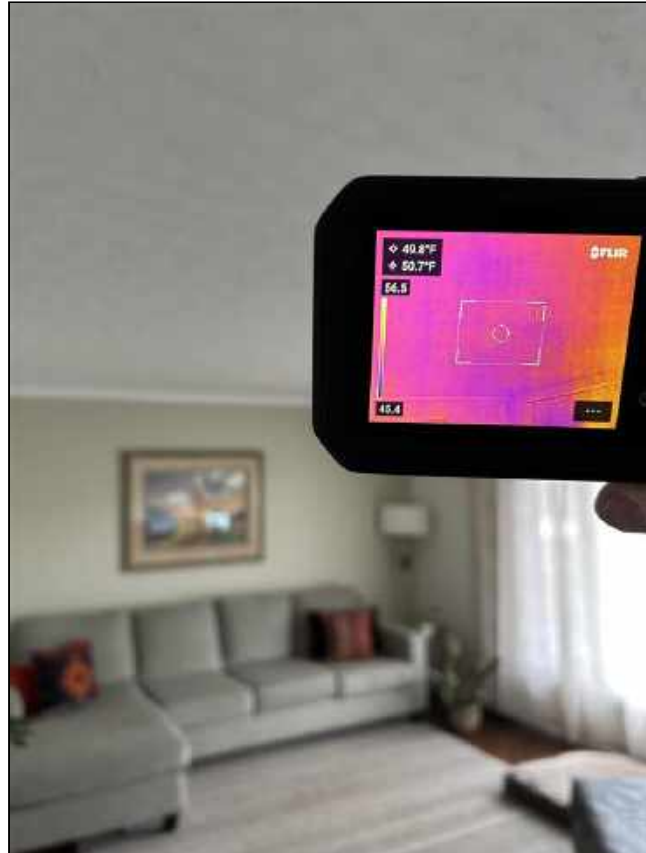
**13.10** The interior rooms and areas were inspected for the presence of moisture at visibly accessible areas through non-intrusive means using thermal imaging, a moisture meter, touch, and visual inspection. No evidence of active moisture was noted in the visibly accessible areas of the walls and ceilings.

13.10 Item 1(Picture) thermal imaging

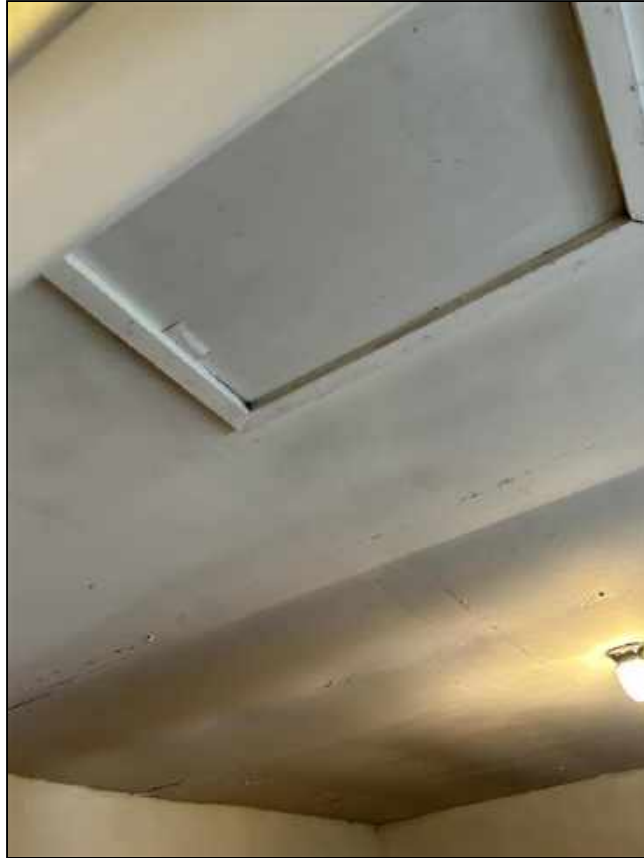
14.0 Item 1(Picture) attic hatch

- Did not enter, unable to access attic due to insulation, low clearance and/or personal storage. Entering attics that are heavily insulated can cause damage to the insulation and attic framing. Attics with deep insulation cannot be safely inspected due to limited visibility of the framing members upon which the inspector must walk. In such cases, the attic is only partially accessed, thereby limiting the review of the attic area from the hatch area only. Inspectors will not crawl the attic area when they believe it is a danger to them or that they might damage the attic insulation or framing. This is a limited review of the attic area viewed from the hatch only; recommend consulting sellers for any additional information.

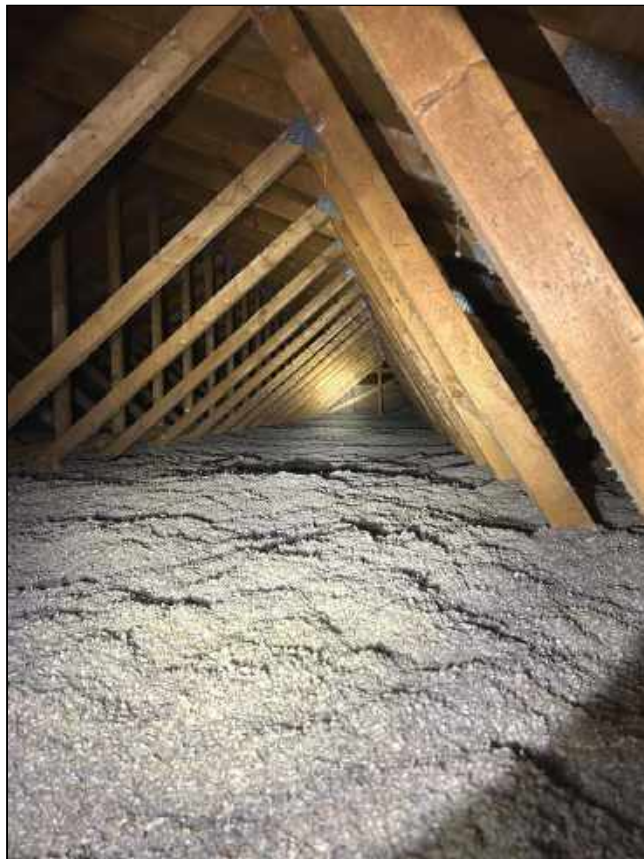
**14.3** We recommend increasing the amount of insulation to current standards as an energy conservation measure.

14.3 Item 1(Picture) insulation conditions

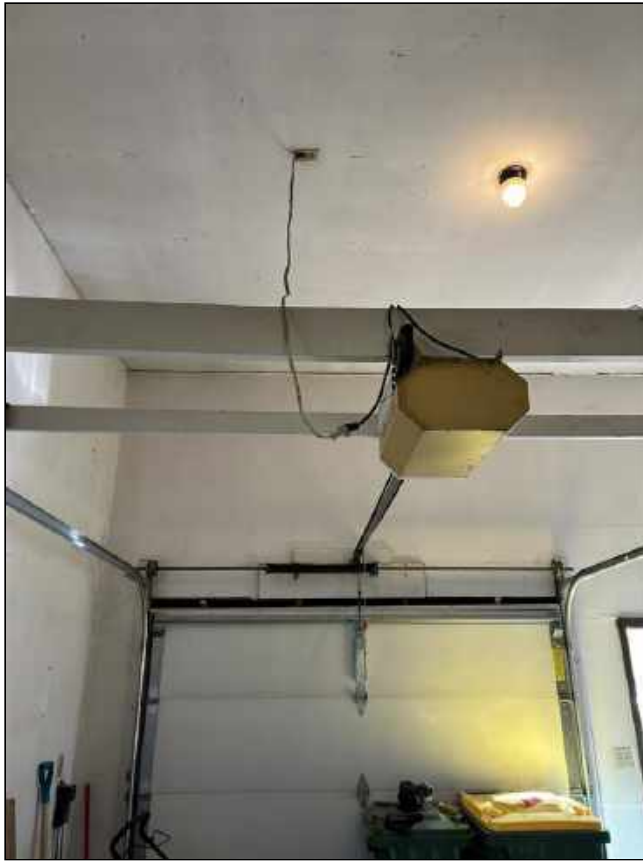
It is recommended all garage doors be equipped with a safety reverse device to reverse the direction of the door if it should meet any resistance on the way down (important safety where children are present). Some older units may not have these safety reverse devices present. Buyer may wish to consider upgrading as a safety enhancement. Door opener is wired with an extension cord. Client should consider installation of a dedicated receptacle that can be plugged in directly as a safety upgrade.

3.4 Item 1(Picture) older opener with extension cord wiring

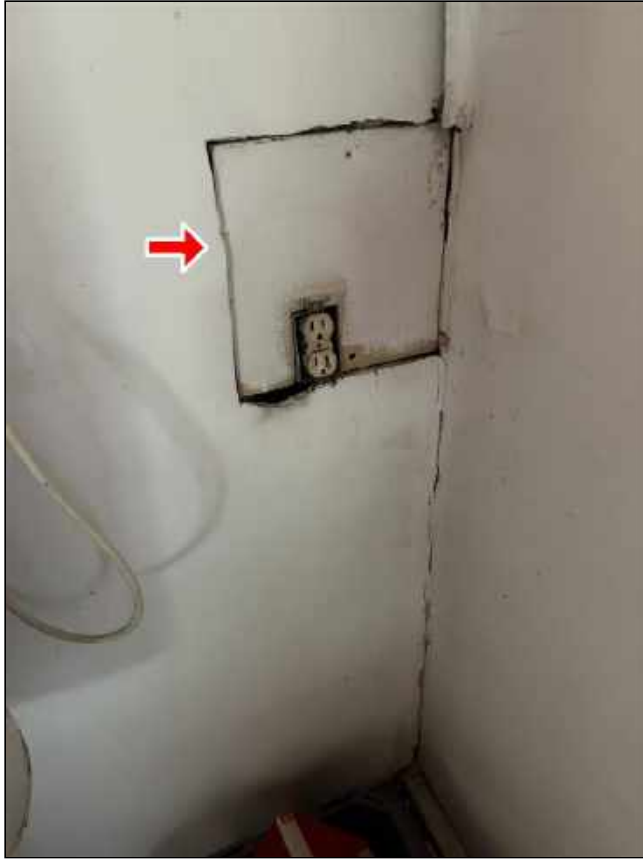
(1) Openings observed between the garage and home which compromises the fire rating of this wall and may permit carbon monoxide to enter the living space of the home. We recommend properly sealing all joints, holes and other openings.

3.7 Item 1(Picture) openings

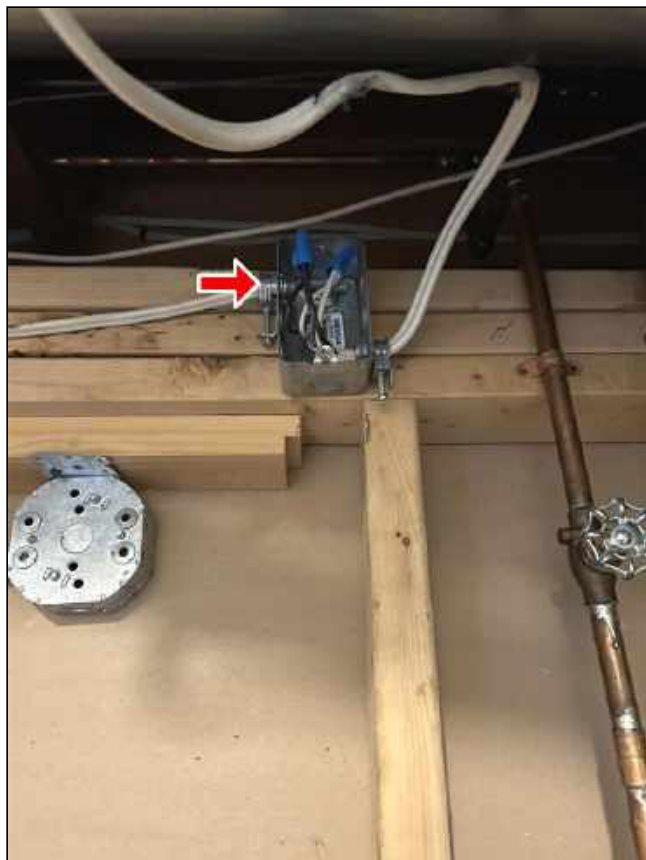
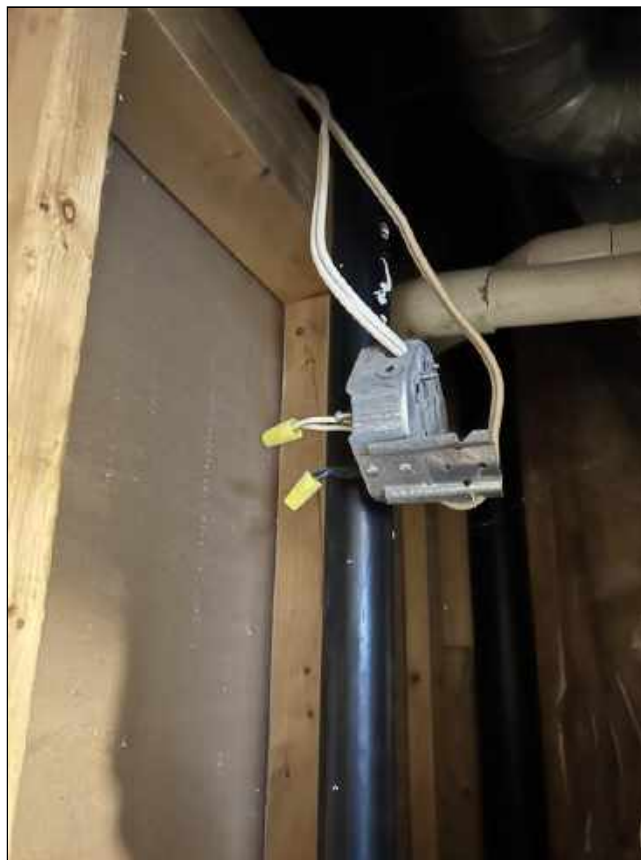
Open and loose junction box(s) were observed in the basement furnace room. Whenever an electric wire is cut and reconnected, the 'splice' should be encased in a covered junction box to prevent shocks and separation of the splice.

4.10 Item 1(Picture) open J box

4.10 Item 2(Picture) loose J box

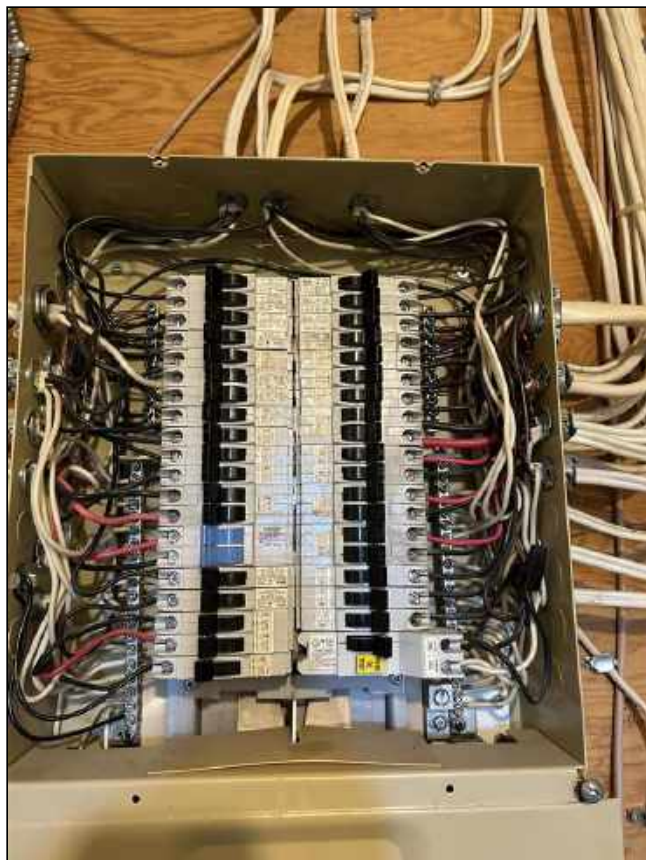
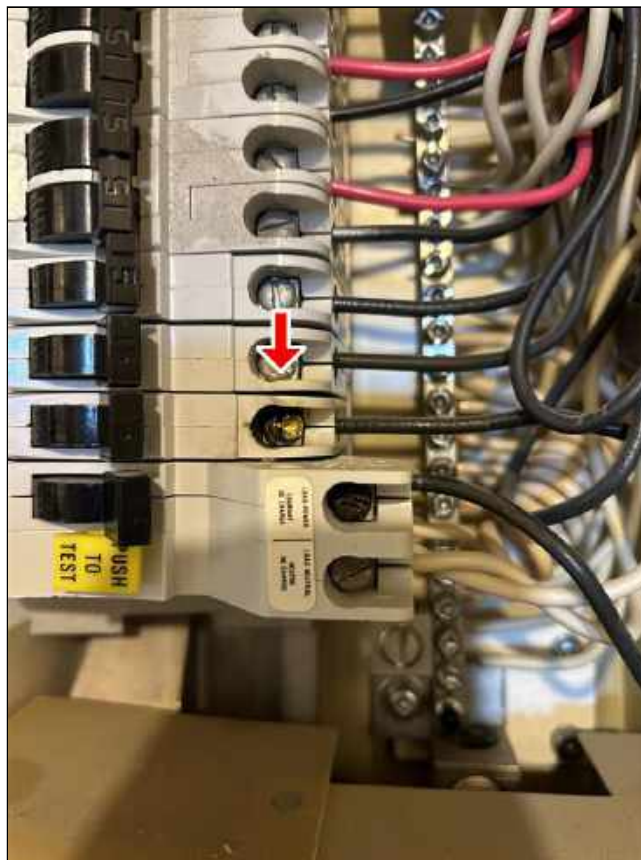
(1) Damaged breaker noted. Recommend further review and repair or replacement by a licensed electrician.

6.2 Item 1(Picture) main panel

6.2 Item 2(Picture) damaged breaker

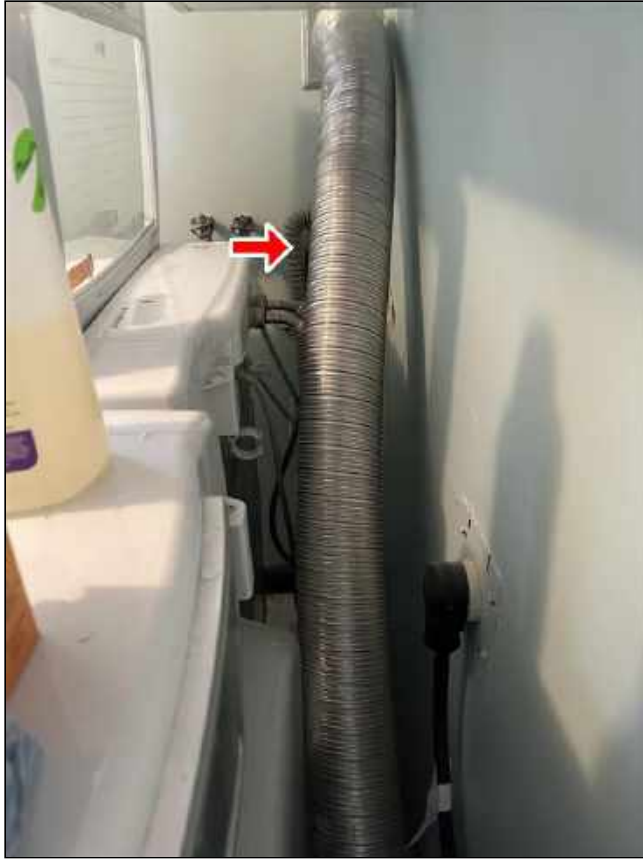
The gas dryer is not properly vented. Venting of a gas dryer should consist of rigid metal duct that is taped (not screwed) together. We recommend vent corrections be completed to ensure safety.

12.8 Item 1(Picture) gas dryer vent

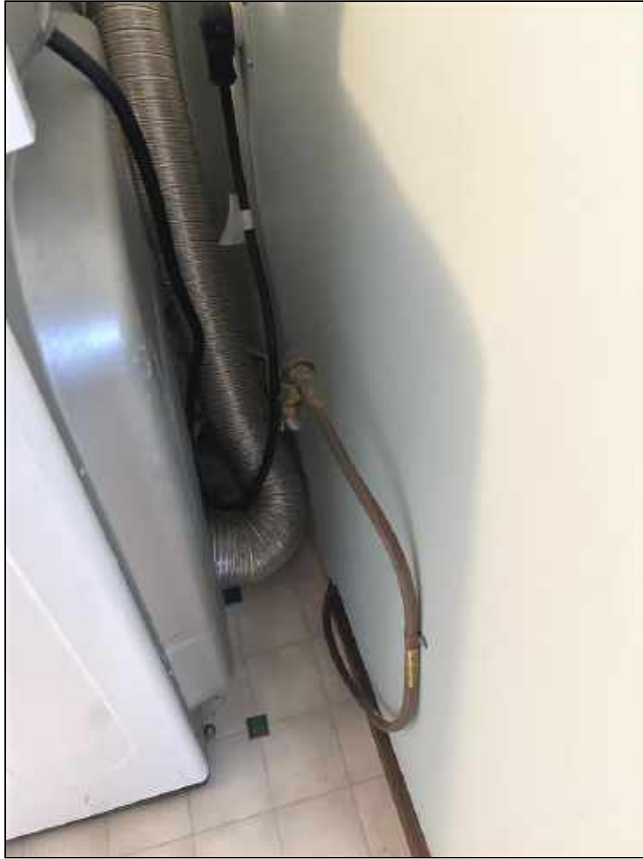
Older flexible connector observed on the dryer. Suggest replacing with an upgraded flexible gas connector for enhanced safety.

12.9 Item 1(Picture) gas connection

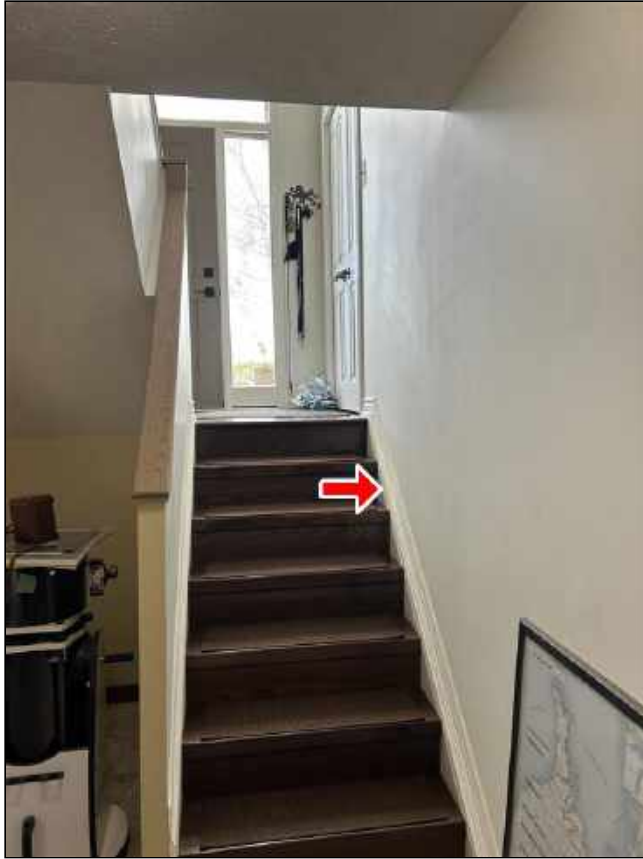
No railings noted, recommend installing handrails for safety.

13.9 Item 1(Picture) missing railing
