**8 Victoria Street, Flesherton**

# Inspection Report

## AmeriSpec Move in Ready

**Property Address:**  
8 Victoria Street  
Flesherton Ontario N0C 1E0

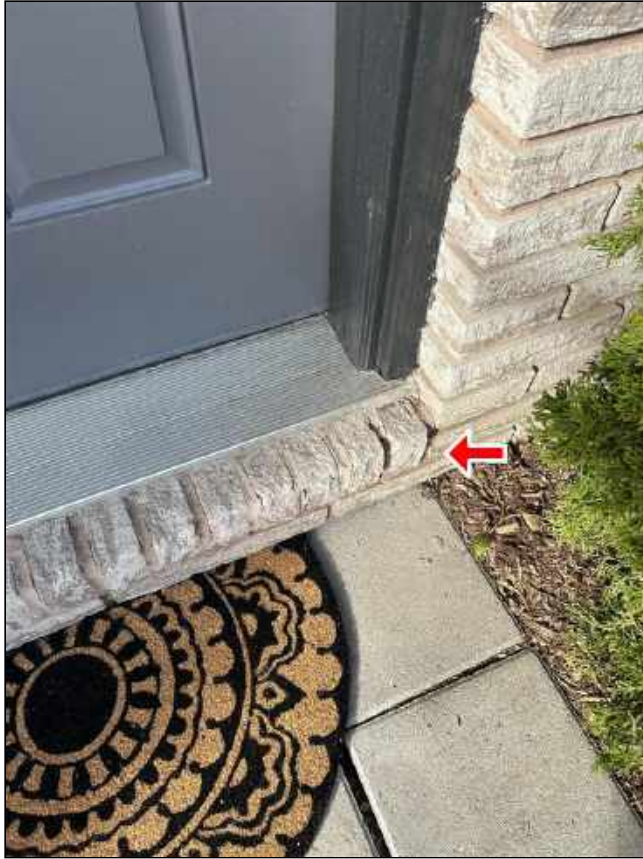
Deteriorated brick noted on the front entry door sill. Recommend repair to prevent further deterioration.

1.5 Item 1(Picture) door sill condition

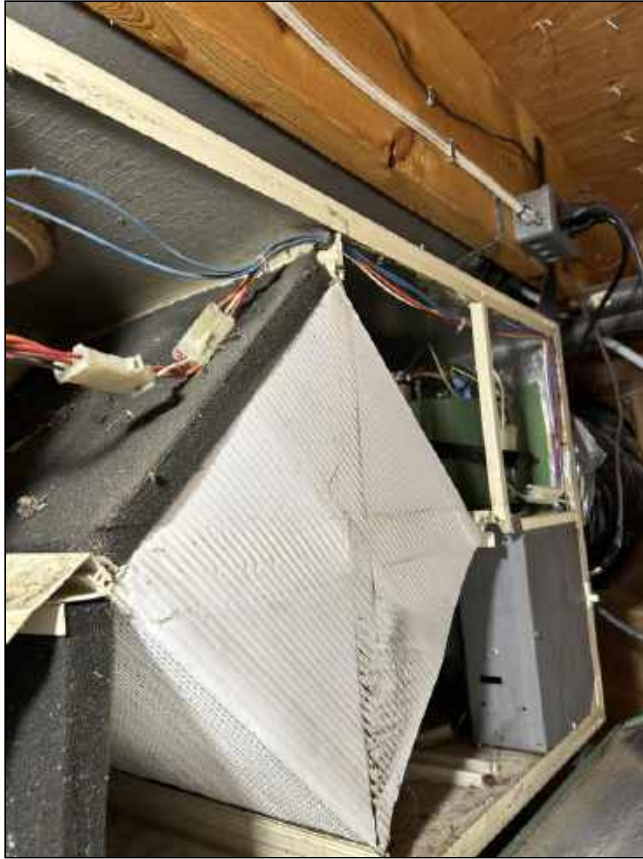
(2) Older unit with dirty filters noted. Suggest having this unit professionally cleaned and tuned to ensure proper and efficient operation.

7.8 Item 2(Picture) filter conditions

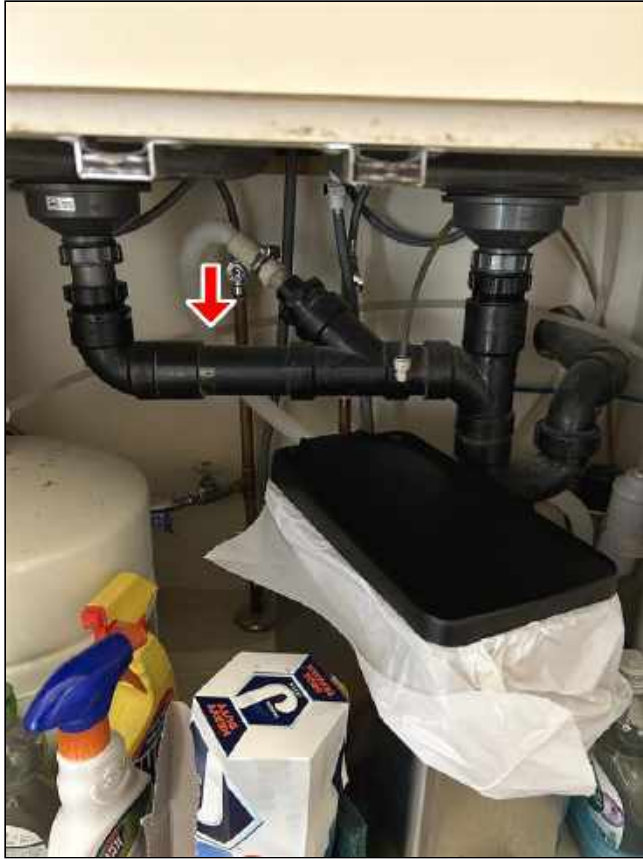
Inadequate drain slope noted. We recommend drain corrections to ensure proper flow.

10.8 Item 1(Picture) drain slope
