Doing It Right

Is Greg Johnson's 1972 T/A the finest Firebird restoration in the world?

1972 455 HO Trans Am

PONTIAC
ENTHUSIAST
MAGAZINE

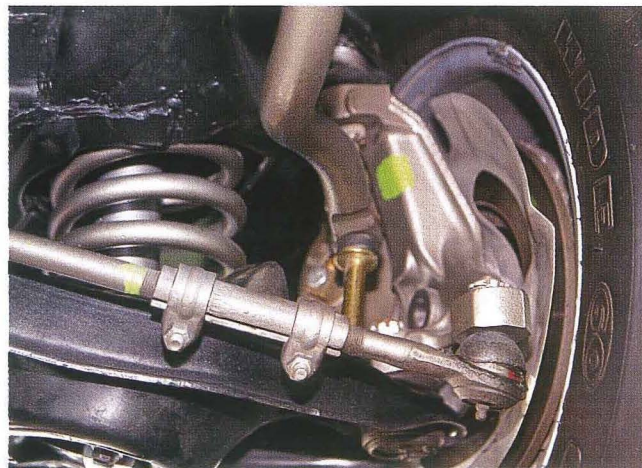
On the driver-side spindle there is a green mark near the top ball joint and another green mark near the tie-rod adjustment.

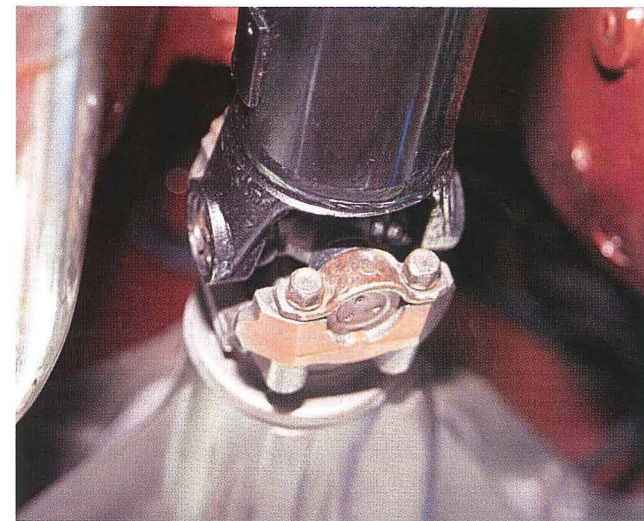
These white inspection marks are on the rear U-joint straps.

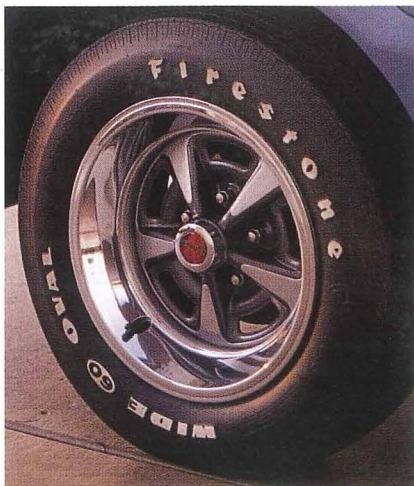
The Trans Am is shod in the correct Firestone "Wide Oval" 60-series tires (these are reproductions).

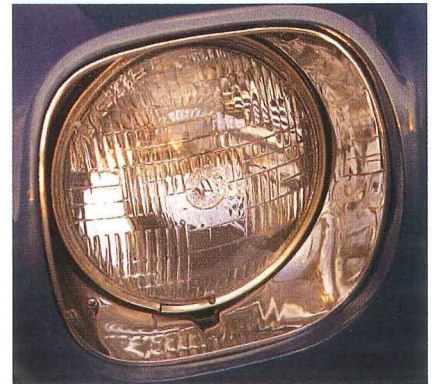
Even the headlights are the correct N.O.S. Guide "Power Beam" lamps. It's details like this that elevates Greg's Trans Am to the level of a Corvette Bloomington Gold Certification.
