Listing Information Package

**2111 Concession 8 South Nottawasaga Road,
Glen Huron**

This inspection is intended to assess the structure (including foundations, floors, walls and roofs), building envelope (including roofing), mechanical systems (including heating and plumbing), the attic space (including insulation), electrical systems and windows.

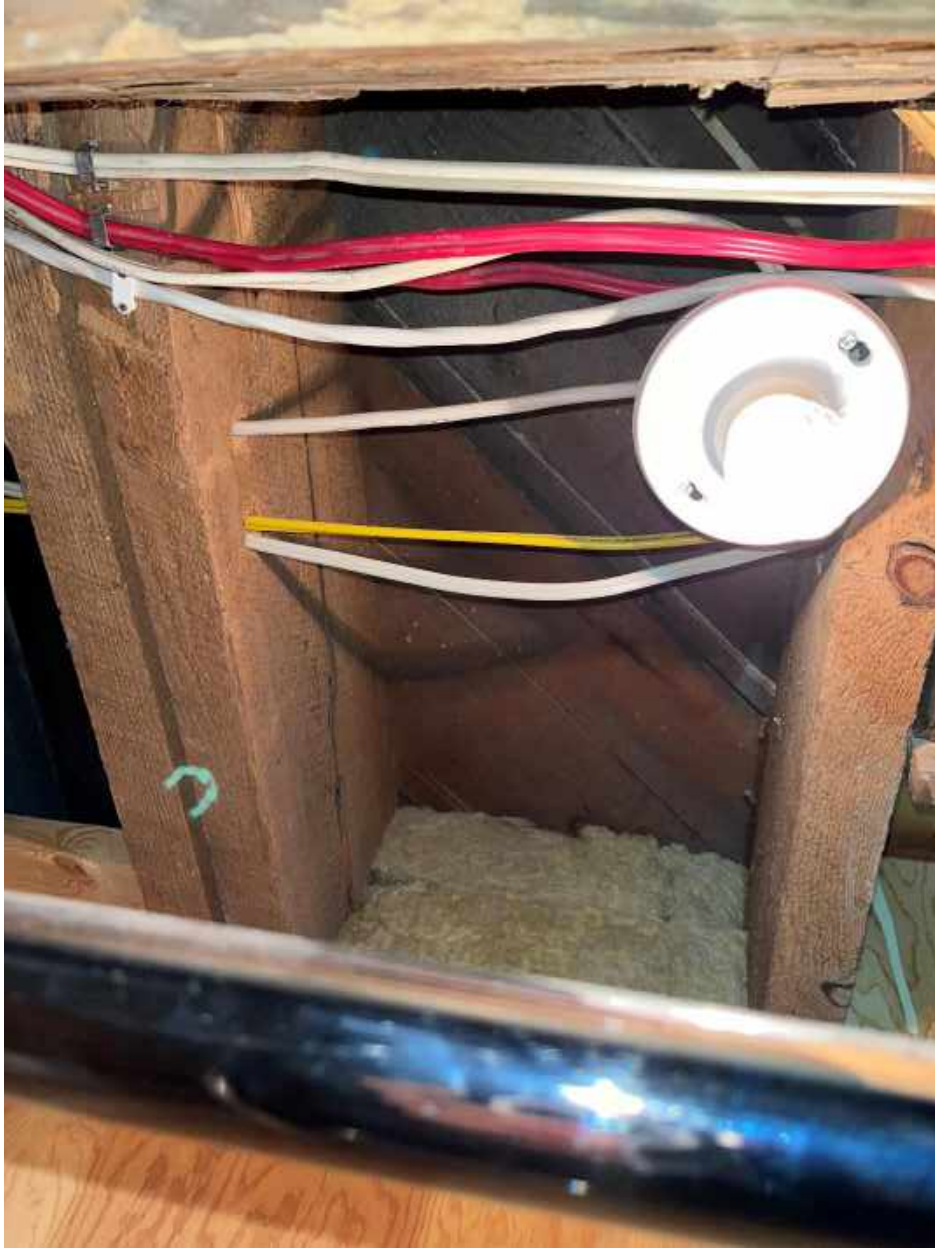
Stable Floor Structure that is Free of Moisture Decay:

Members were prodded to confirm the absence of moisture decay.

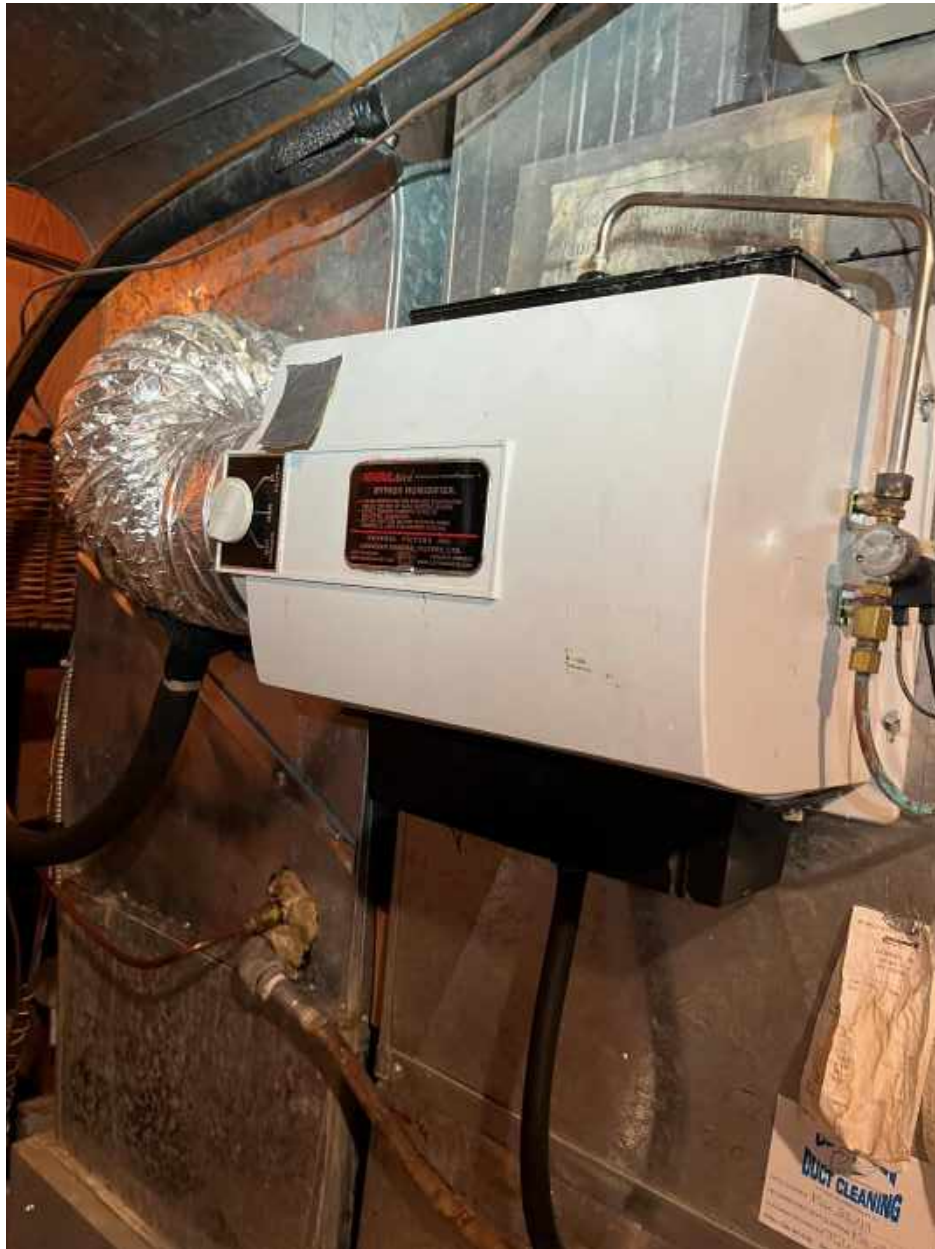
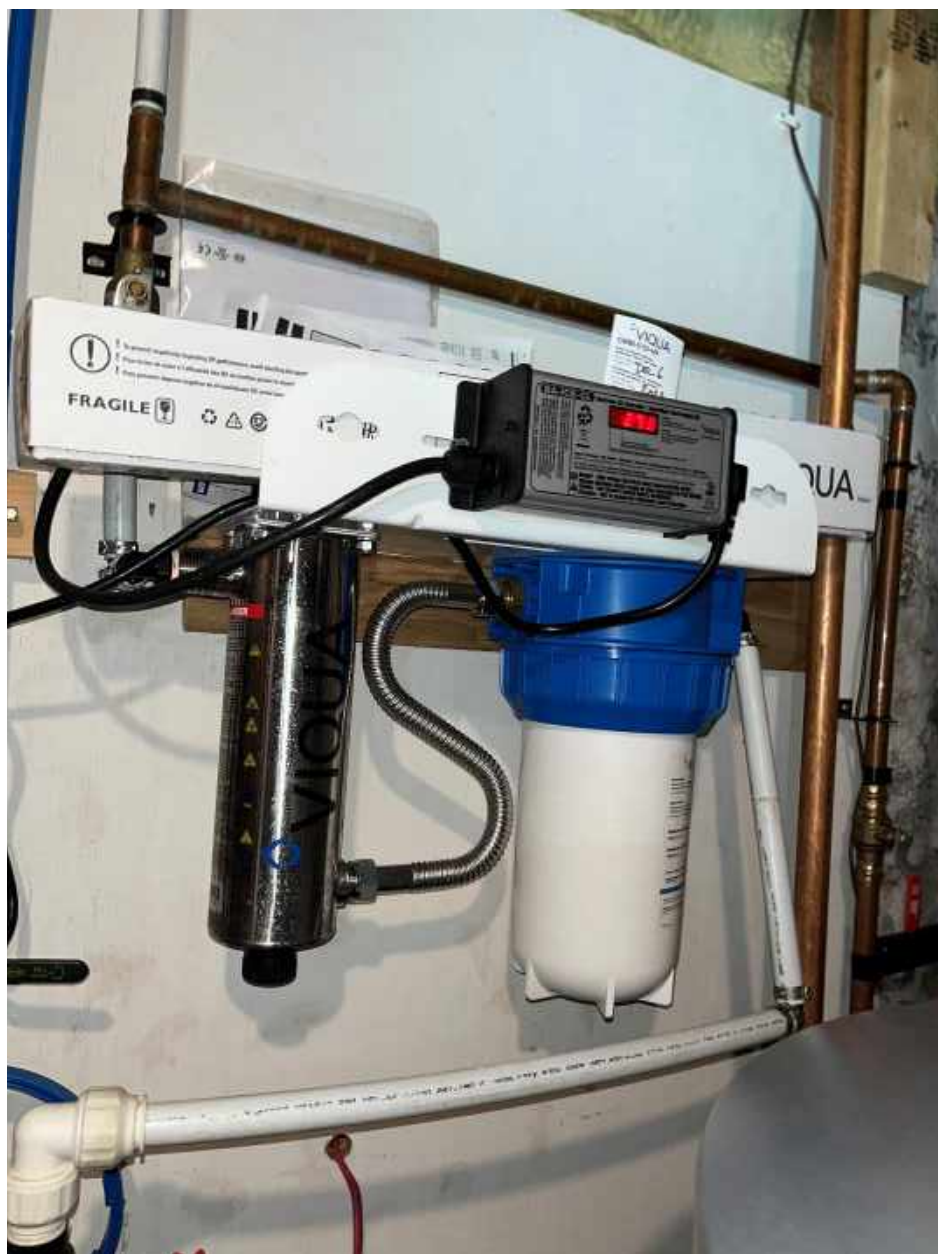
The Humidifier and Ultraviolet (UV) Treatment Units are Significant Benefits:
