Listing Information Package

**2111 Concession 8 South Nottawasaga Road,
Glen Huron**

This inspection is intended to assess the structure (including foundations, floors, walls and roofs), building envelope (including roofing), mechanical systems (including heating and plumbing), the attic space (including insulation), electrical systems and windows.

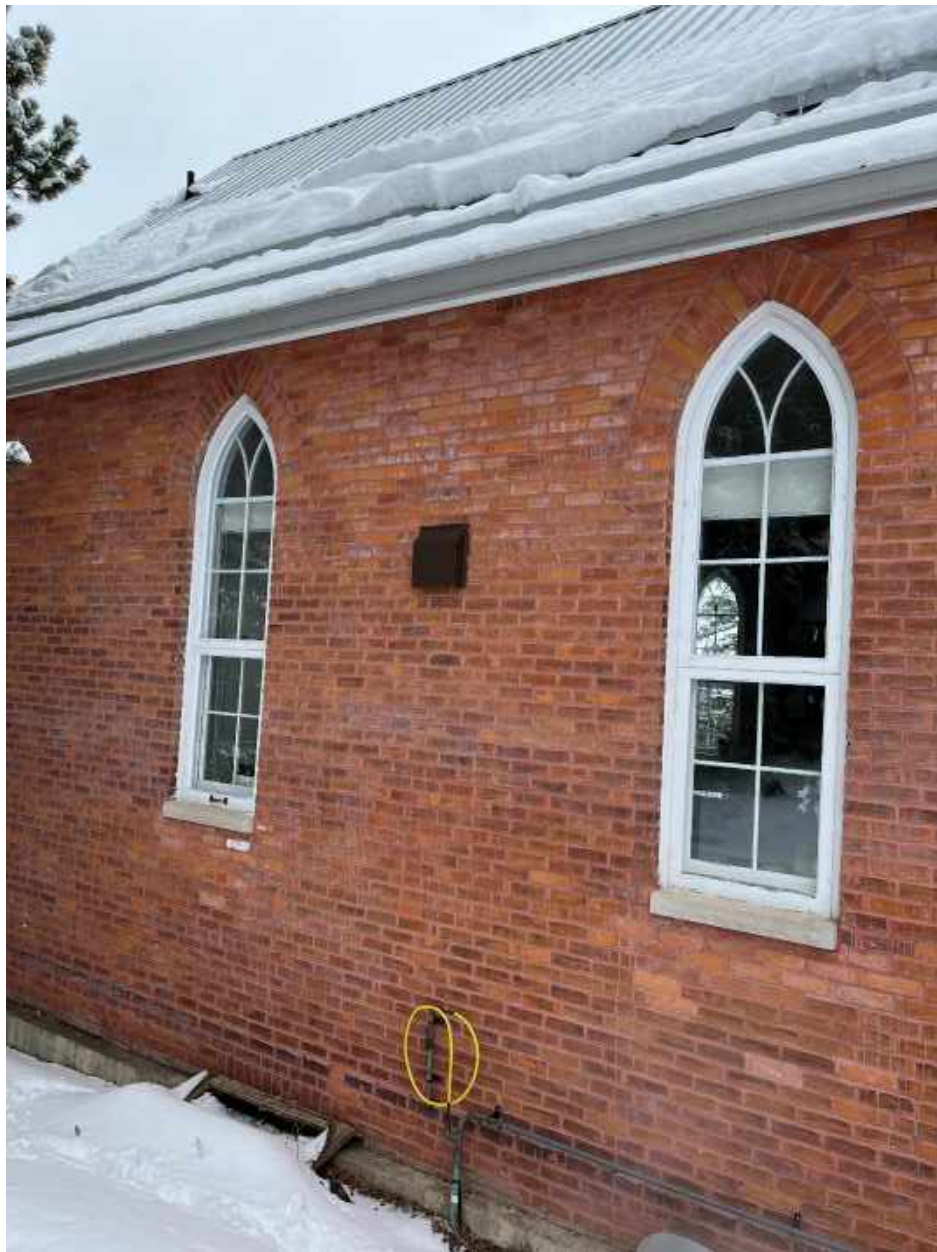
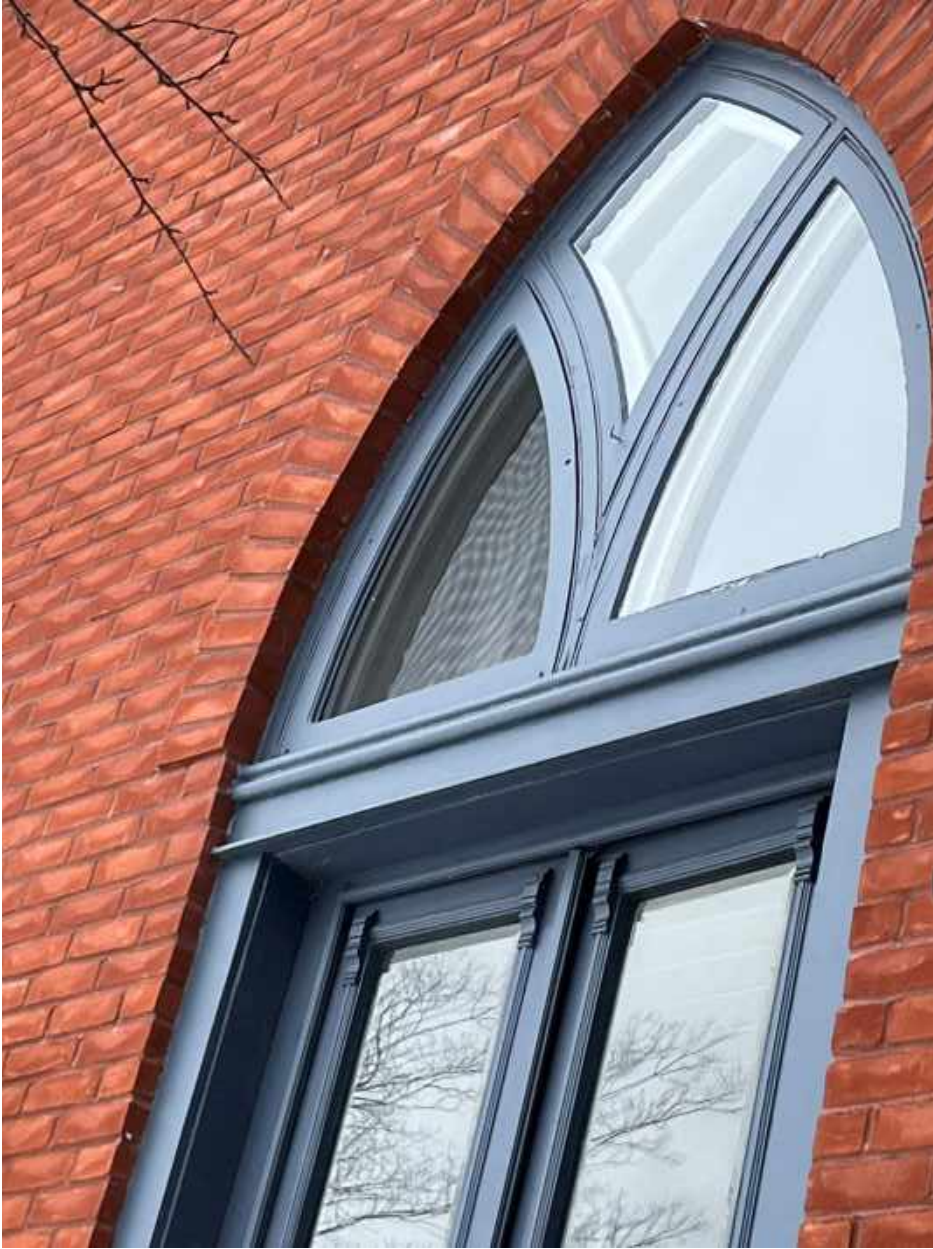
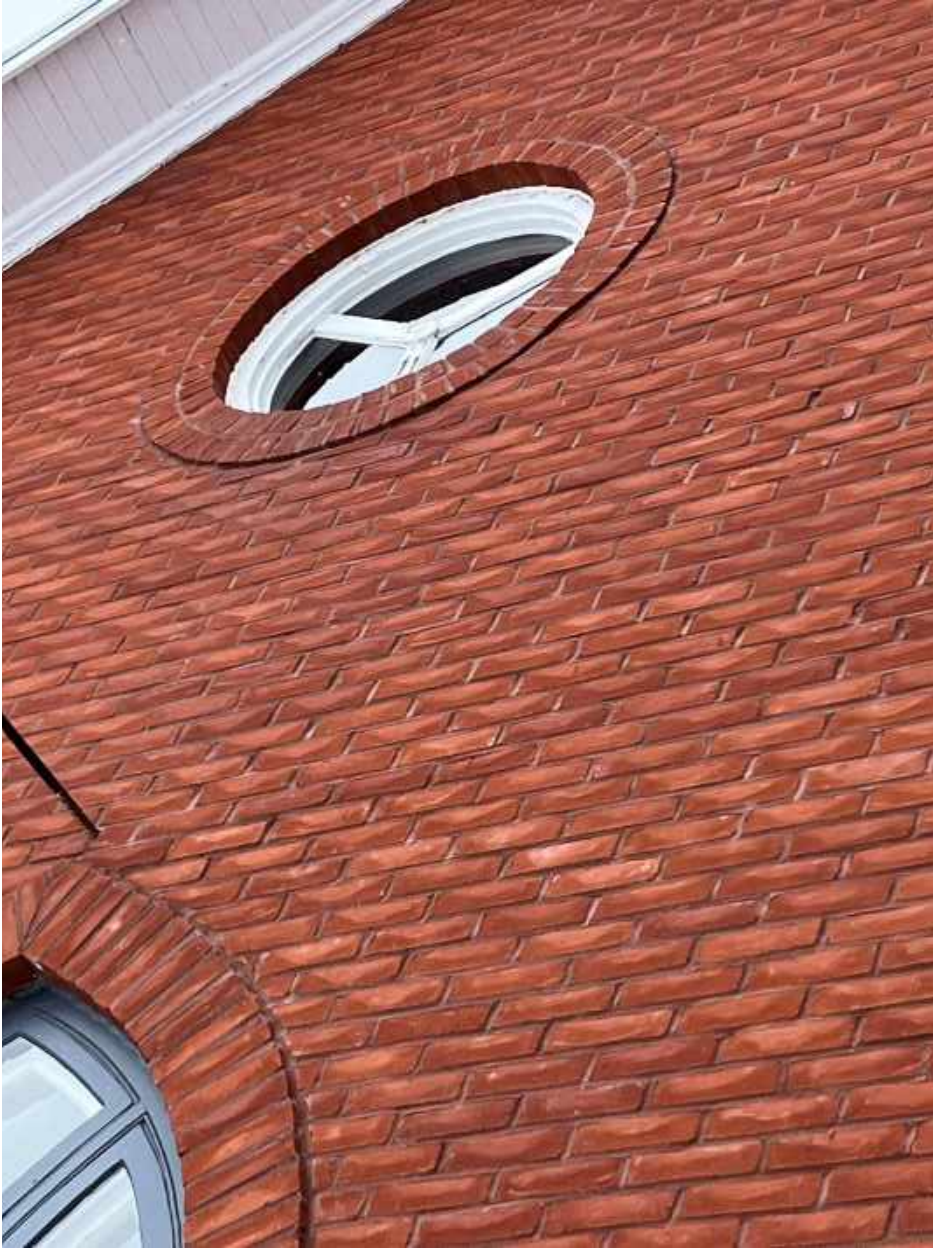
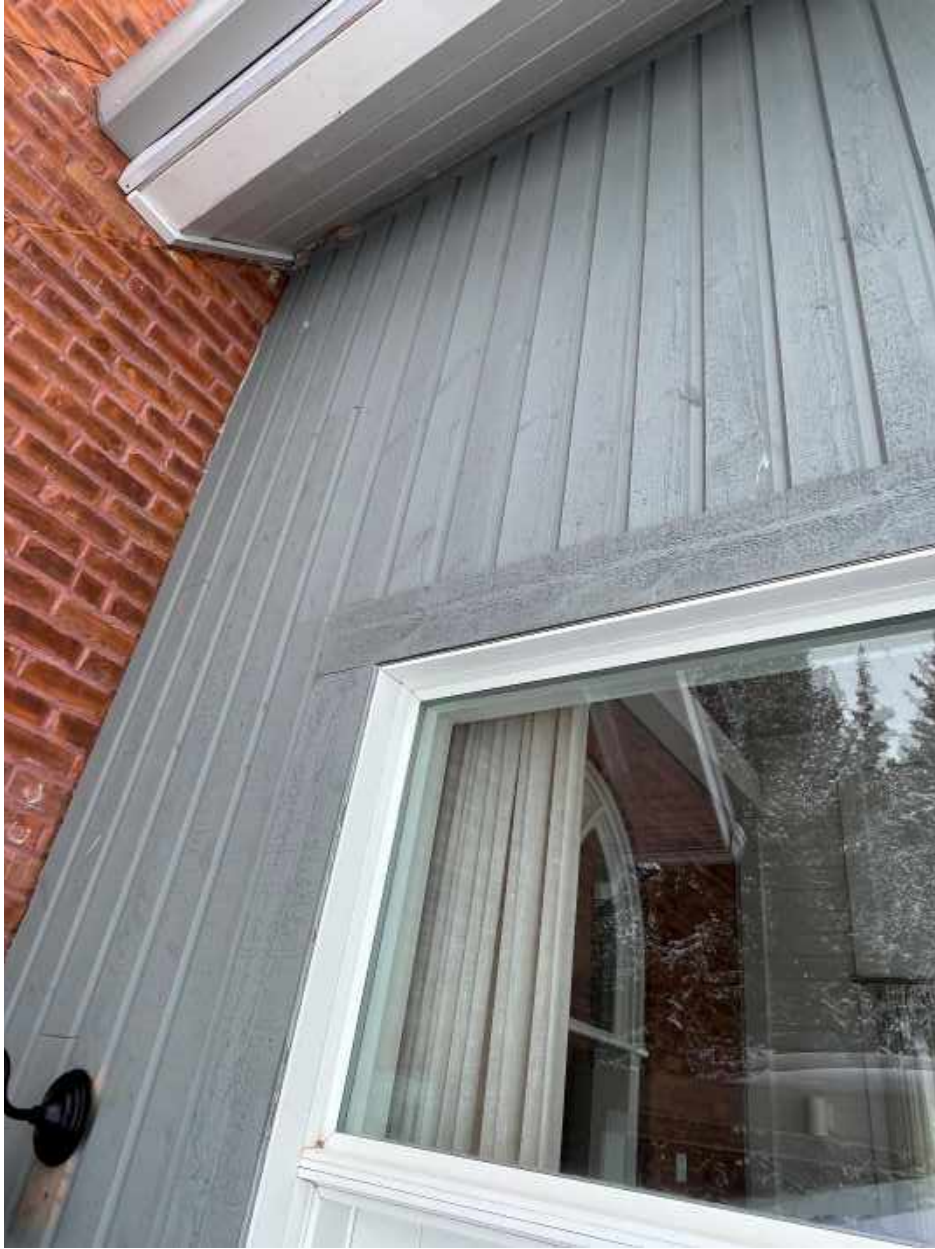
Stable Brick Masonry and Exterior Walls:

The brick system is in very good condition; it is free from significant damage/degradation.

The wood outside windows and doors is stable. See Work Required regarding some re-finishing.

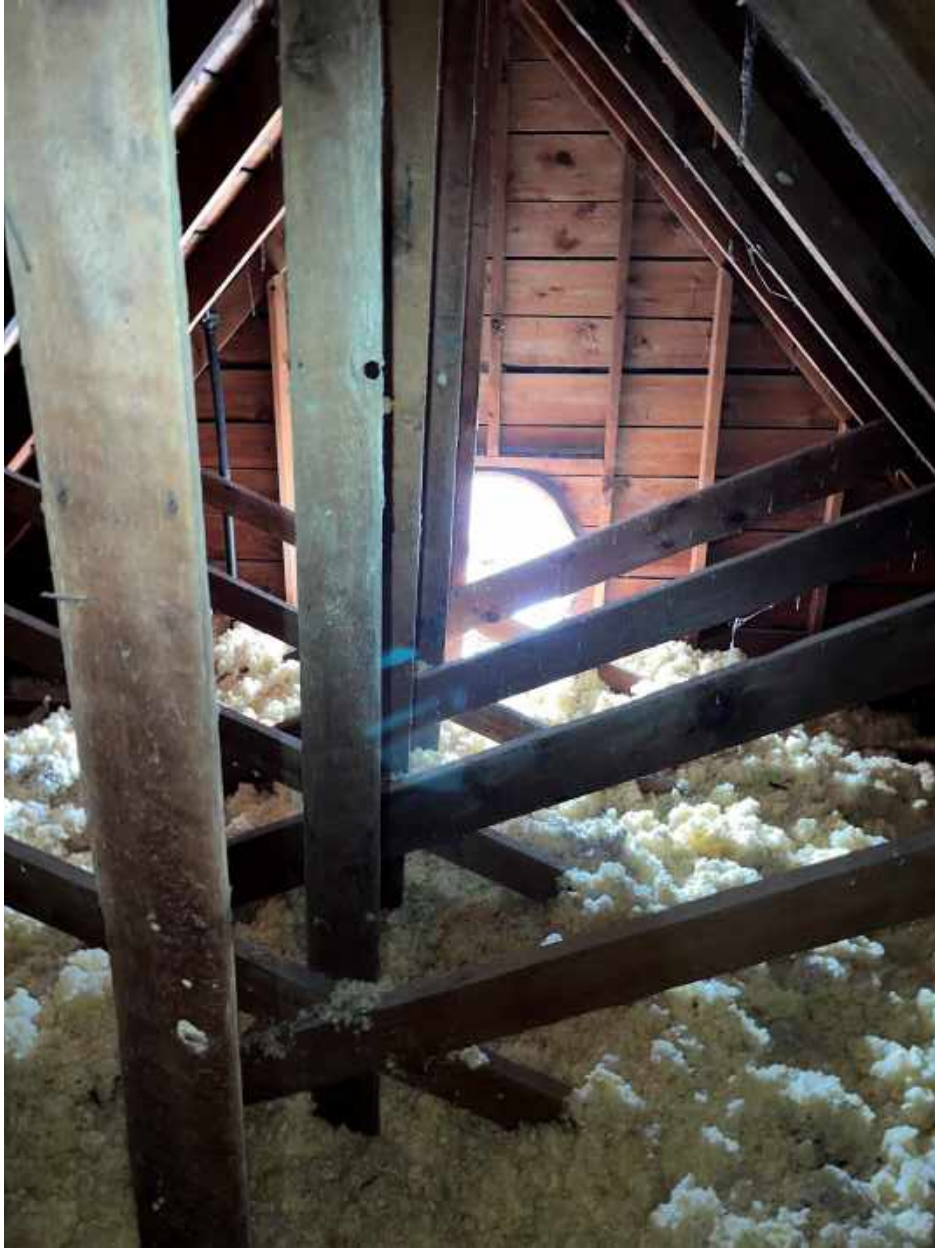
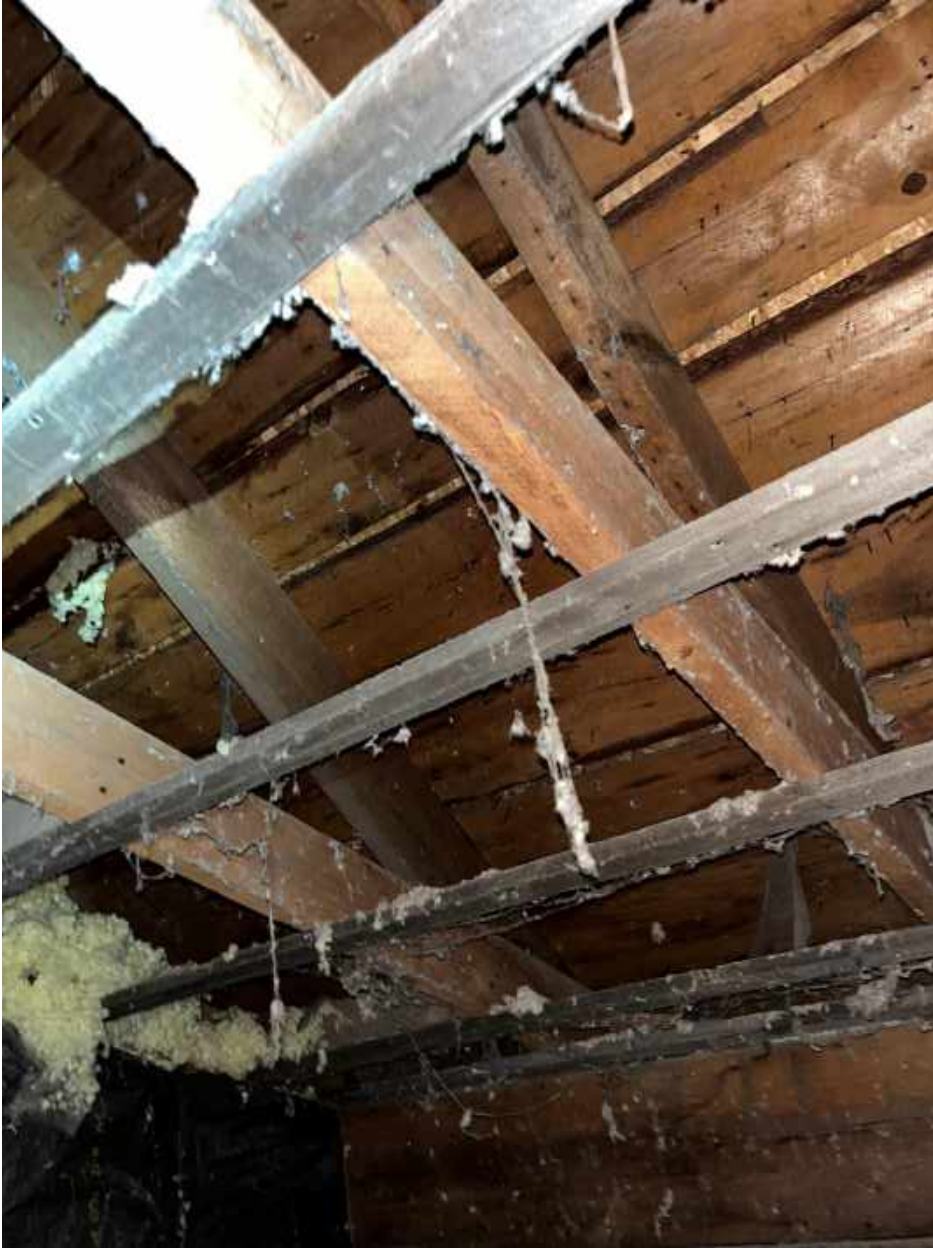
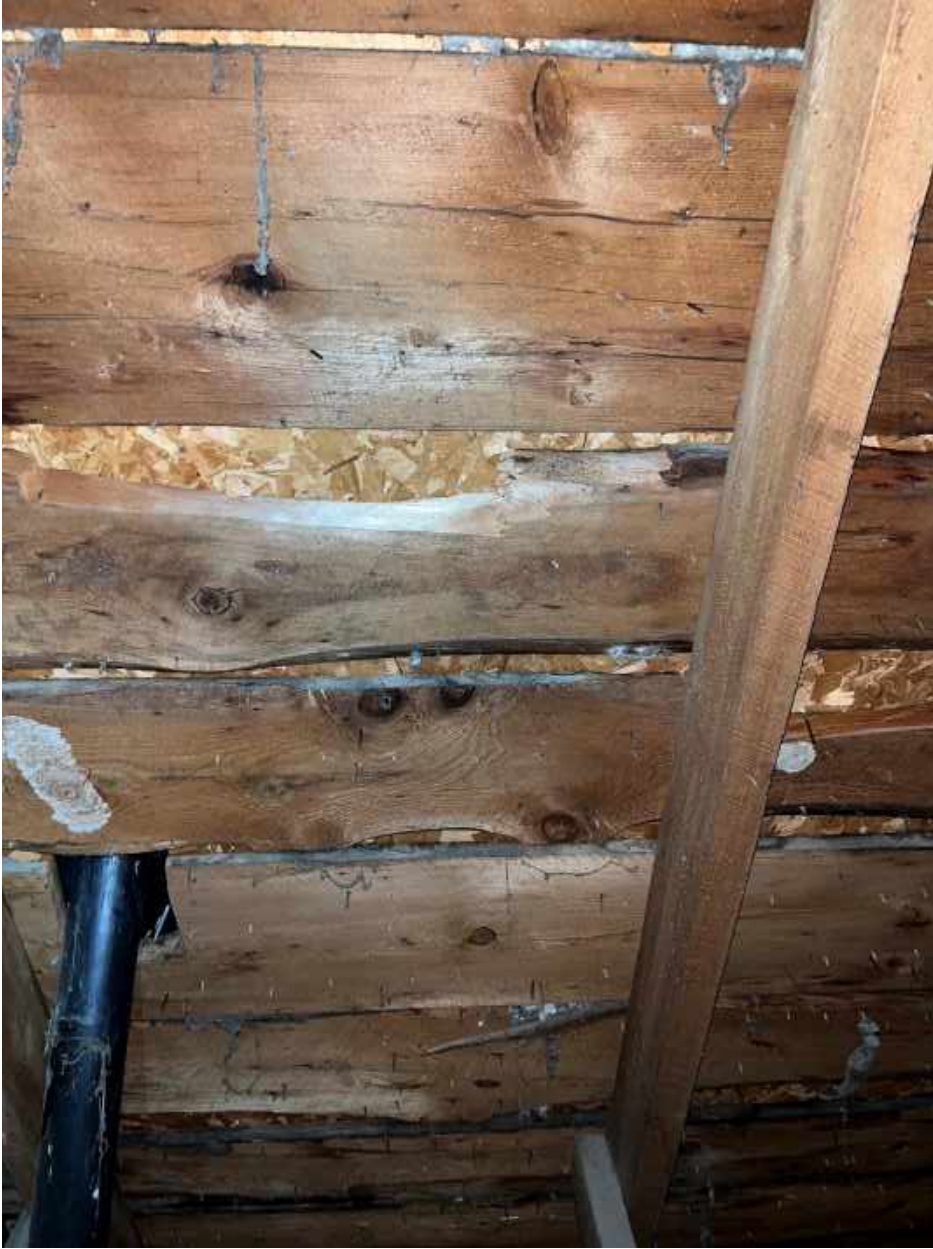
Stable Roof Structure Free of Significant Damage and Mould:

The roof structure is stable and was well-constructed overall. See the Work Required section.

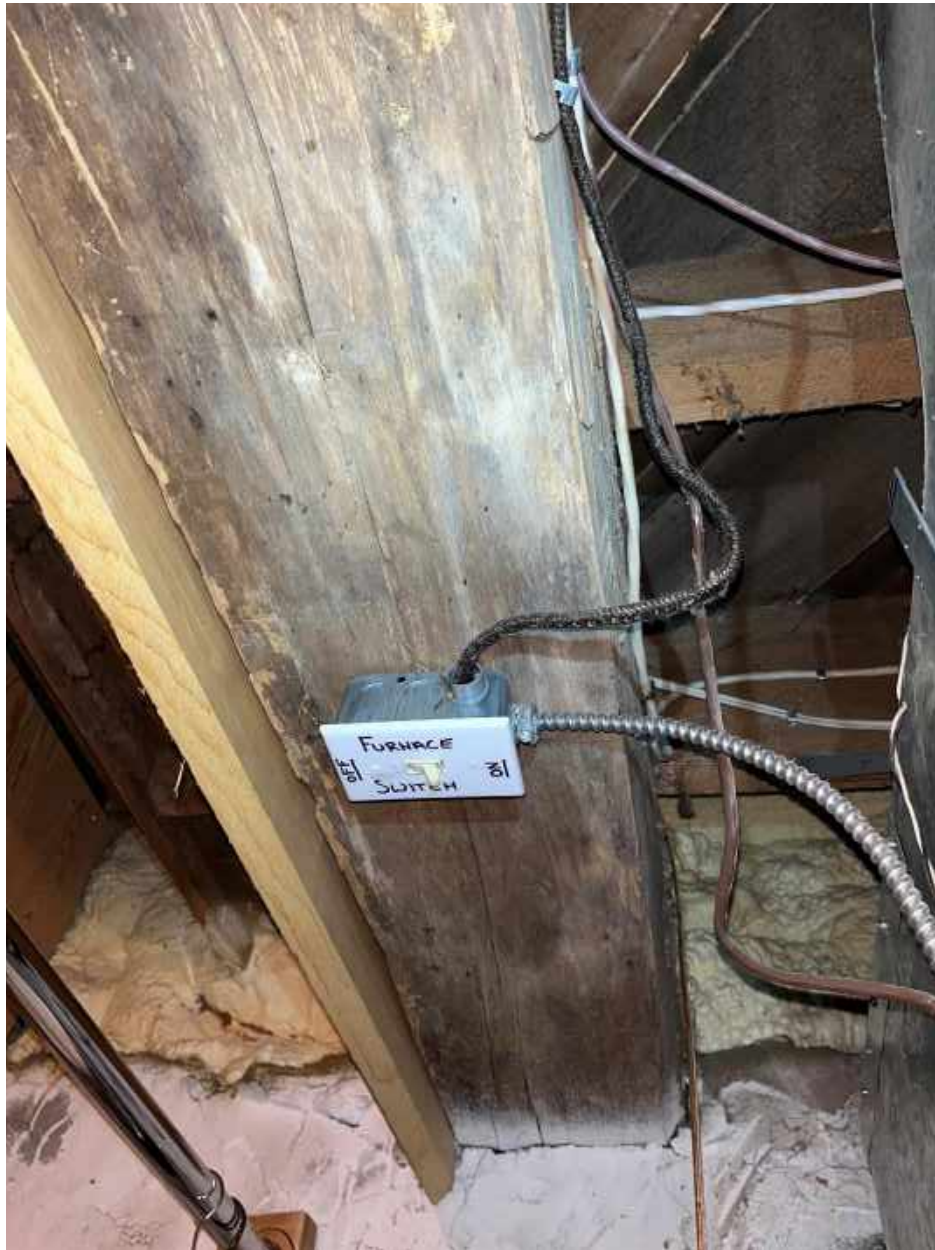
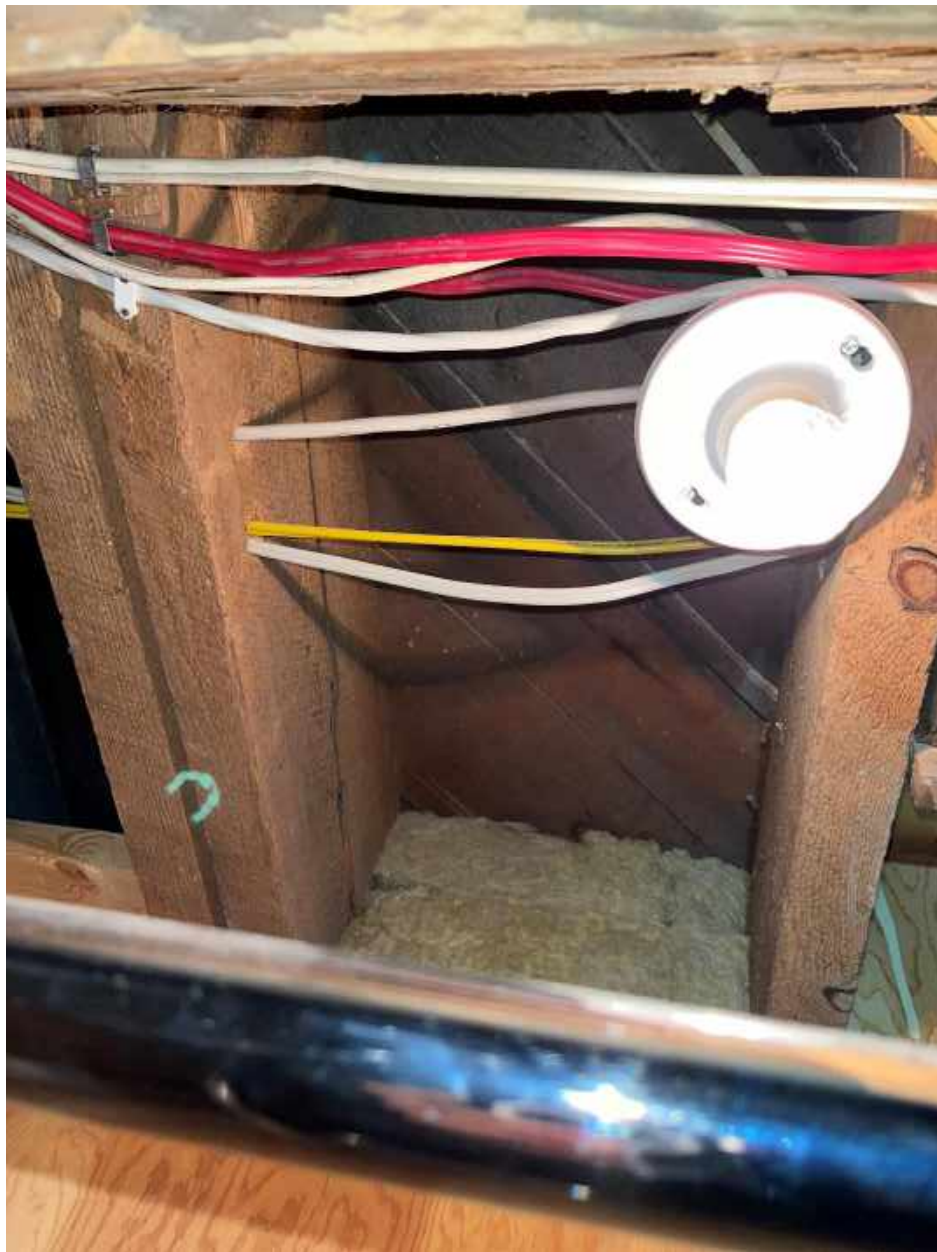
Stable Floor Structure that is Free of Moisture Decay:

Members were prodded to confirm the absence of moisture decay.

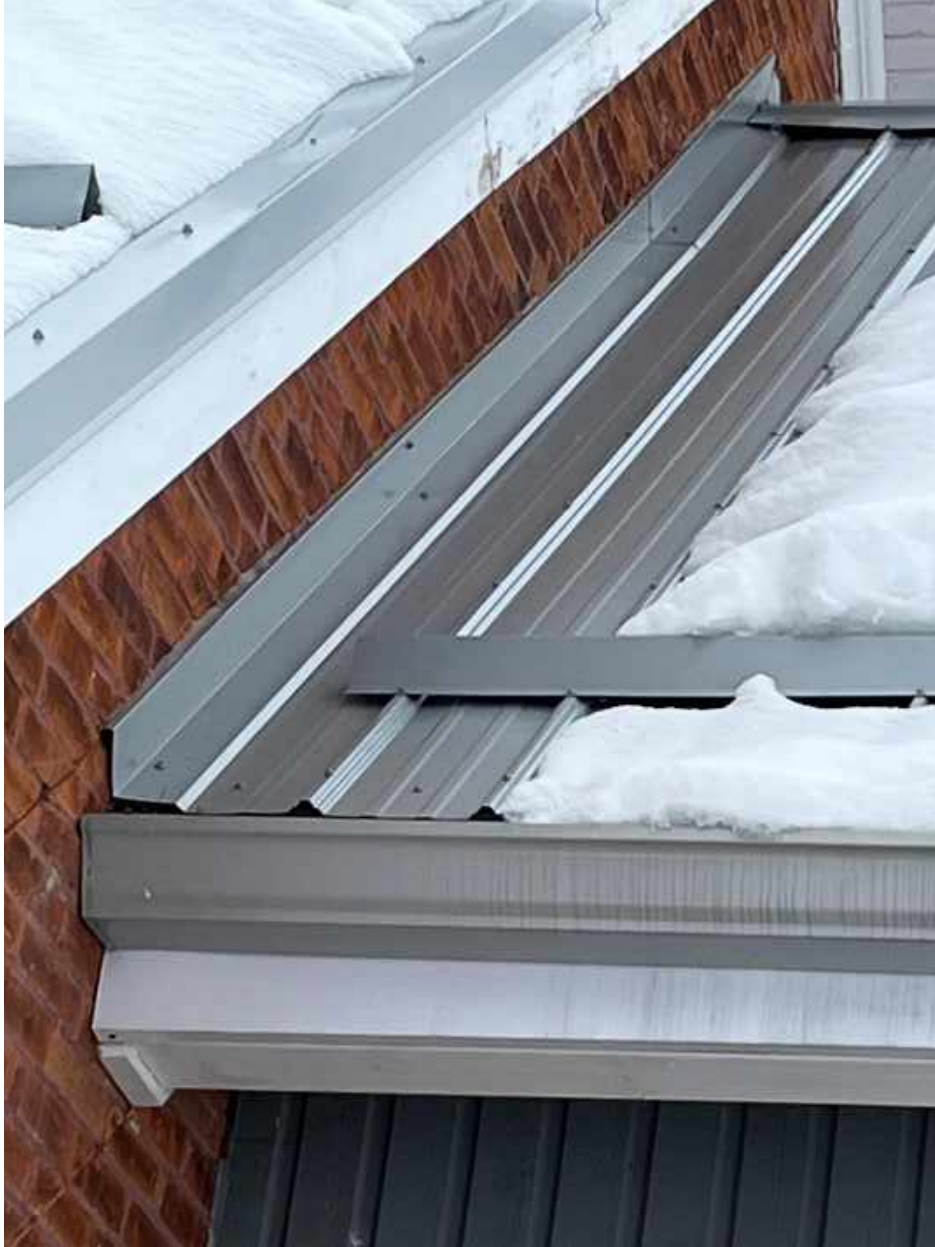
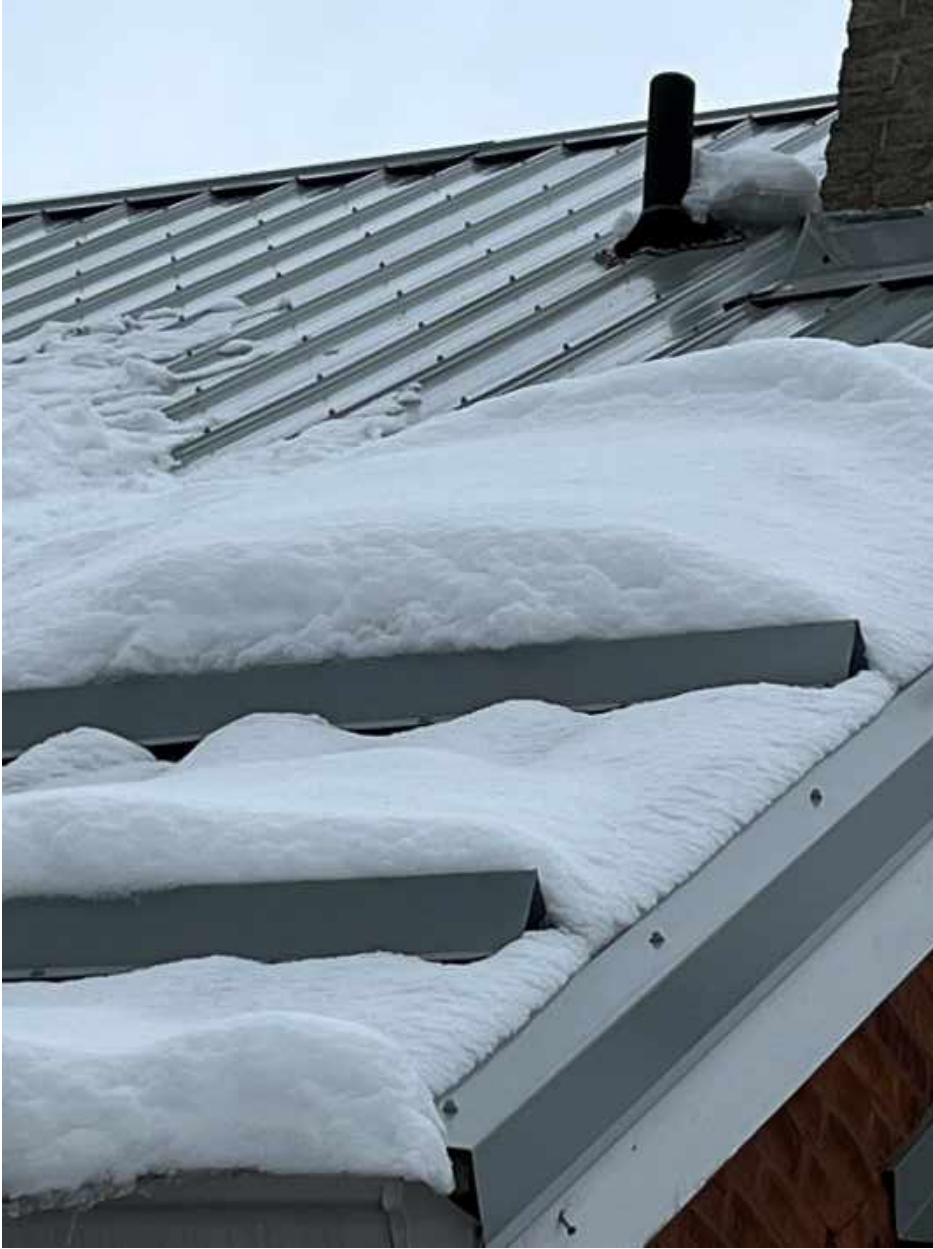
Newer Metal Roofing:

The metal roof system is newer, and has been well-installed and well-fastened based upon partial observation.

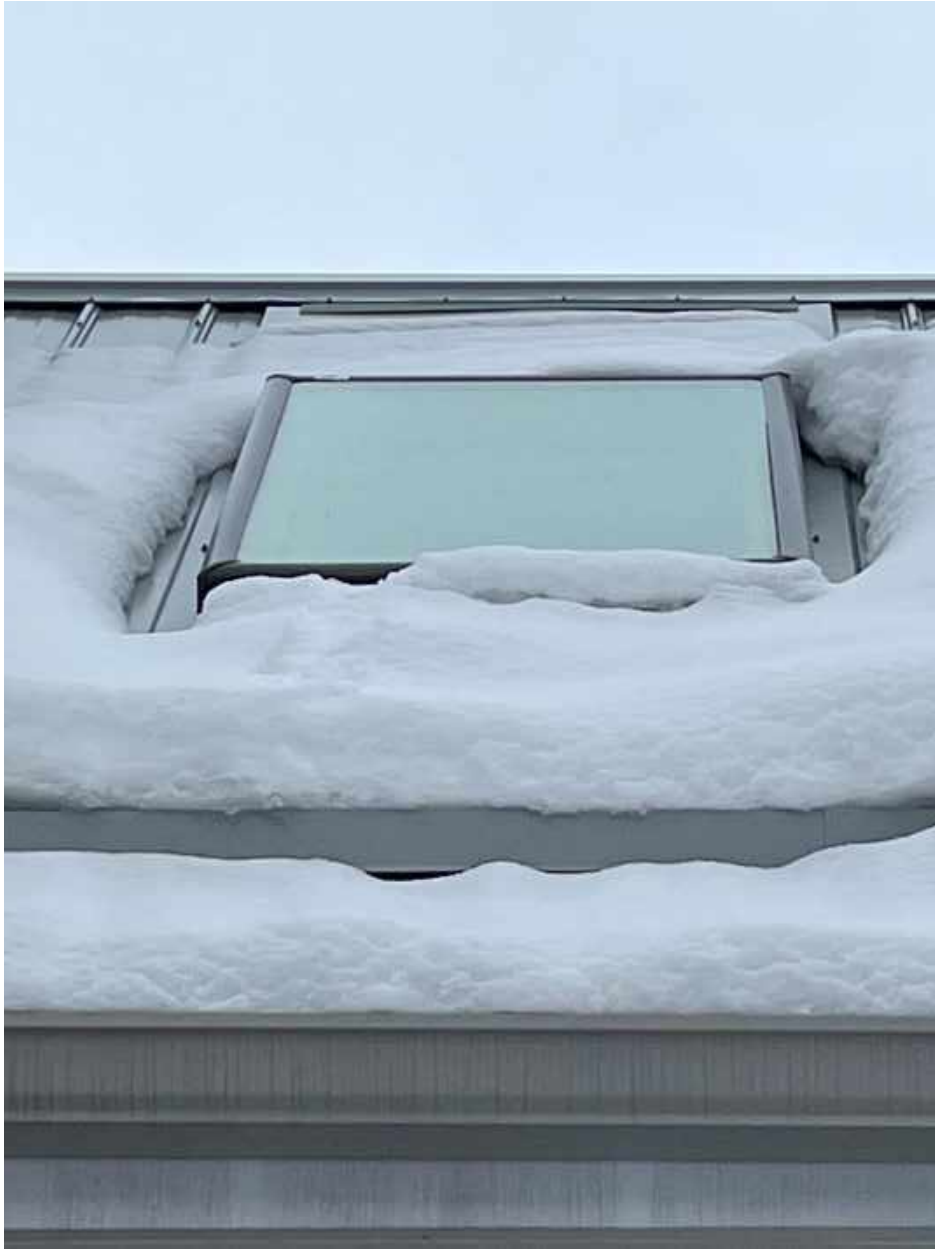
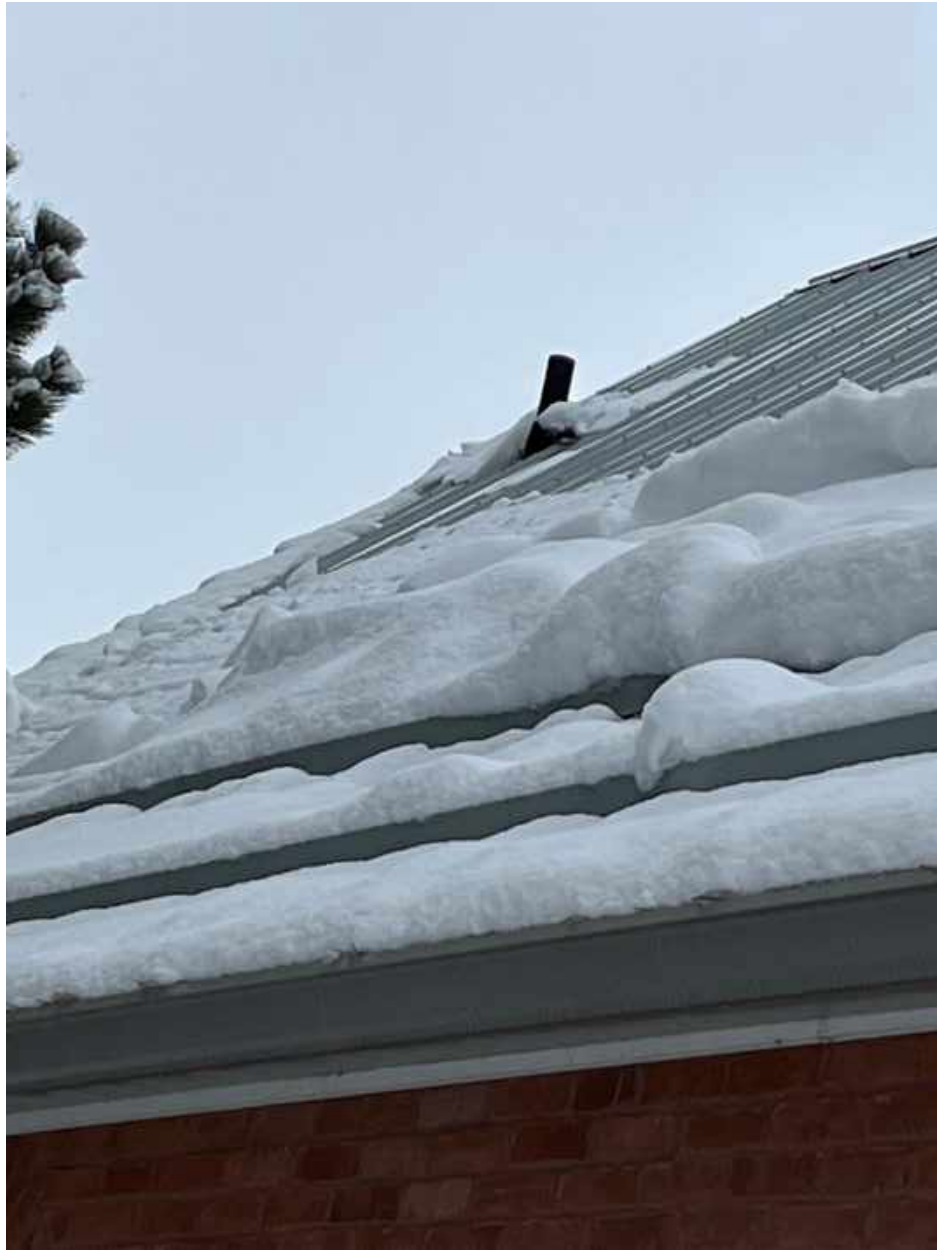
Much of the roof was covered with snow and ice.

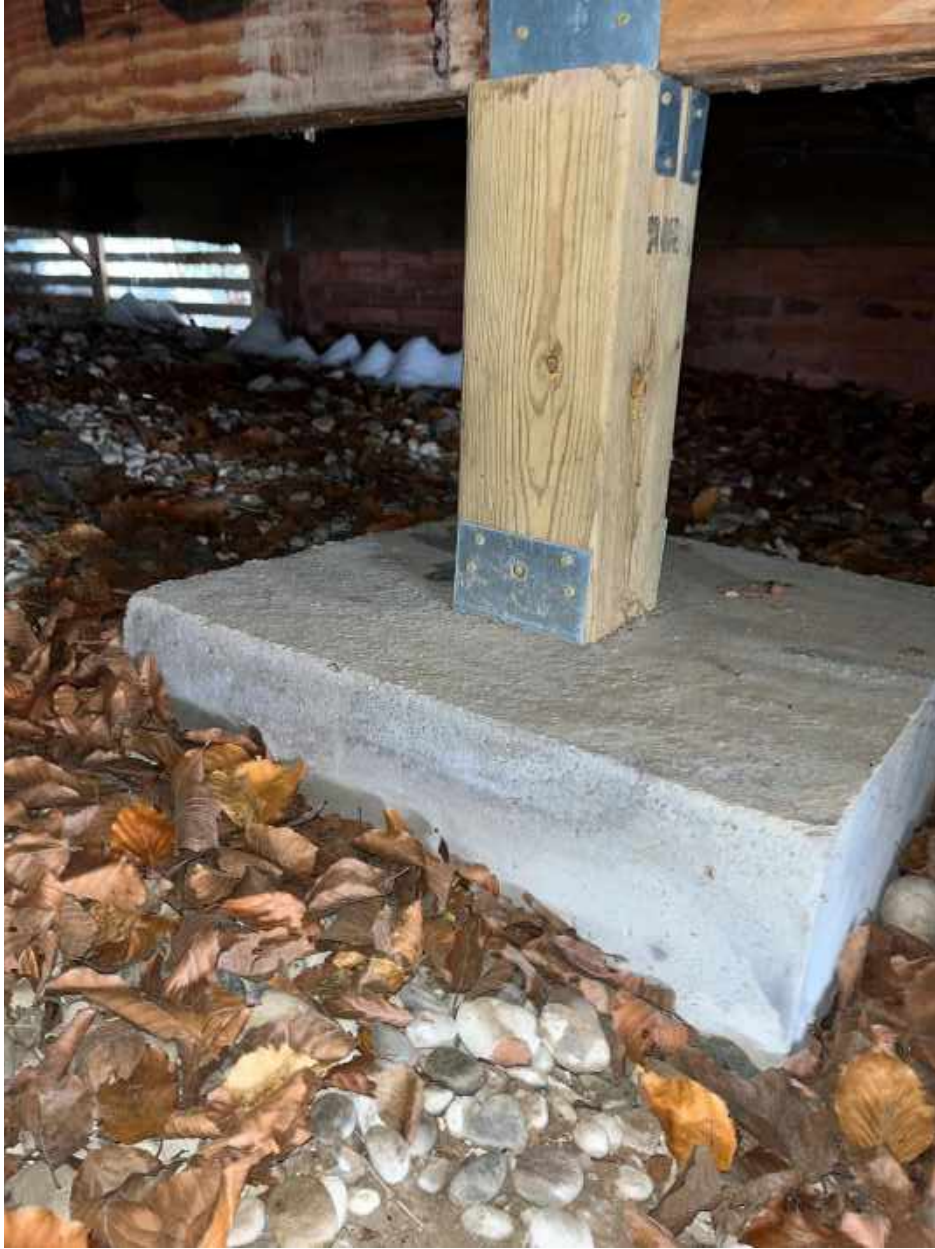
Stable Decks as Observable:

The decks are stable and were well-built, as observable by crawling (all the way through) the crawlspace.

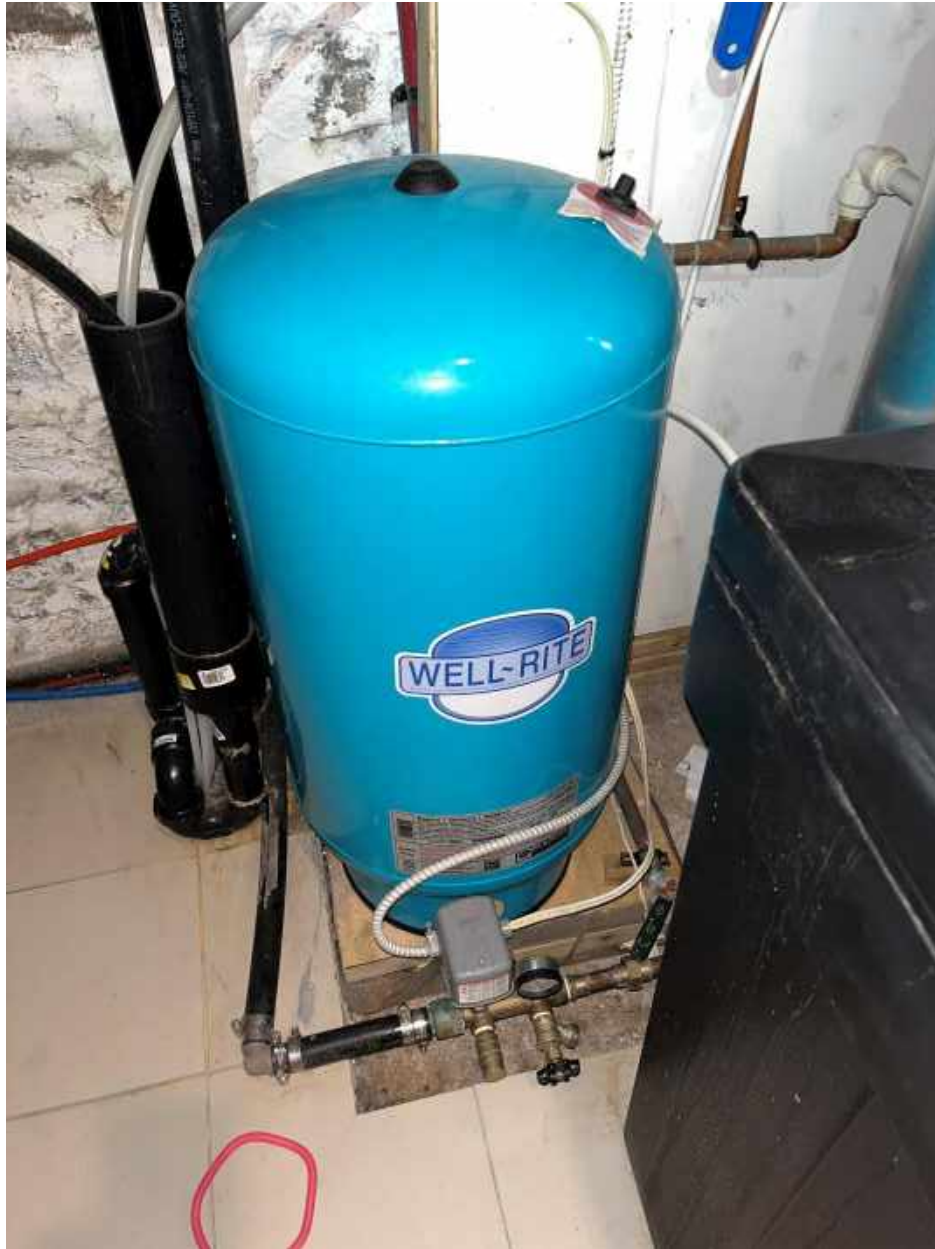
Main Shutoff Valve: Beside the pressure tank, just above floor elevation, to the right of the pressure gauge in the photo below.

It is functional.

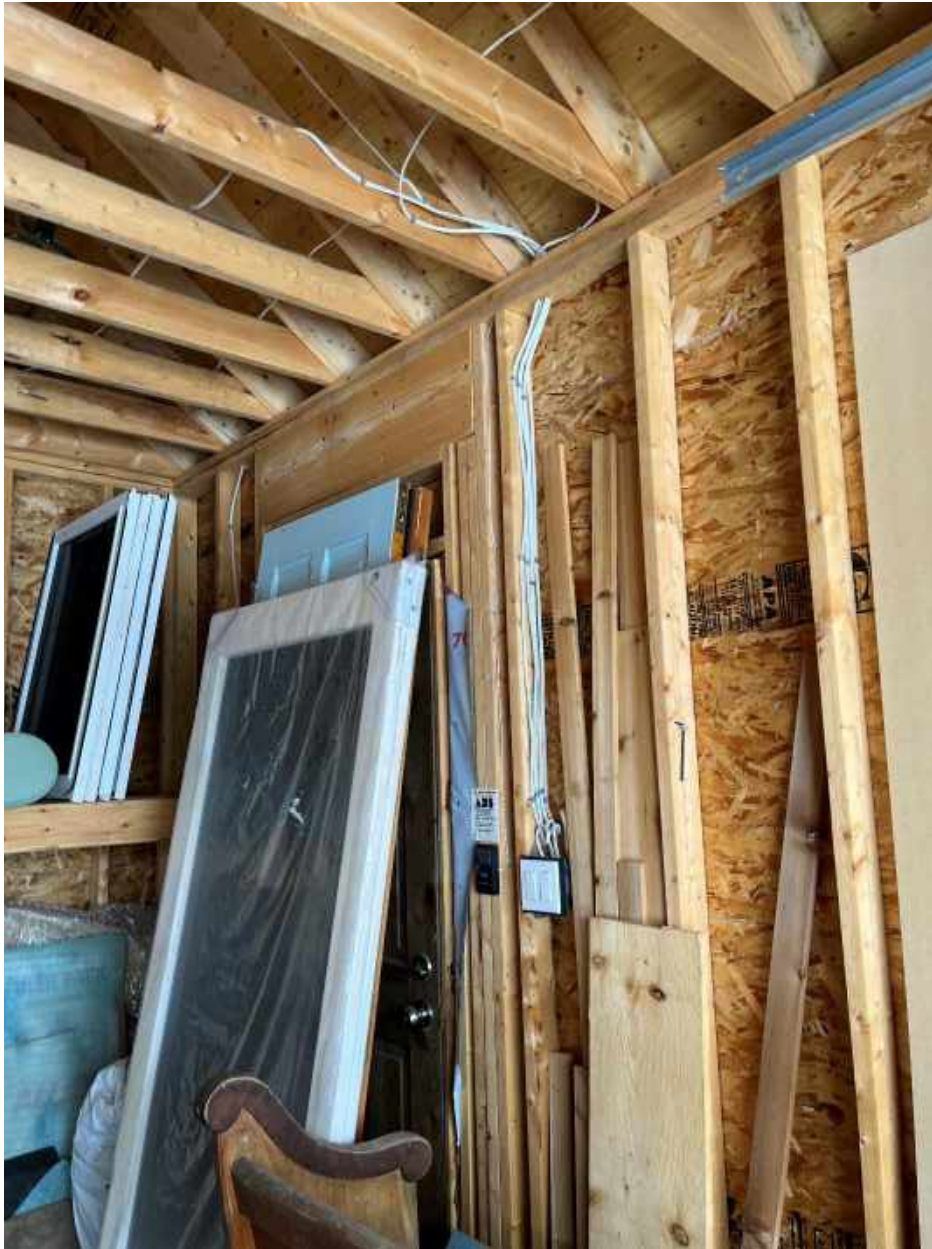
The garage is stable and was well-constructed.

Exterior wood will slowly soften if not protected.
