# Listing Information Package 102 Schooner's Lane, Thornbury

# Quick Facts 102 Schooner's Lane, Thornbury

Cover Page1
Table of Contents
Intro Page4
<u>1 Exterior5</u>
2 Roof System 11
<u>3 Garage13</u>
4 Structural Components15
5 Plumbing System
6 Electrical System22
7 Heating System25
8 Air Conditioning System29
<u>9 Water Heater31</u>
10 Kitchen(s) and Built-in Appliances
<u>11 Bathroom(s)37</u>
12 Laundry Area40
13 Interior Rooms and Areas42
<u>14 Attic45</u>
General Summary

This is a new home referenced under the PDI documentation and the Tarion Construction Performance Guidelines. These conditions may be covered by the Tarion Warranty Program. Additional information can be obtained by logging onto their Web Site at: www.tarion.com or by calling Tarion at 1-877-982-7466. We also recommend managing your warranty online at MyHome, Tarion's online service for homeowners. Reference number H3597403 Warranty start date 2023-07-11.

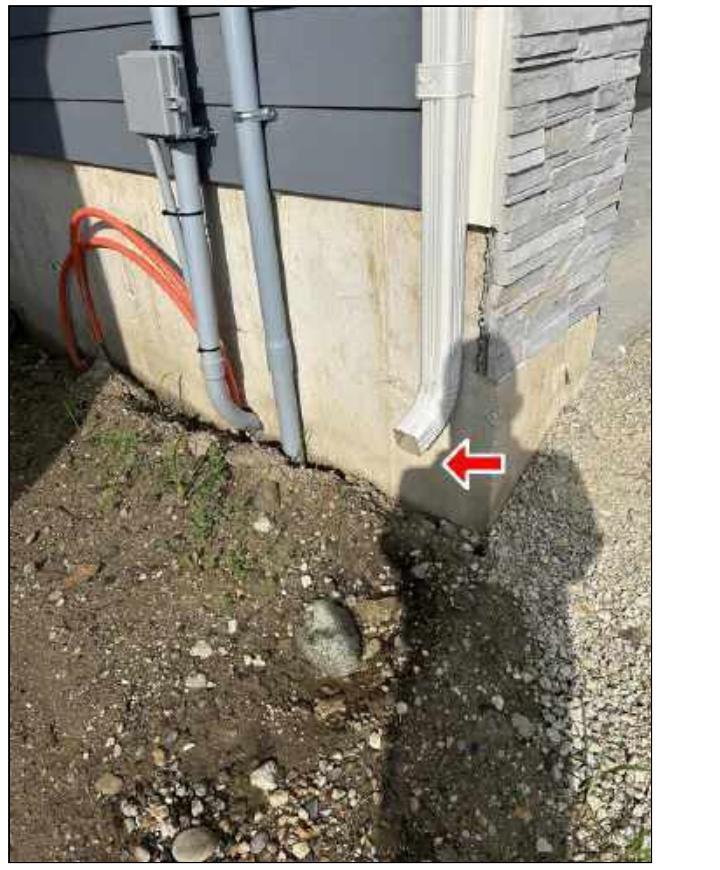
2.2 Item 1(Picture) missing extension

**2.2** Downspout extensions not installed at inspection time.

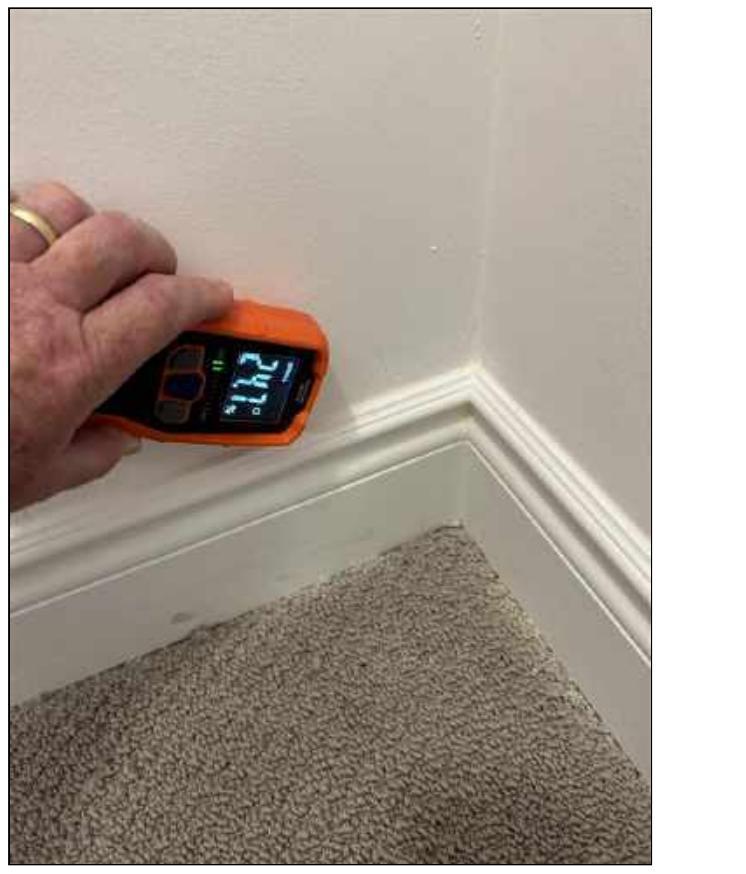
4.3 Item 1(Picture) normal moisture reading

**4.3** The basement walls were inspected for the presence of moisture at visibly accessible areas through non-intrusive means using thermal imaging, a moisture meter, touch, and visual inspection. No evidence of active moisture was noted in the visibly accessible areas of the basement walls.

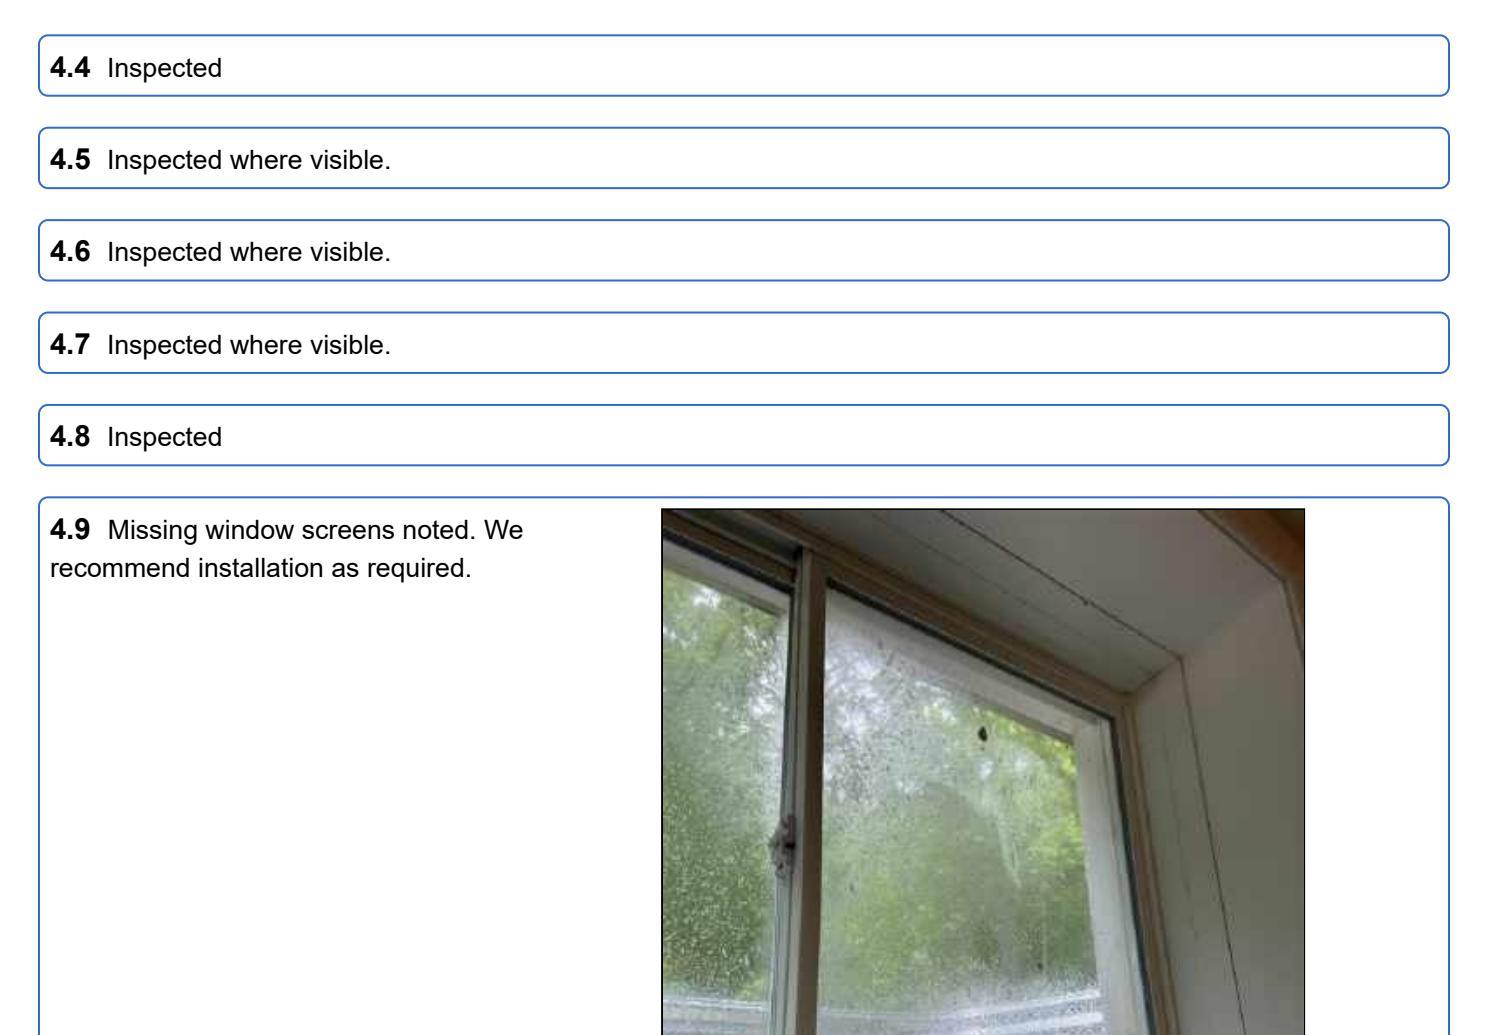
4.9 Item 1(Picture) window conditions

Missing window screens noted. We recommend installation as required.

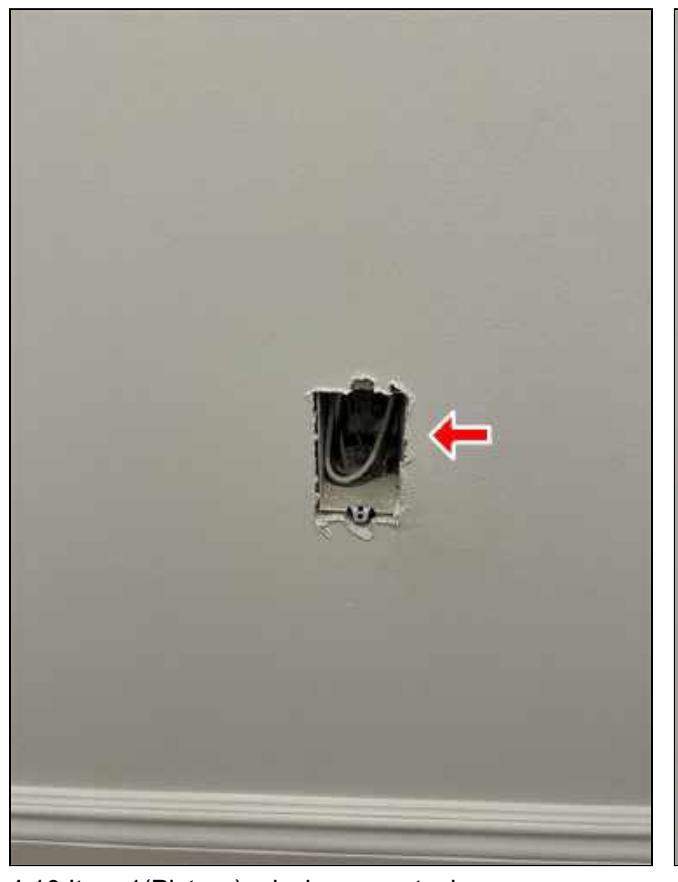
4.10 Item 1(Picture) missing receptacle

**4.10** Receptacle not installed in the basement stairwell. Open ground outlet noted on the wall mounted receptacle. We recommend electrical repairs be completed.

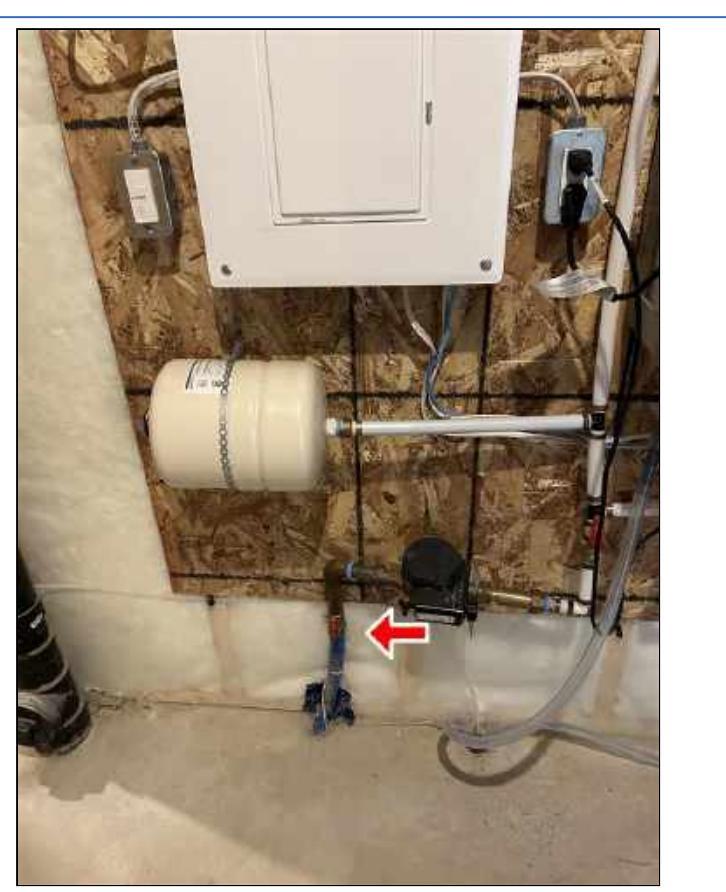
5.0 Item 1(Picture) main shut off

**5.0** Inspected. A cross connection control (back flow prevention) with an expansion tank is present.

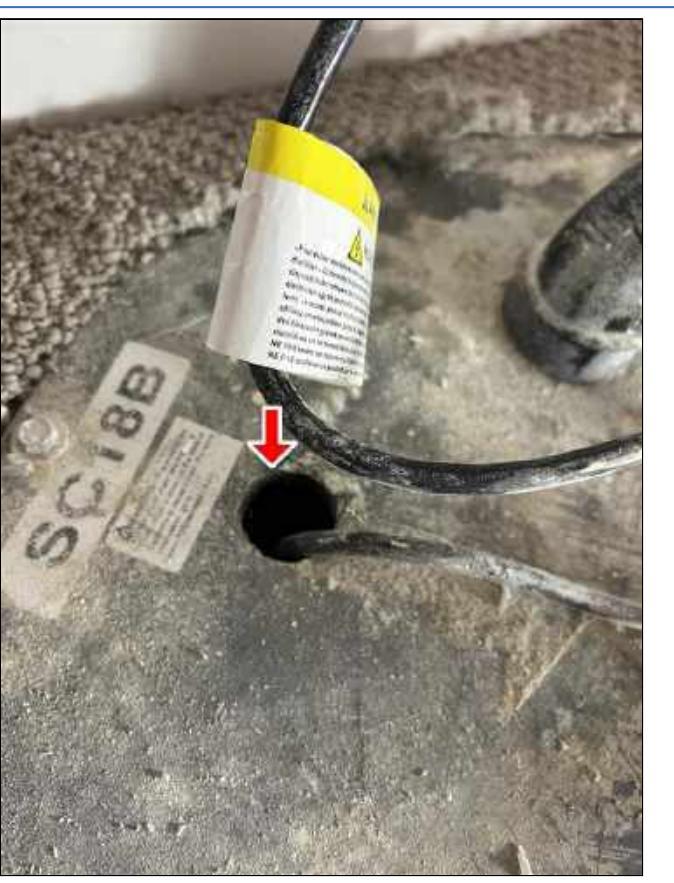
5.3 Item 1(Picture) opening

**5.3** Missing gasket noted on the sealed sump lid. We recommend installation as required.

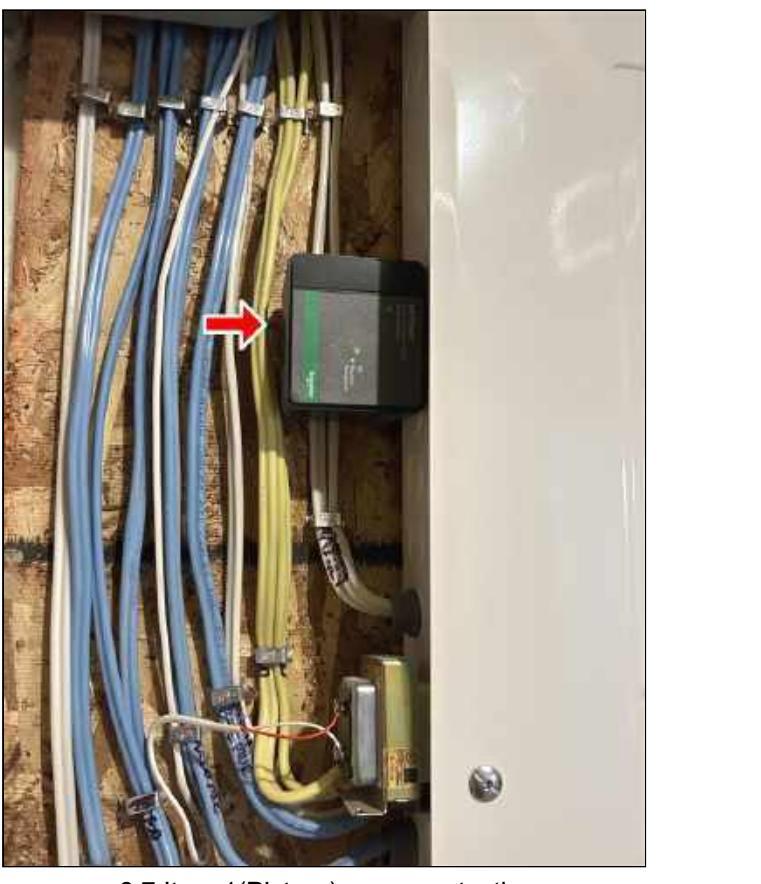
6.7 Item 1(Picture) surge protection

**6.7** A whole house surge protector has been installed at the main panel.

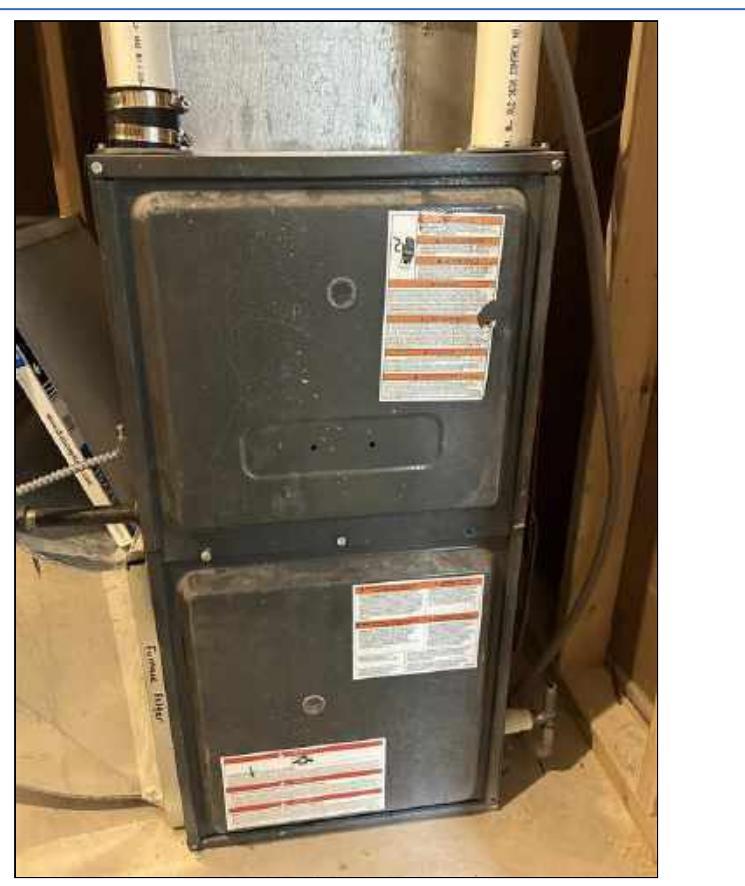
7.0 Item 1(Picture) furnace conditions

**7.0** (1) Cover attachment screw and manufacturers plate missing. We recommend installation as required.

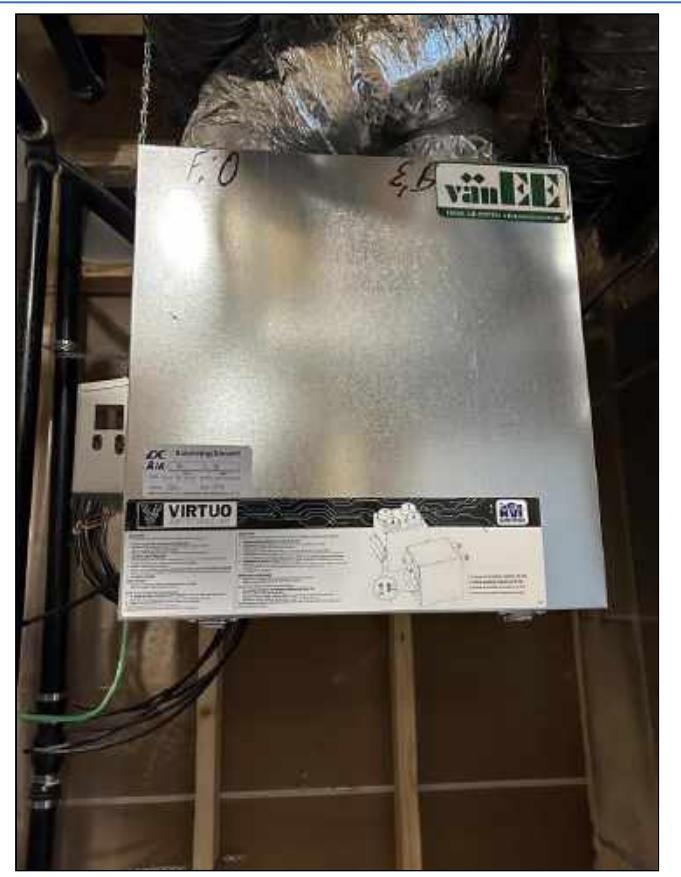
7.7 Item 1(Picture) HRV

7.7 The home is equipped with a VANEE heat recovery ventilation system (HRVS). The system tested operable at the time of the inspection. HRVS are mechanical ventilation systems that provide controlled ventilation to homes. This type of system delivers a continuous supply of fresh air into the home, while venting stale, humid indoor, along with household pollutants, to the exterior of the home. While in operation, the HRV will extract heat from the outgoing stale air (cool air in the summer), and use it to preheat (or cool) the incoming fresh air. The stale air then gets exhausted to the exterior of the home. As a result of this process, significantly less energy is required to heat (or cool in summer) the incoming air. Your filters and core of the HRV should be cleaned according to manufacturer's directions and serviced annually. If you are not comfortable doing it yourself, contact a technician accredited by the Heating, Refrigeration and Air Conditioning Institute of Canada (HRAI). Make sure the technician you call has been trained by the manufacturer of your HRV. You can find additional information on maintaining your HRV at this site http://www.cmhcschl.gc.ca/en/co/maho/gemare/ gemare\_004.cfm

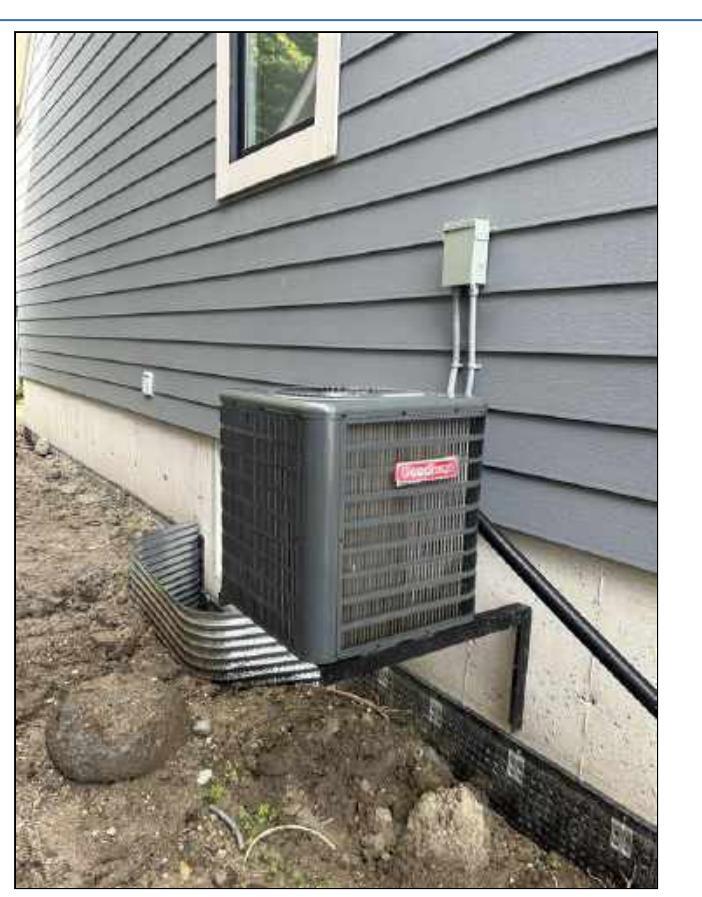
8.0 Item 1(Picture) air condenser

**8.0** The air conditioner was activated to check the operation of the motor and the compressor, both of which are in serviceable condition. As a detailed review of the cooling capacity of this unit is beyond the scope of this inspection, we make no warranty as to the system's adequacy.

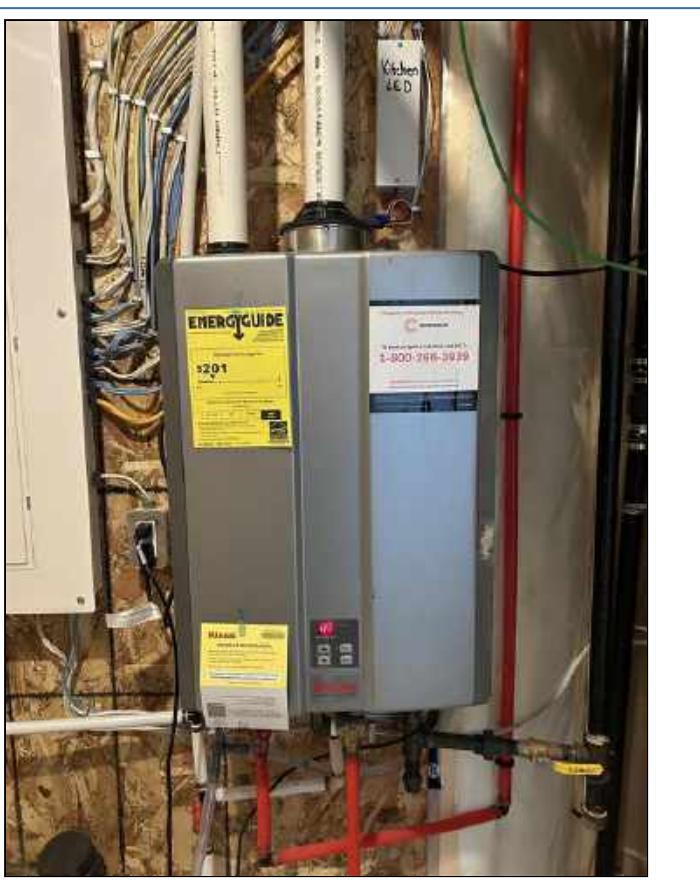
9.0 Item 1(Picture) water heater

**9.0** (1) Inspected

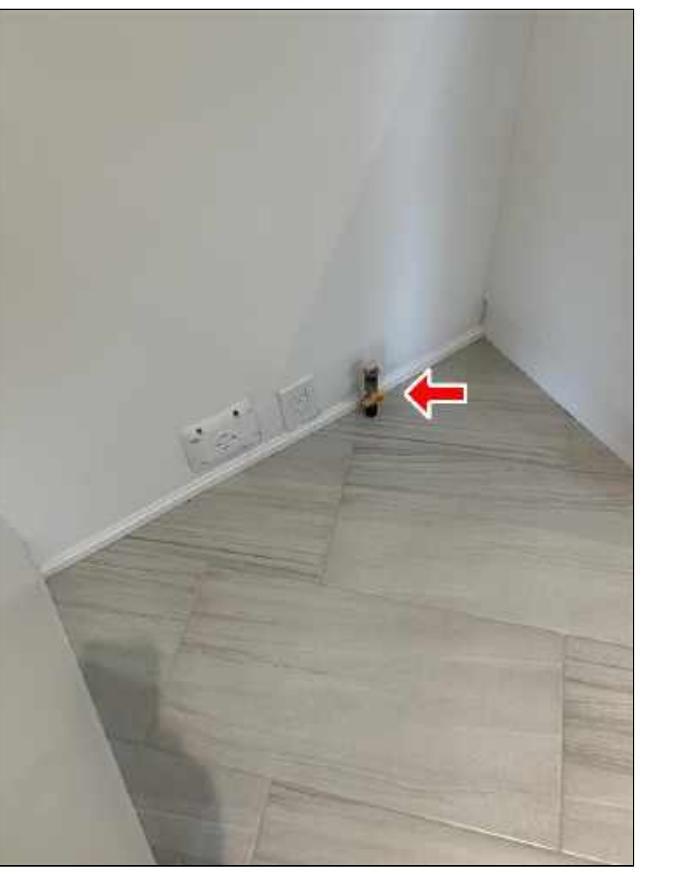
10.9 Item 1(Picture) gas line

**10.9** Not installed at inspection time. Capped gas line with shut off noted.

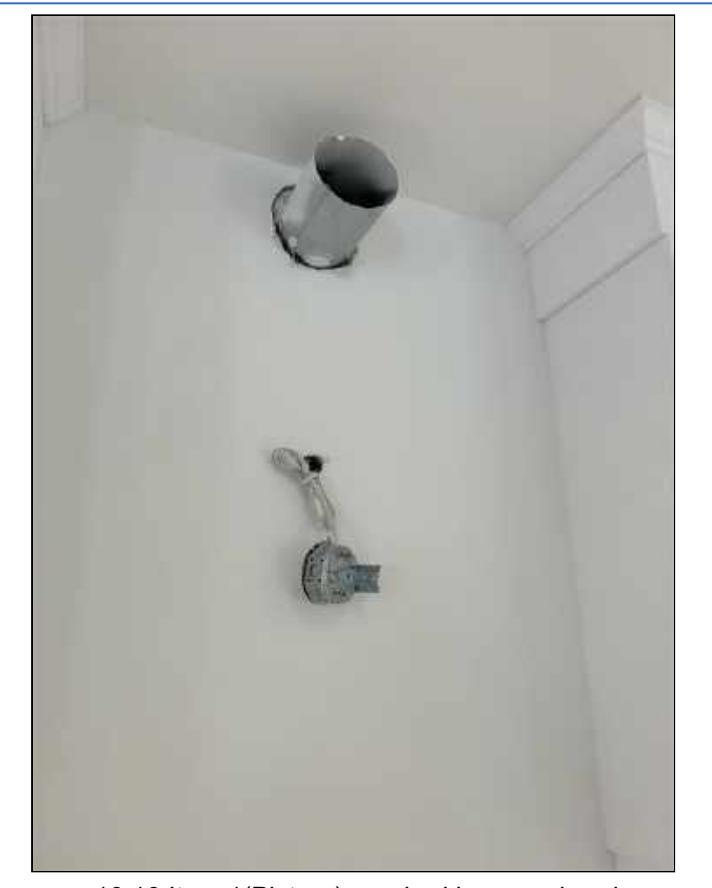
10.10 Item 1(Picture) roughed in range hood

**10.10** Not installed at inspection time.

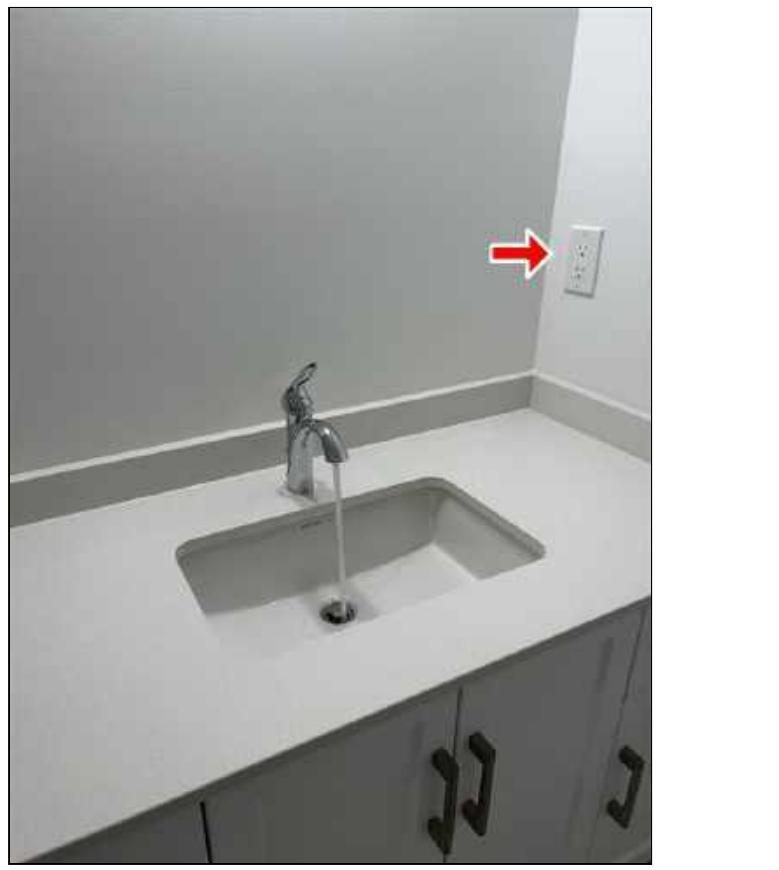
11.7 Item 1(Picture) standard outlet

**11.7** A Ground Fault Circuit Interrupter (GFCI) is not present in the downstairs bathroom, suggest installing GFCI for safety.

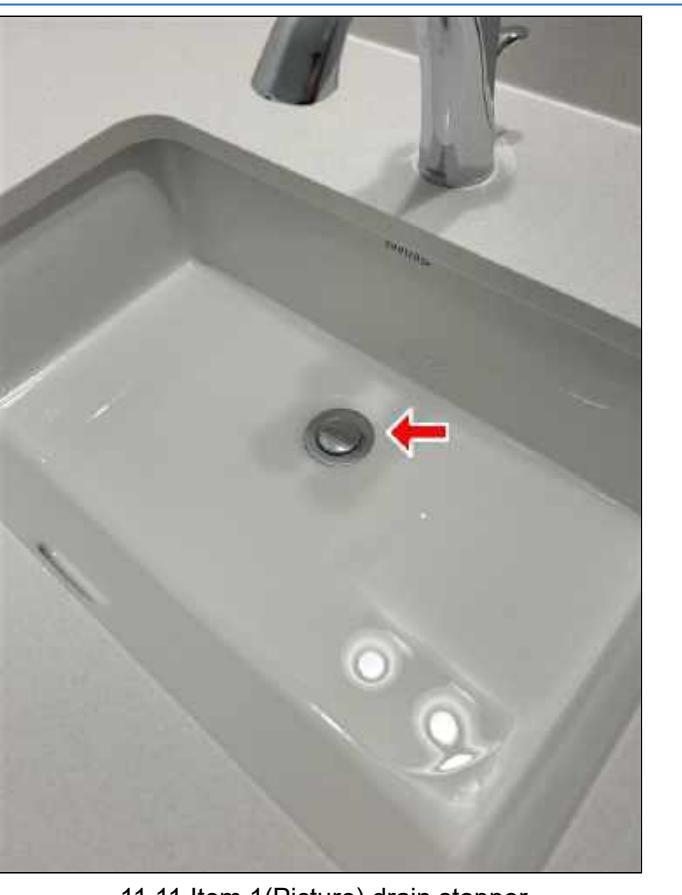
11.11 Item 1(Picture) drain stopper

**11.11** Stopper to the sink in the hall bathroom did not operate properly; adjustments/replacement is needed for proper operation.

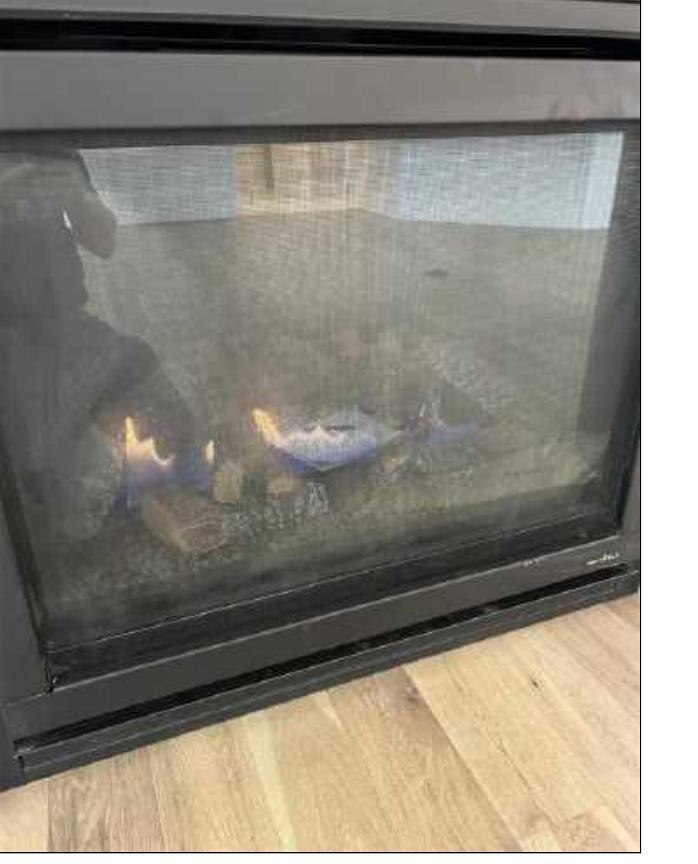
13.8 Item 1(Picture) gas fireplace

**13.8** The gas fireplace tested operable using the normal operating controls.

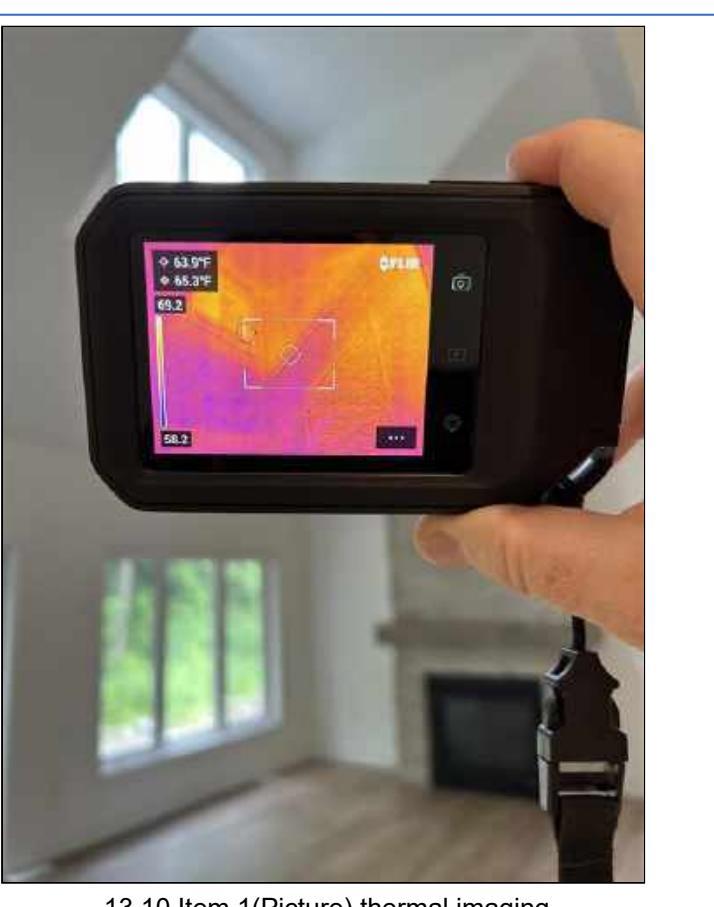
13.10 Item 1(Picture) thermal imaging

**13.10** The interior rooms and areas were inspected for the presence of moisture at visibly accessible areas through non-intrusive means using thermal imaging, a moisture meter, touch, and visual inspection. No evidence of active moisture was noted in the visibly accessible areas of the walls and ceilings.

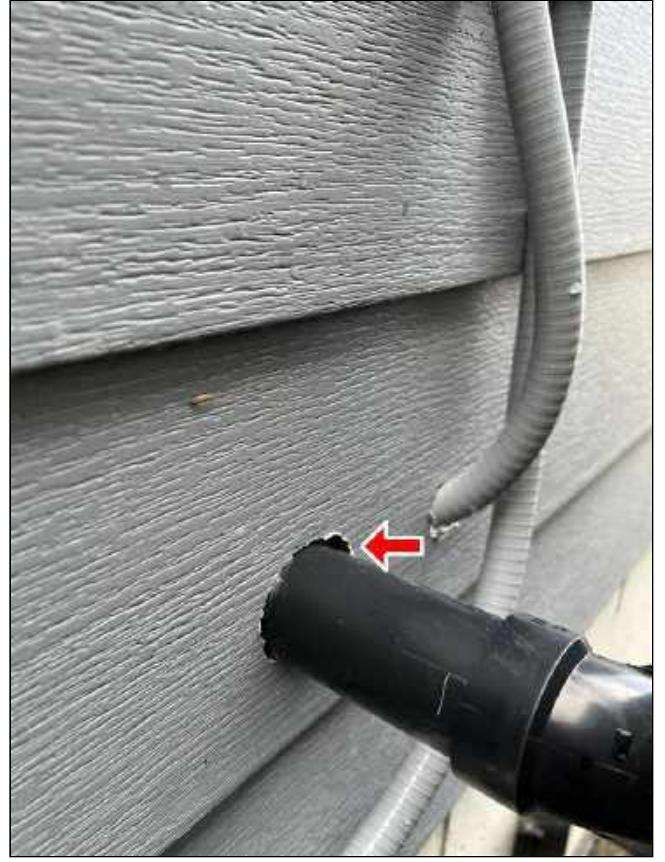
1.2 Item 1(Picture) unsealed pipe

**1.2** Opening noted around the sump pump discharge pipe at the left side. We recommend properly caulking and sealing.

Opening noted around the sump pump discharge pipe at the left side. We recommend properly caulking and sealing.

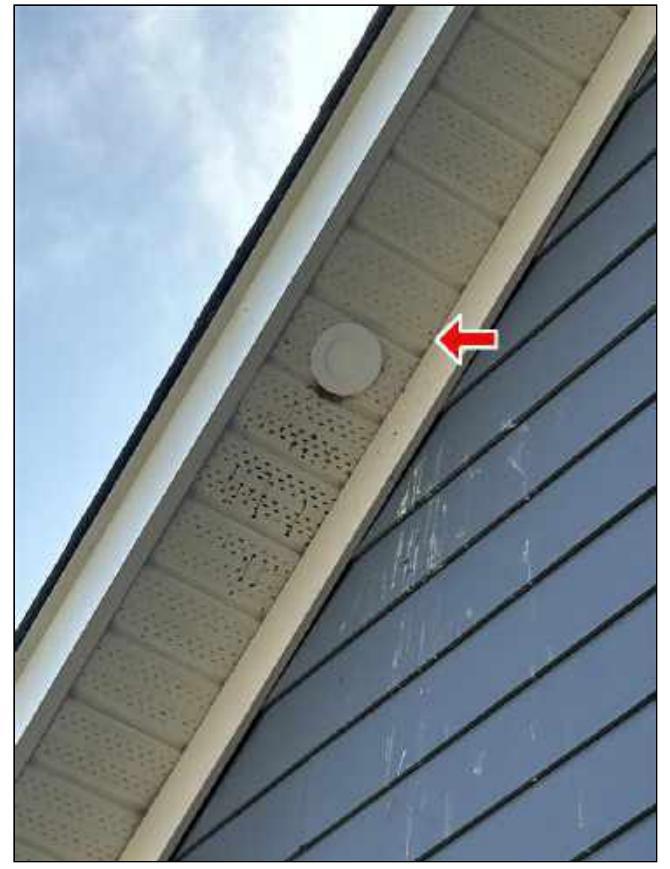
<sup>1.3</sup> Item 1(Picture)

**1.3** Evidence of previous bird infiltration noted at the right side soffit light. We recommend further review and removal as required.

Evidence of previous bird infiltration noted at the right side soffit light. We recommend further review and removal as required.

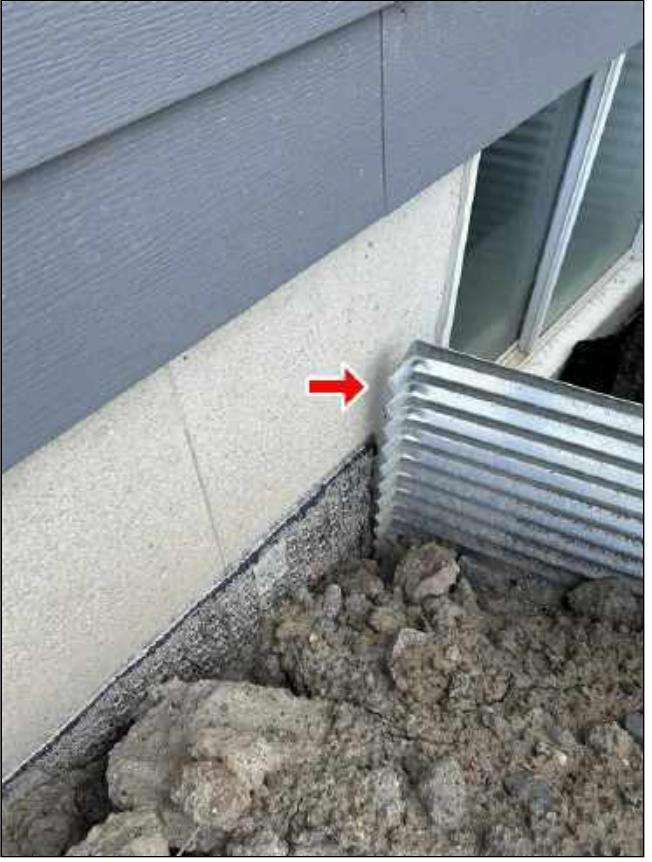
1.4 Item 1(Picture) loose window wells

**1.4** (1) Loose window wells noted. We recommend they be secured to the foundation as required.

(1) Loose window wells noted. We recommend they be secured to the foundation as required.

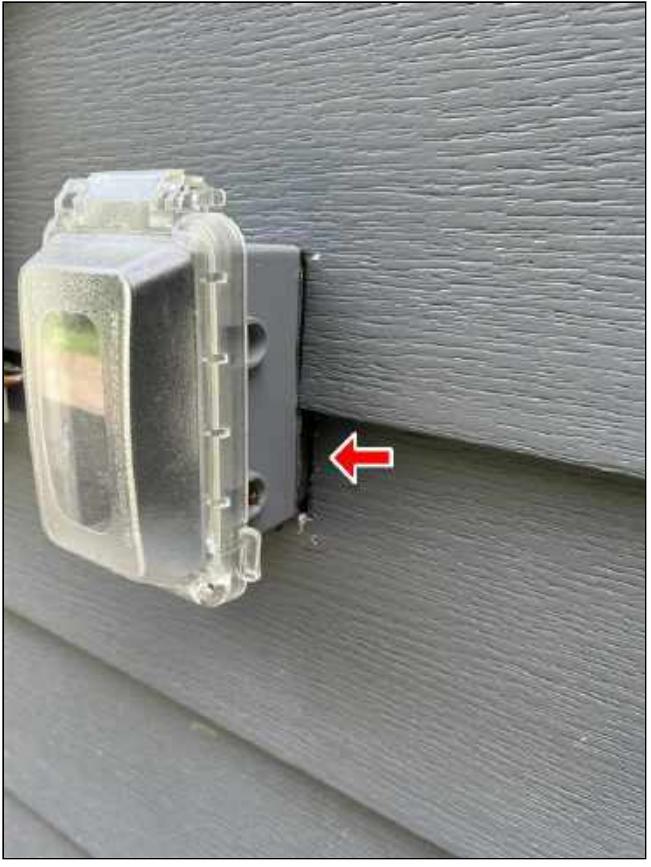
1.6 Item 1(Picture) openings

**1.6** (2) Openings noted around the exterior outlet box by the patio door. We recommend caulking/sealing to prevent water entry.

(2) Openings noted around the exterior outlet box by the patio door. We recommend caulking/sealing to prevent water entry.

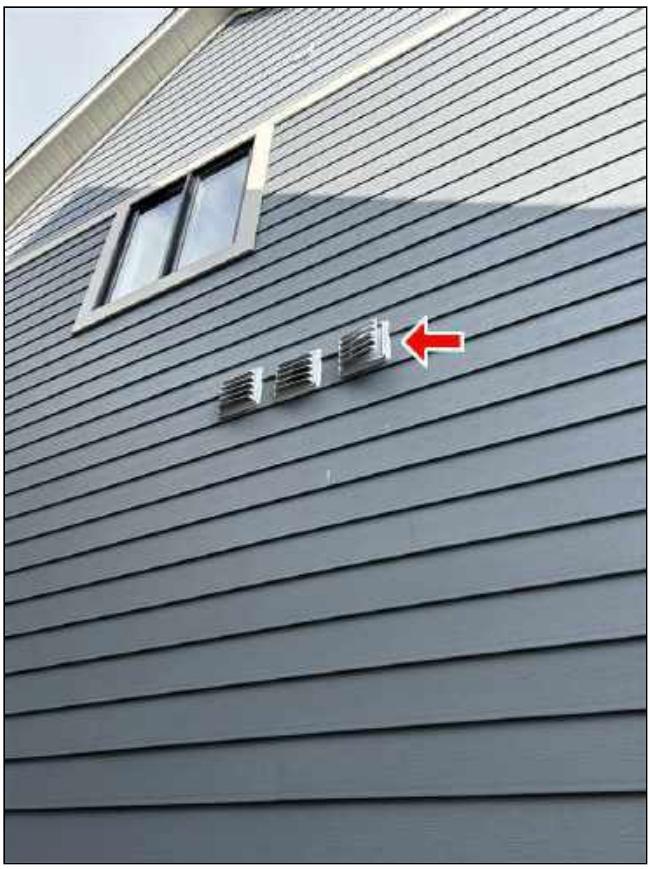
**1.11** Loose vent covers noted at the left side and rear. We recommend properly securing. Evidence of previous bird infiltration noted at the right side vent. We recommend further review and removal as required.

Loose vent covers noted at the left side and rear. We recommend properly securing. Evidence of previous bird infiltration noted at the right side vent. We recommend further review and removal as required.

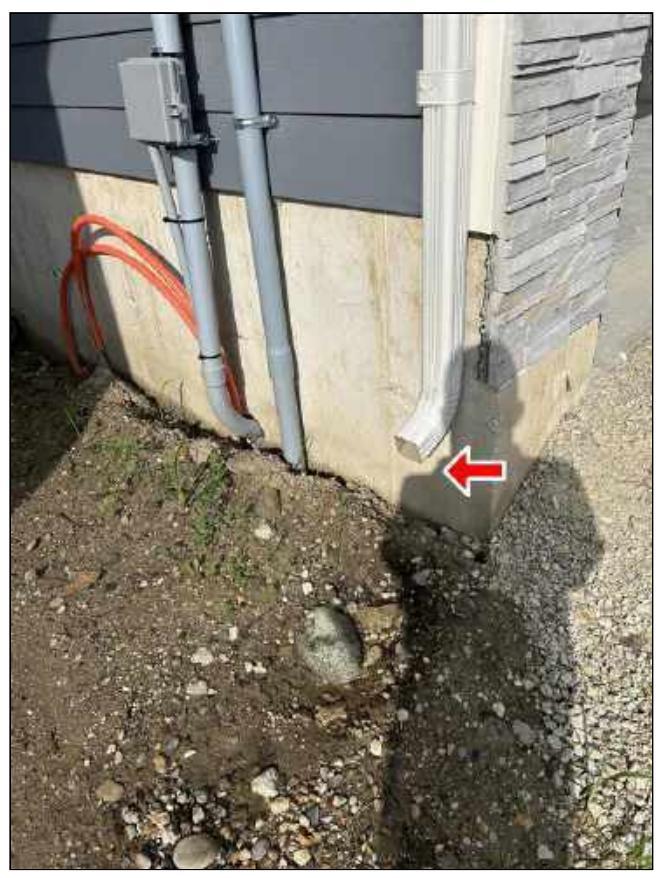
2.2 Item 1(Picture) missing extension

Downspout extensions not installed at inspection time.

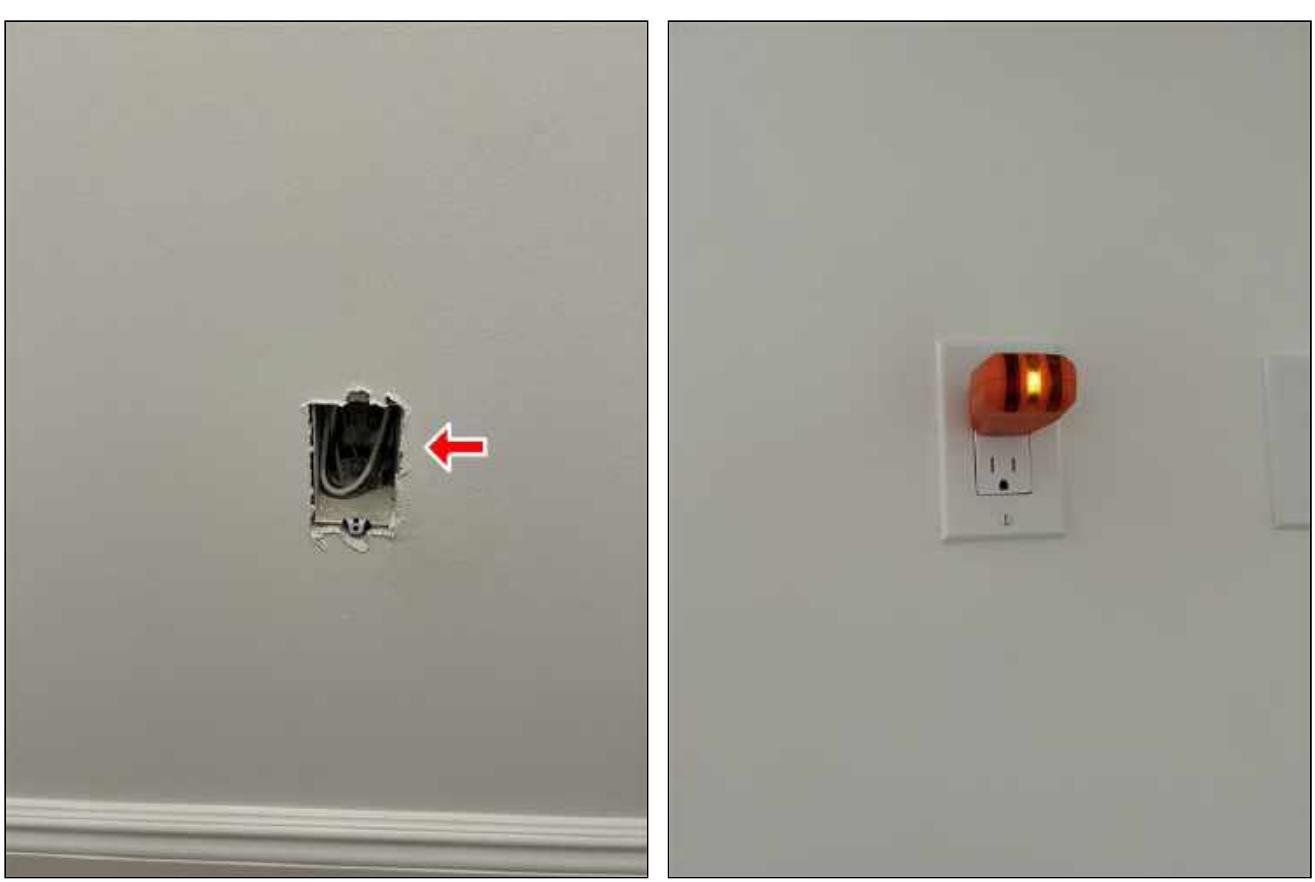
4.10 Item 1(Picture) missing receptacle

Receptacle not installed in the basement stairwell. Open ground outlet noted on the wall mounted receptacle. We recommend electrical repairs be completed.

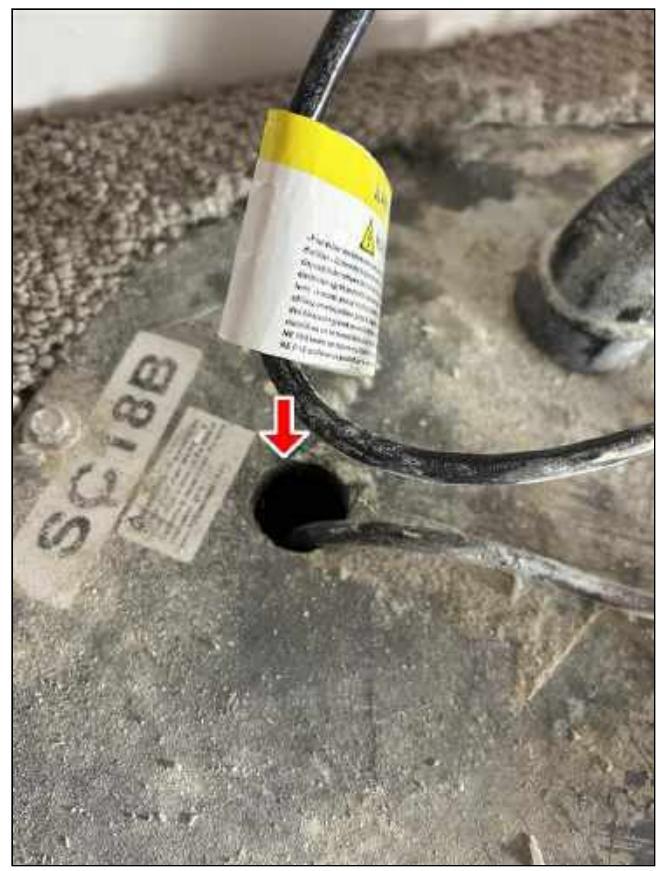
5.3 Item 1(Picture) opening

Missing gasket noted on the sealed sump lid. We recommend installation as required.

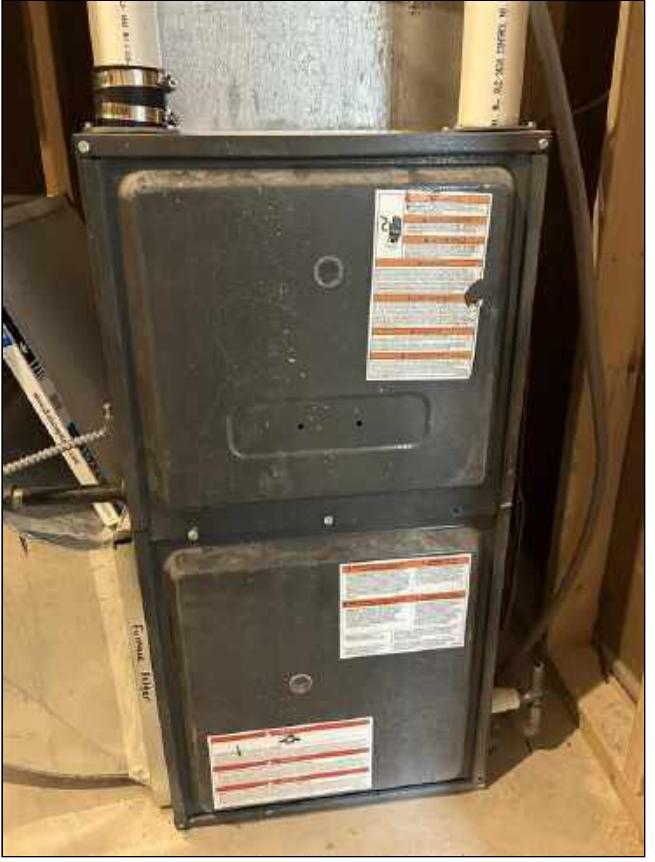
7.0 Item 1(Picture) furnace conditions

(1) Cover attachment screw and manufacturers plate missing. We recommend installation as required.

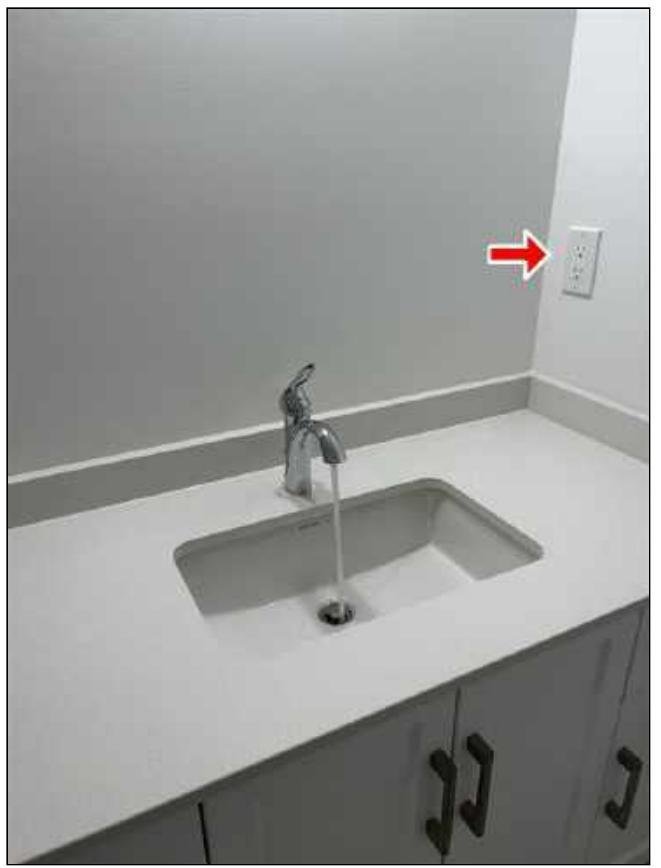
11.7 Item 1(Picture) standard outlet

A Ground Fault Circuit Interrupter (GFCI) is not present in the downstairs bathroom, suggest installing GFCI for safety.

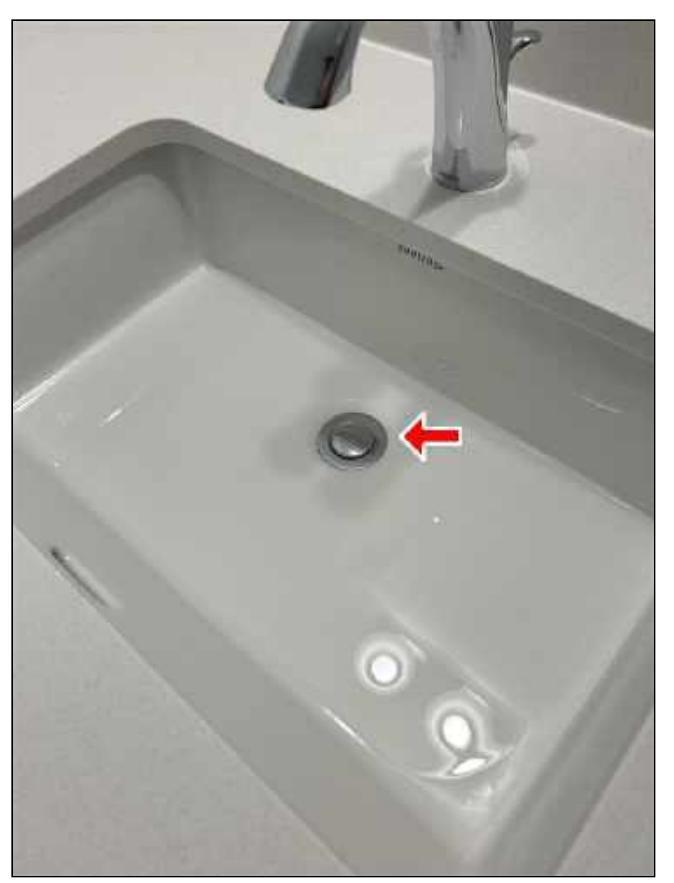
11.11 Item 1(Picture) drain stopper

Stopper to the sink in the hall bathroom did not operate properly; adjustments/replacement is needed for proper operation.
